# GTZ KIEN GIANG BIOSPHERE RESERVE PROJECT

## SEA DYKE REHABILITATION IN KIEN GIANG PROVINCE, VIETNAM

TECHNICAL REPORT NO : 11E1209MICH

## Report on the Reconnaissance Mission from 4<sup>th</sup> to 7<sup>th</sup> December 2009

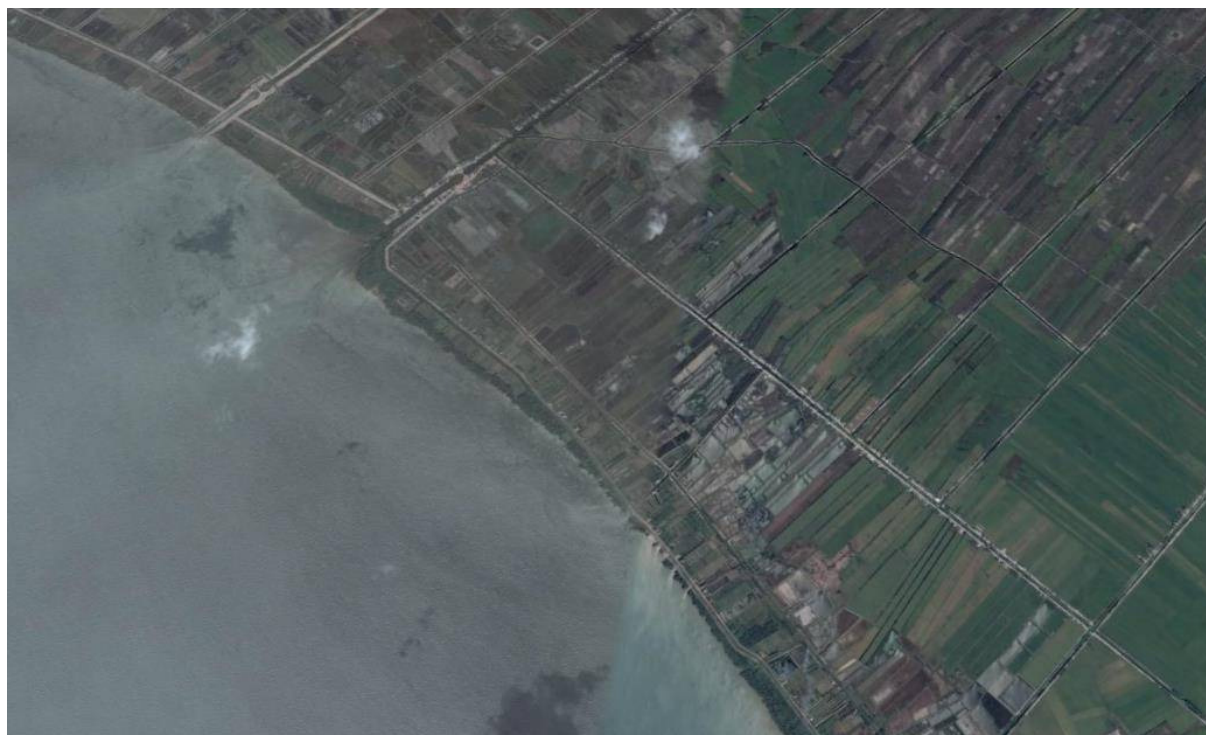
Photo 2: Affected area at Hon Dat District approx. 2 km south of the channel mouth

Caused by strong sea currents and erosion of the foreshore the natural mangrove belt south at Hon Dat District has been destroyed for a distance of 500 to 600 m along the coast. In this area replanting of mangroves has failed and the dyke behind the mangroves is heavily eroded and in some parts completely destroyed.

The material for the dyke construction was extracted from the seaside area. This has resulted in the formation of a wide and deep trench along the seaward side of dyke toe. This extraction of soil, combined with strong currents appears to be the cause of the erosion of the foreshore.

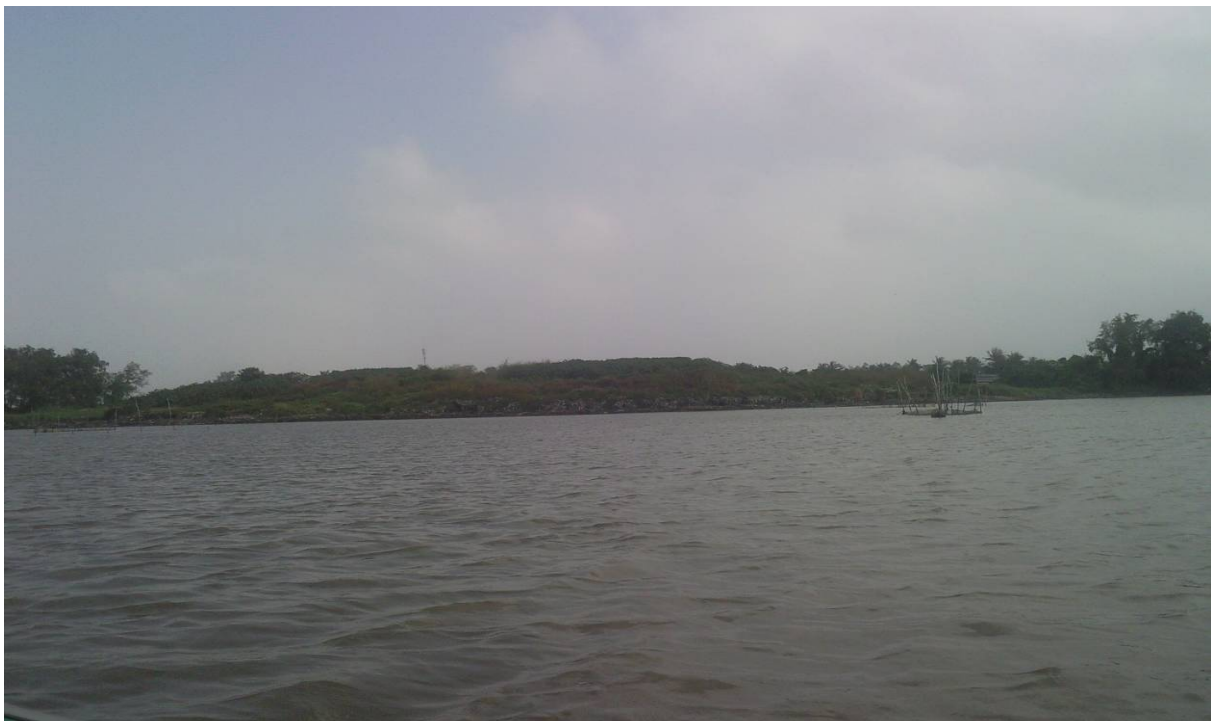
A first boat stop was made at a waste disposal area located in the North of Rach Gia close to the coastline. The waste disposal area was covered by soil but due to currents and waves the seaward cover of the waste disposal area has been eroded and waste as well as pollutants can be washed out into the sea. Fig. 1 shows the actual situation. It is recommended to stop the wash out of waste by covering and protecting the waste disposal area as soon as possible.

Fig.1: Waste disposal area close to Rach Gia City

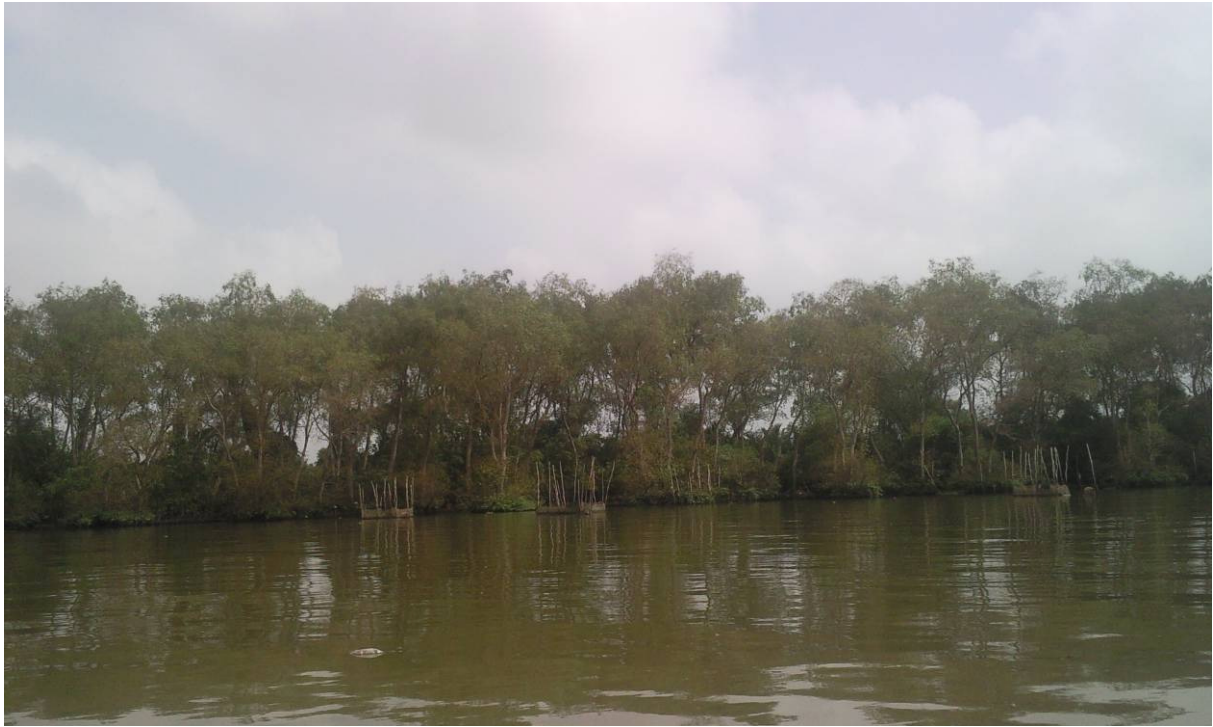
A second boat stop was made to visit the mangrove forest north of Rach Gia (Fig. 2). The mangrove belt is about 20m wide. The influence of this mangrove belt on waves and currents will not be significant during storm surge events. Anyway, no erosion from the seaside was

observed but the inner side of this mangrove area is used for agriculture and housing. Fig. 2 and Fig. 3 show the same site, Fig. 2 from the seaside and Fig. 3 from the landside.

Fig.2: Mangrove forest north of sea bridge No 1, Rach Gia City

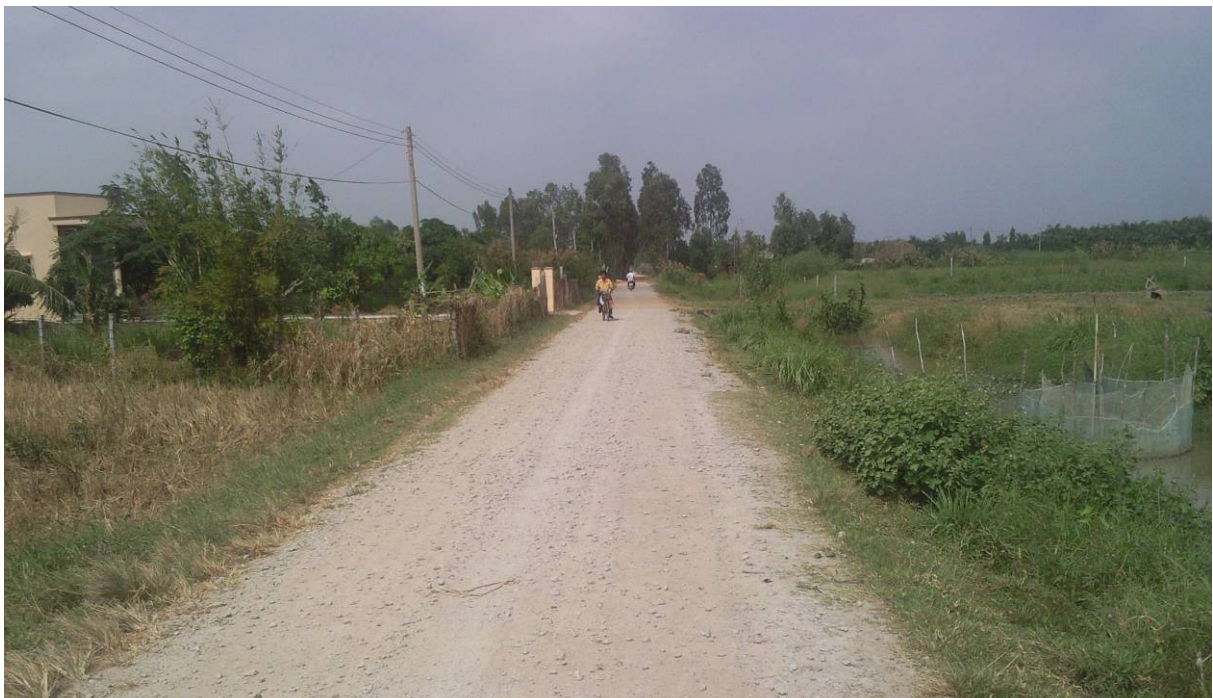
Fig. 3 shows the coastal defence dyke in the North of Rach Gia. The dyke has been built as a military defence road and became a coastal defence dyke in recent years. The dyke has a crest level of about 1.6m above MSL and a crest width of about 6m. The slopes with a gradient of about 1:2 are covered by grass on both sides. No dike protection like a revetment or an overflow protection is applied at this site.

Fig.3: National defence dyke, Vinh Quang , Rach Gia City

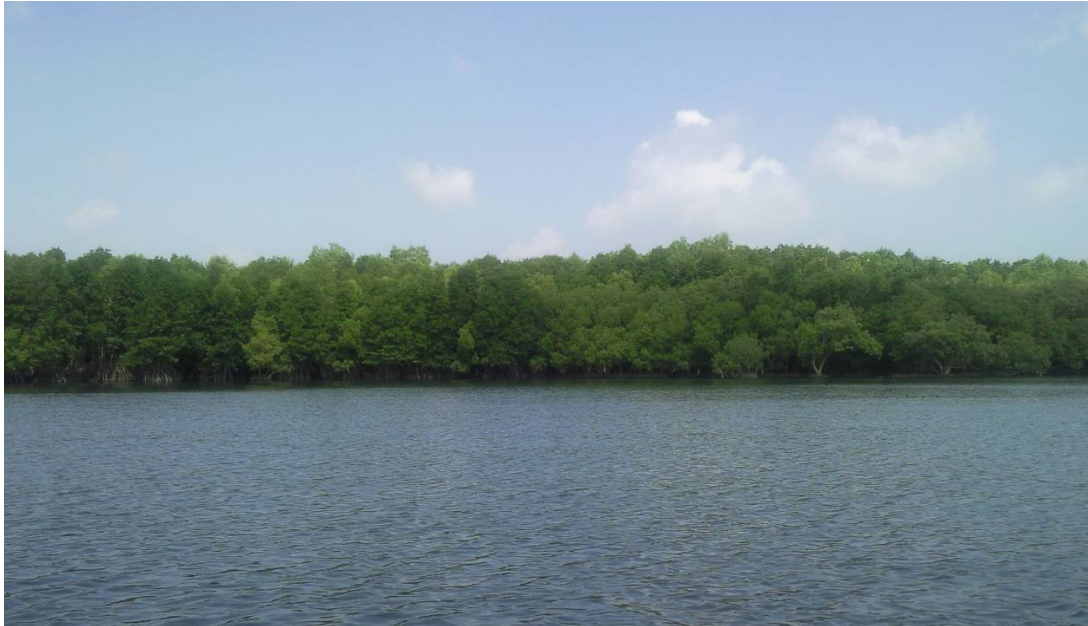
The second stop of the site visit was in Hon Dat district. In Hon Dat district, in some areas the coastal mangrove belt shows no erosion (Fig. 4) and seems to be in a very good condition in these areas. The mangrove belt consists of different mangrove species. The width of the mangrove belt is estimated to be around 100m.

Fig.4: Mangrove forest without erosion in Hon Dat district

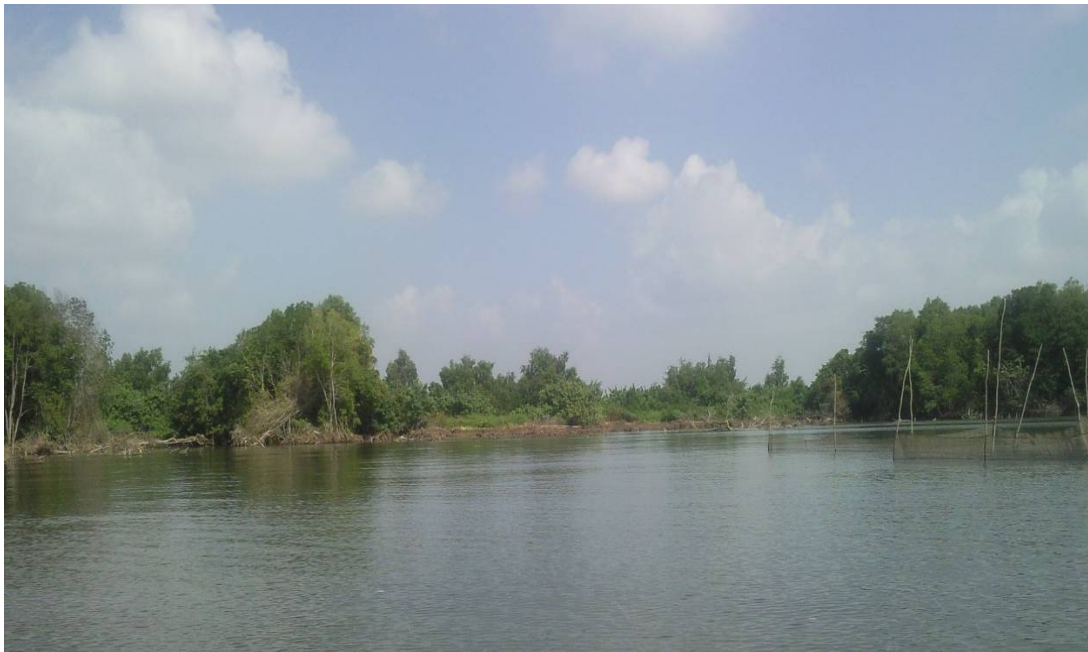
In other areas in Hon Dat district, severe erosion of the coastline resulting in a retreat of the mangrove belt occurred (Fig. 5). In parts, no mangroves are protecting the coastal dyke anymore. No explanation for this retreat of the mangrove belt was given by the local authorities. The collapse of the mangrove belt resulted in dyke failures and dyke breaks already observed during the last mission in November 2008.

Fig.5: Mangrove forest with erosion in Hon Dat district

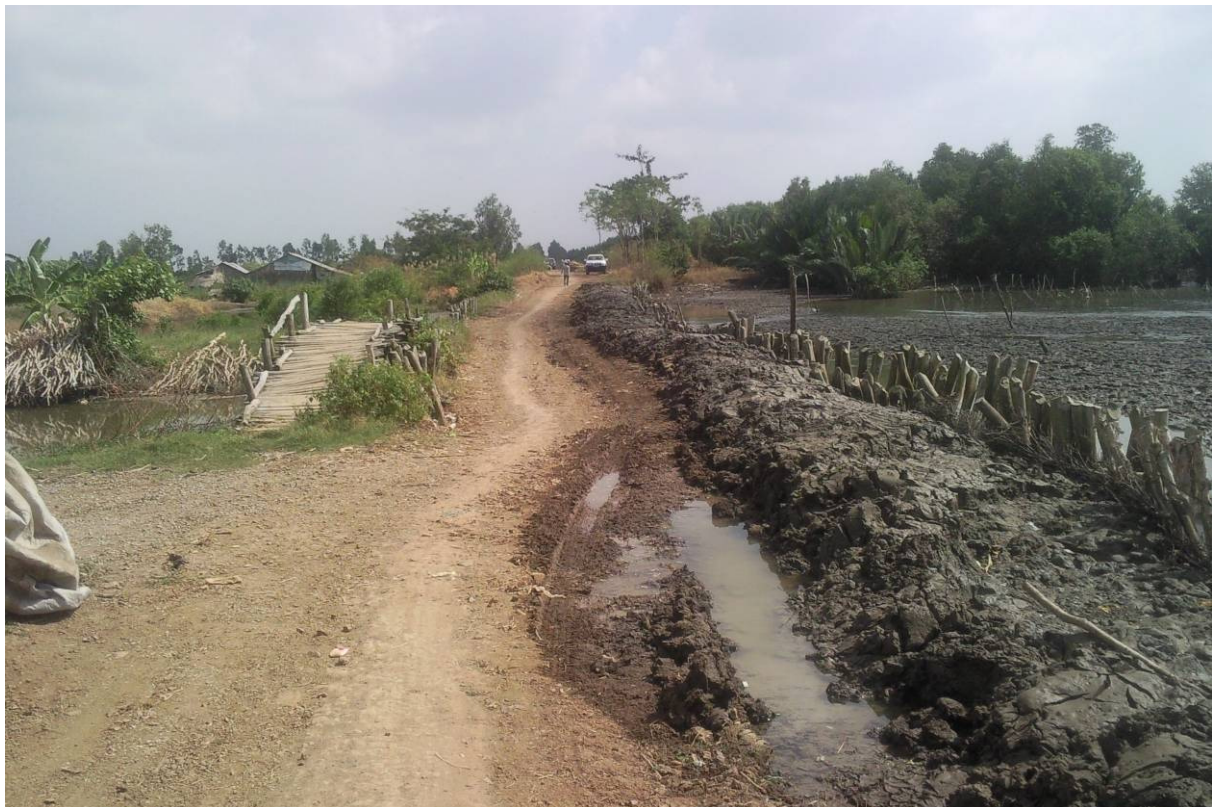
The collapsed dyke without any mangrove protection is shown in Fig. 6. It is obvious that the material for the dyke construction was taken from the seaward side of the dyke resulting in the excavation of a canal being parallel to the dyke. In addition, canals were built to connect the sea with the dyke in these areas. Therefore, the tides and storm surge currents are able to enter the canals resulting in high currents at the toe of the dyke. Since the clay material of the dyke can be easily eroded, the dyke has no residual strength and fails.

Fig.6: Eroded dyke with emergency repair in Hon Dat district

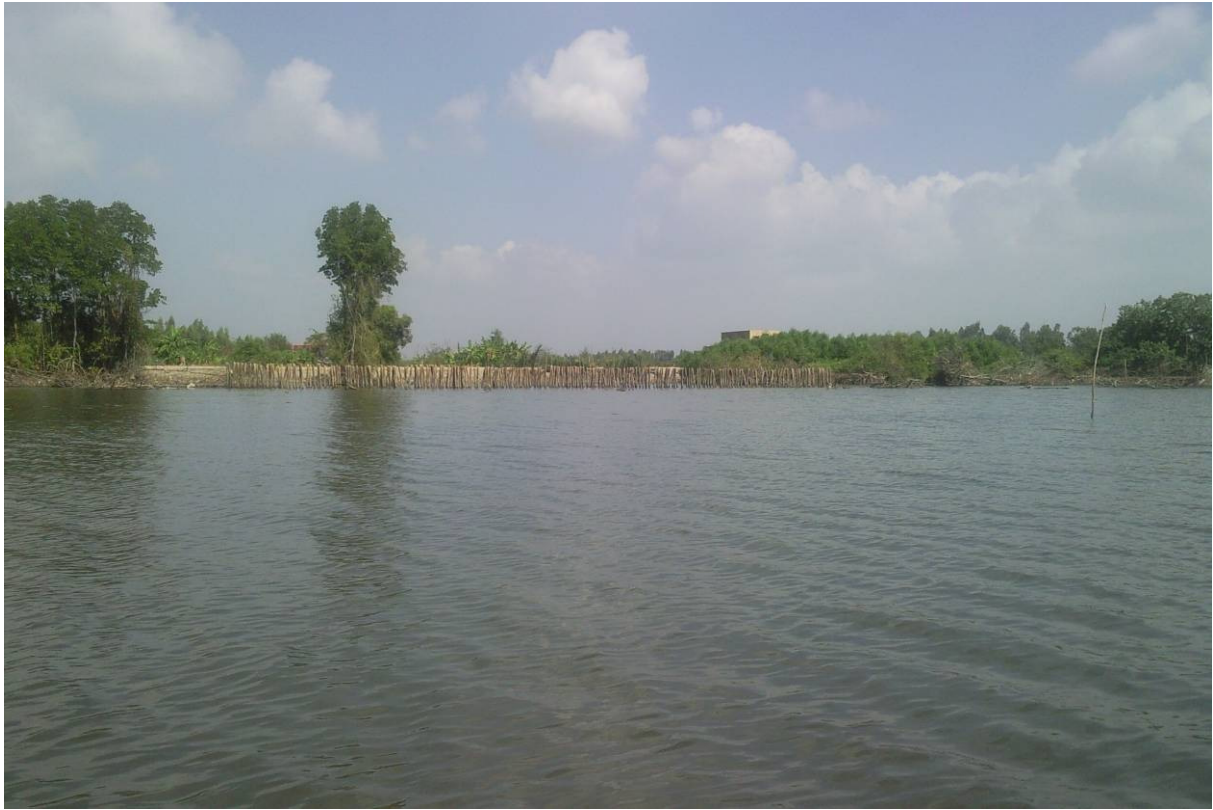
Wooden fences were built along these mangrove retreat areas to reduce the incoming currents and waves, to initiate and to support siltation and to create areas for mangrove rehabilitation (Fig. 7).

Fig.7: Protection of eroded area by wooden fences

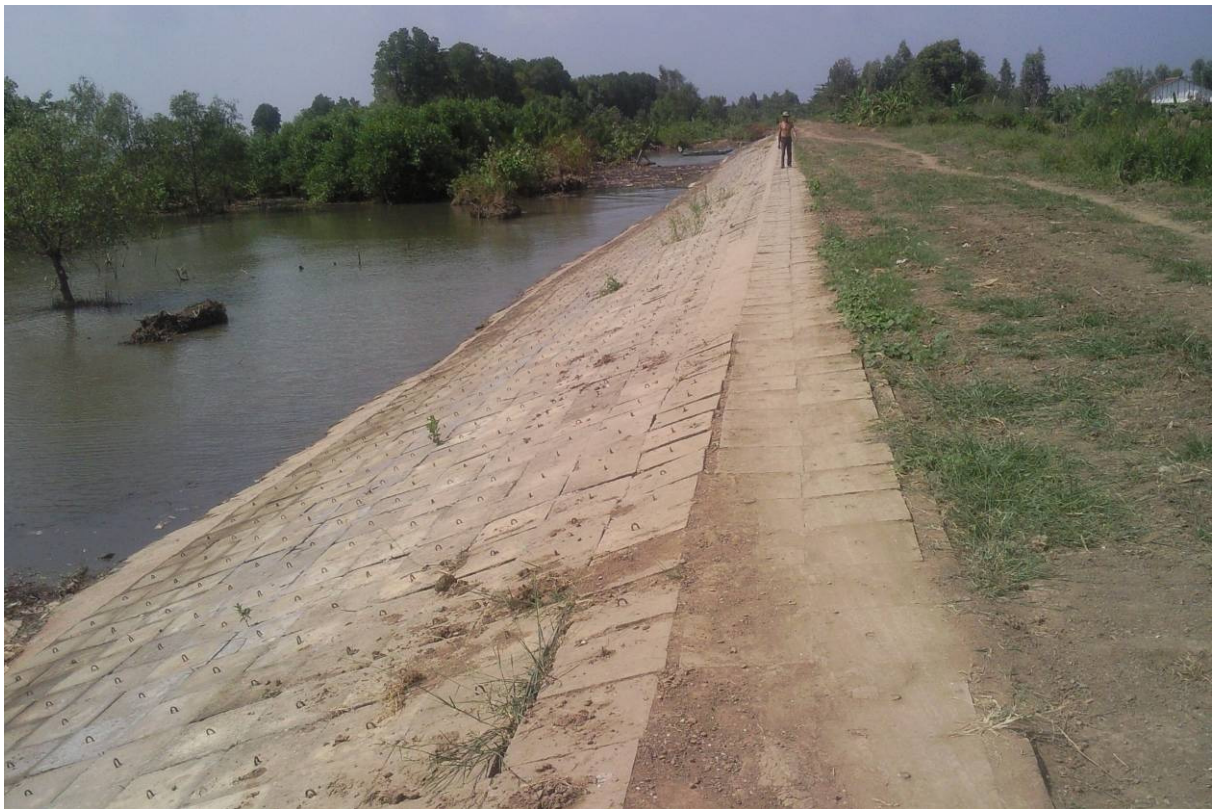
In addition, parts of the dyke were rebuilt as a pitched slope revetment in between the mission in November 2008 and the present mission in December 2009. The crest level height is estimated to be only 2.0m above MSL, the slope is 1:3 and the width of the crest is 6.0m. The revetment is built out of placed prefabricated concrete slaps on a geotextile. However, deviating from the recommendations placing of a filter zone of gravel material has been omitted. It was reported that a special foot protection consisting of concrete culverts filled with rock material is installed according to the recommendations but cannot be proven whether this has been applied to the whole section of dyke reconstruction.

Fig.8: New coastal dyke in Hon Dat district

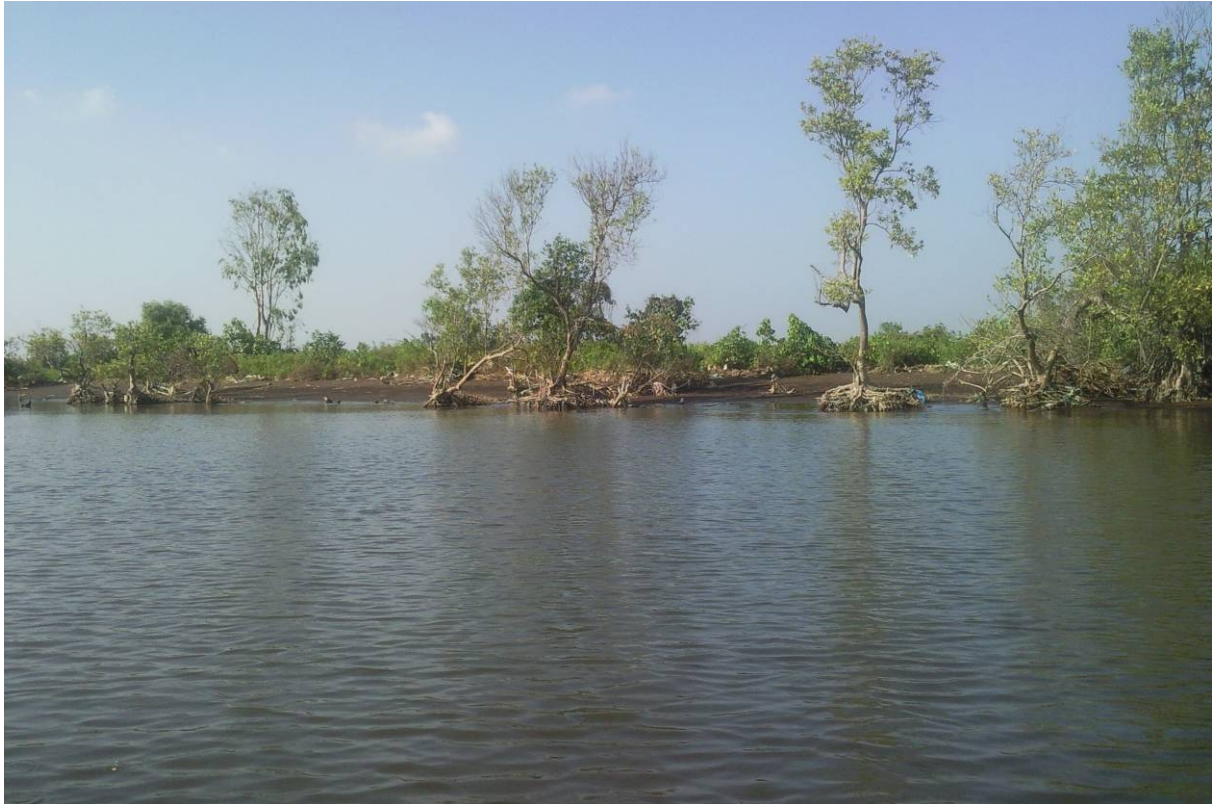
Site 3 is located south of the canal T6. Here, the present condition of the mangrove forest was visited by boat. As can be seen from Fig. 9, the mangrove forest is strongly eroding. No measures were undertaken up to now to reduce this erosion. In some areas, the erosion of the mangrove forest has already reached the dyke toe.

Fig.9: Erosion of dyke mangrove forest close to T6 canal

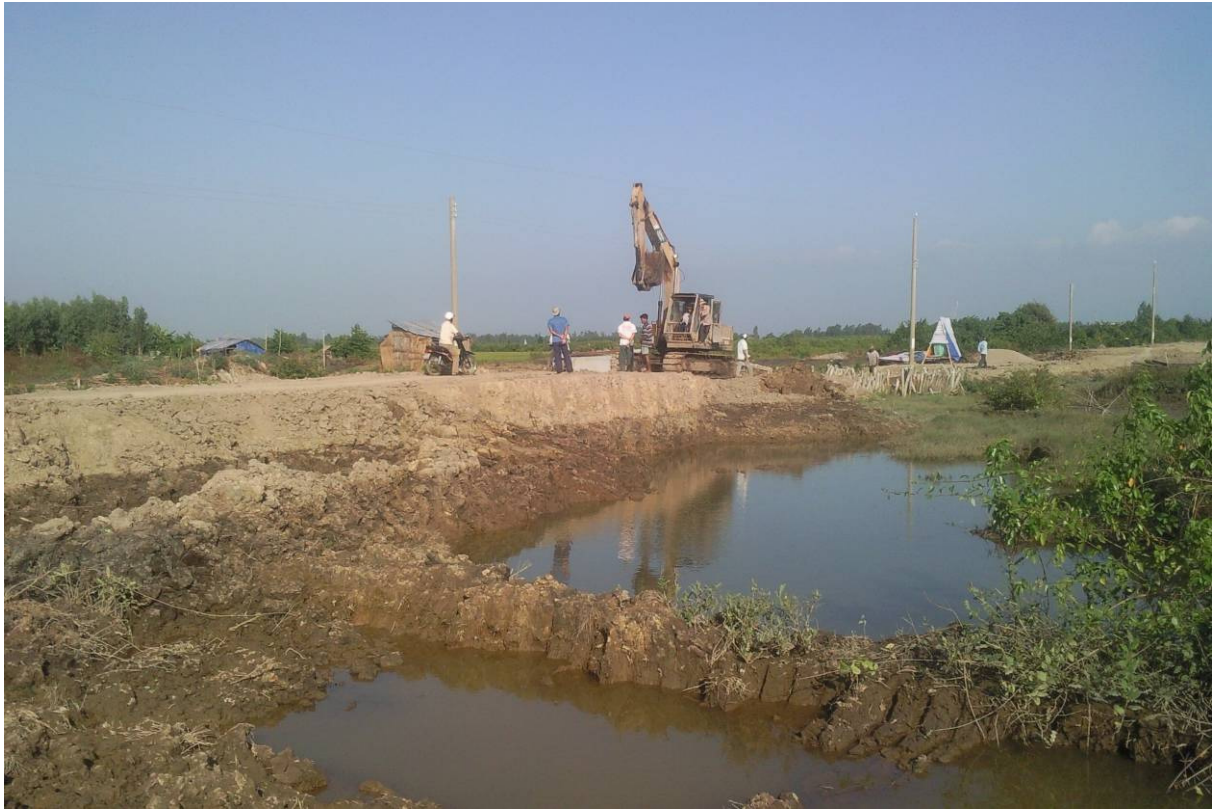
Dyke construction works were ongoing at this site during the site visit (Fig. 10). As can be seen from Fig. 10, the dyke construction material is taken from the seaward side. This results in a new dyke parallel canal which will have the same negative effects on the dyke safety as already mentioned for the dyke in the Hon Dat district in Fig. 6.

Fig.10: Dyke construction works close to T6 canal

- Use dyke construction material from the landward side and not from the seaward side.
- Before placing new embankment or revetment material the foundation area shall be cleared of any organic or other material. Wherever required the area shall be compacted by vibrating rollers.
- Trees, roots, houses or other items in the dyke should be removed before constructing the dyke.
- Special attention should be paid to the intersections between seaward slope and crest to avoid backward erosion.

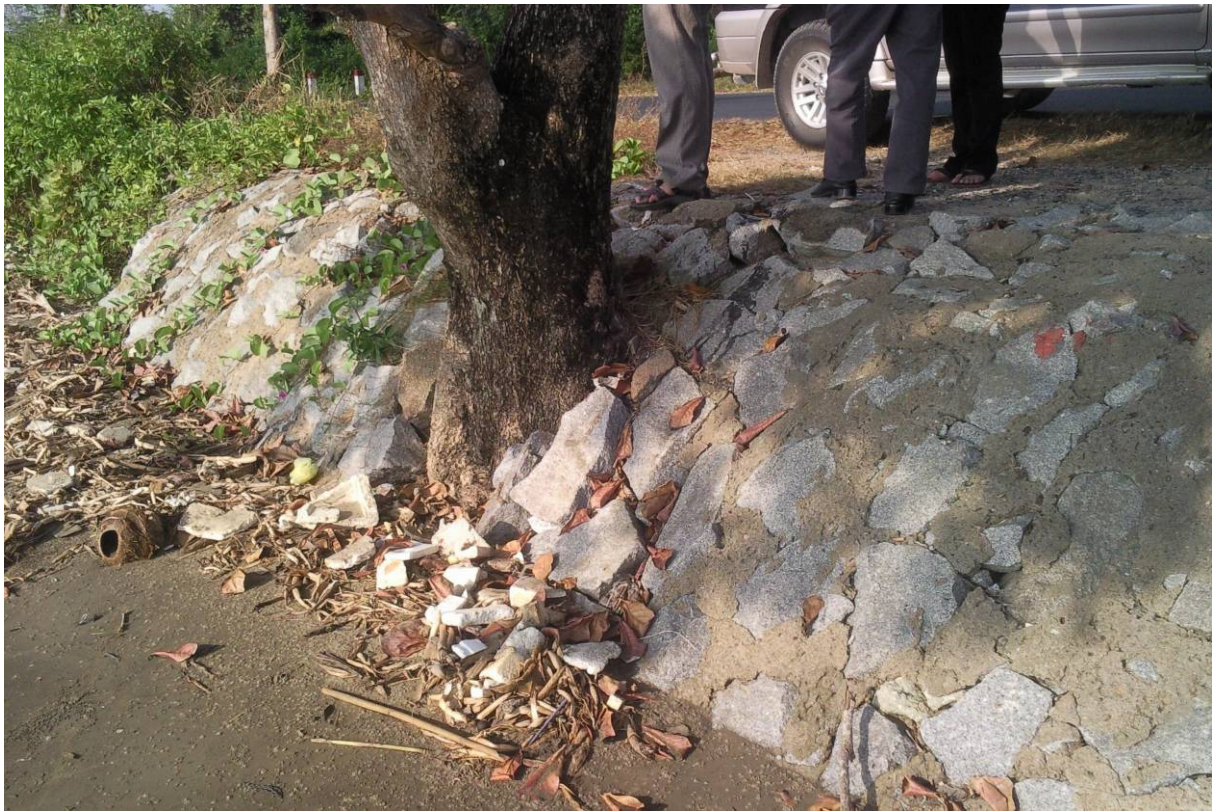
In the south of Ha Tien, the road connecting Rach Gia and Ha Tien is protected by a coastal revetment with a single rubble mound layer (slope of 1:1). A number of weak points were identified during the site visit:

- Trees in the revetment (Fig. 11)
- Break outs in the seaward slope (Fig. 12)
- Missing geotextile
- Missing foot protection
- Missing stability due to bad concrete
- Roots under the cover layer

These weak points are points of initiation for further erosion, stability lost and breaching of the revetment.

Fig.11: Coastal revetment south of Ha Tien Town

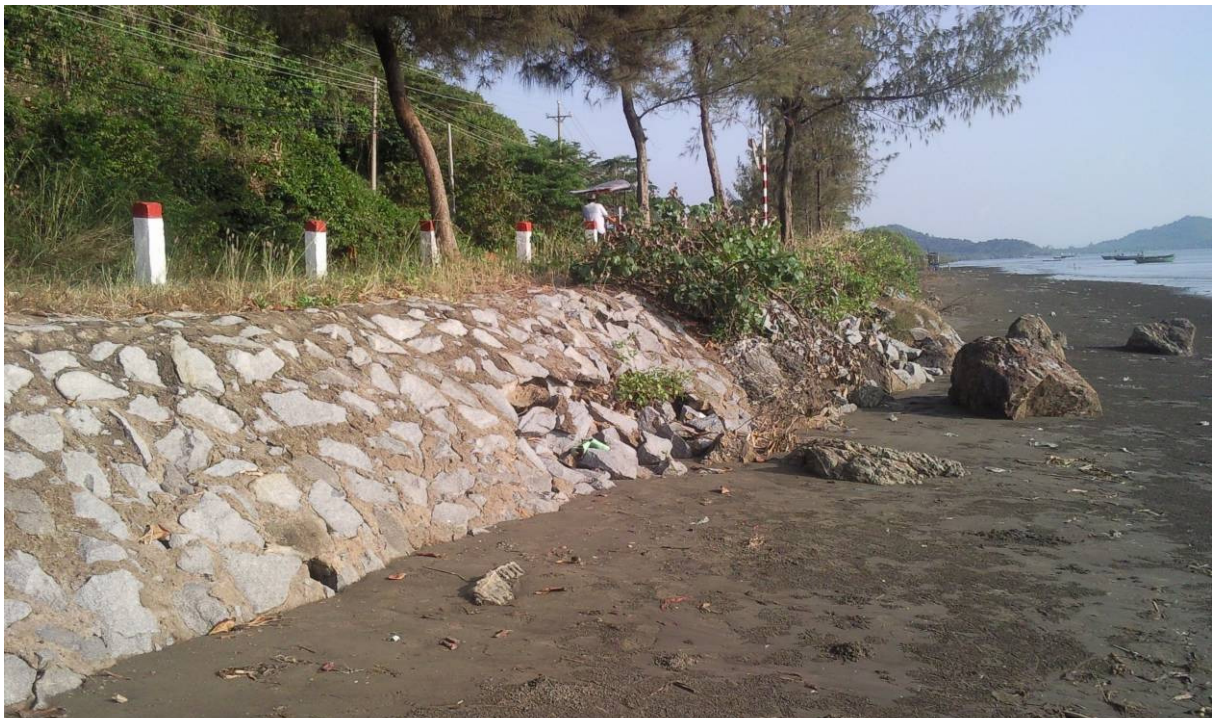
Fig.12: Coastal Revetment south of Ha Tien Town

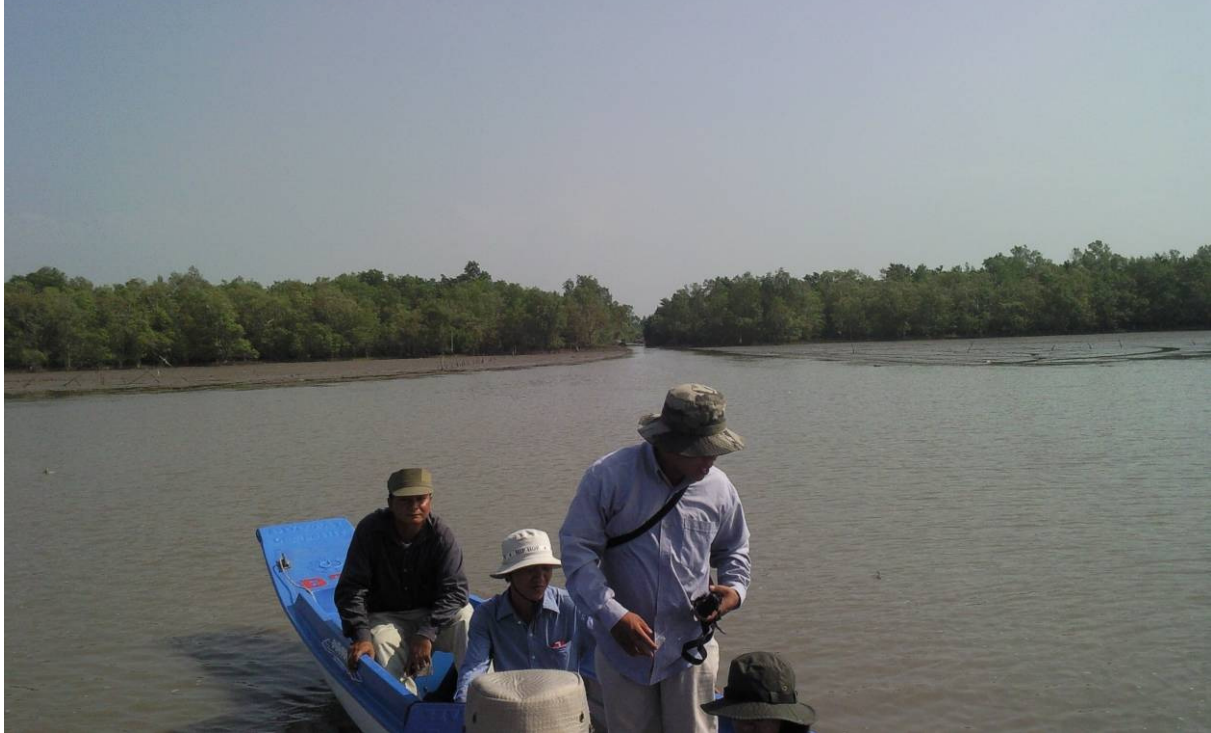
Site 5 – An Bien was reported by the local authorities as an erosion site. The mangrove belt at this site has a width of more than 100m and a very shallow foreshore. No signs of erosion were detected during the site visit (Fig. 13). This site was observed by boat.

Fig.13: Mangrove forest without coastal erosion at An Bien

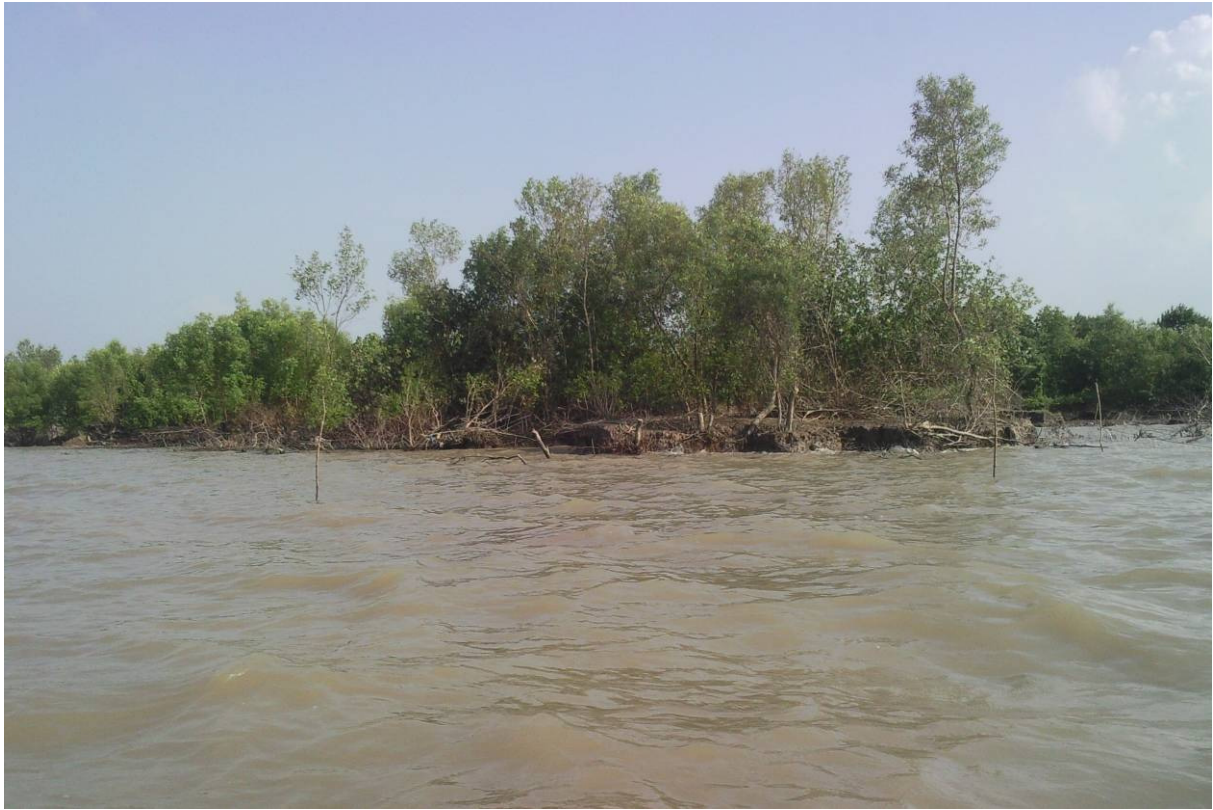
A severe retreat of the mangrove forest was observed at site 6 – An Minh (Fig. 14). This site was also visited by boat.

Shrimp farms were built in the mangrove forests in the past and connected by canals with the sea. The canals eroded and a breaching of the shoreline occurred due to currents and waves. Therefore, the water can enter this site and erode the clayey soil. The soil is eroded in between the roots of the mangroves and thus, the mangroves lose their stability and fall into the water. This process is very fast resulting in a retreat of the mangroves from about 10 to 20 m/year. Fig. 15 shows a detail of the eroded coastline. The coastal erosion could even be observed during the site visit. Small clayey aggregates fell into the water.

Fig.14: Retreat of mangroves at An Minh District

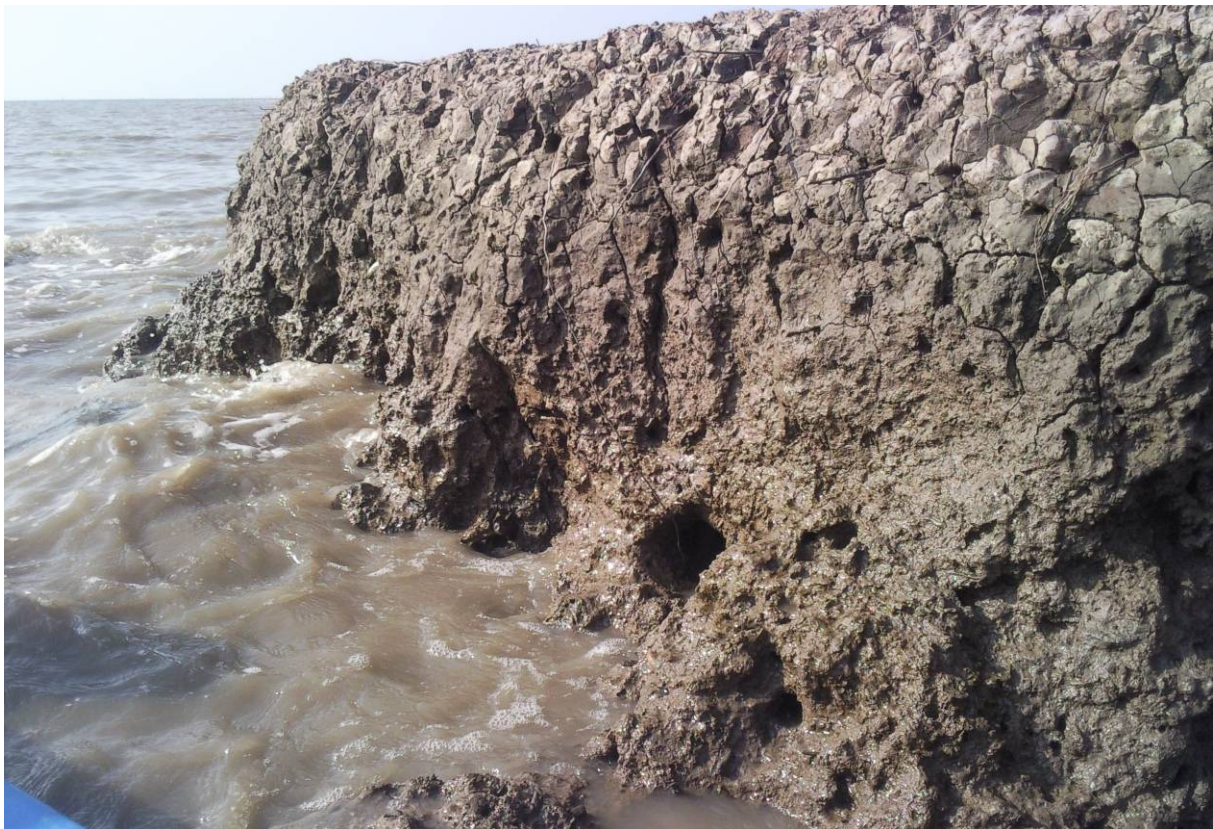
Fig.15: Detail of coastal Erosion of a Mangrove forest at An Minh District

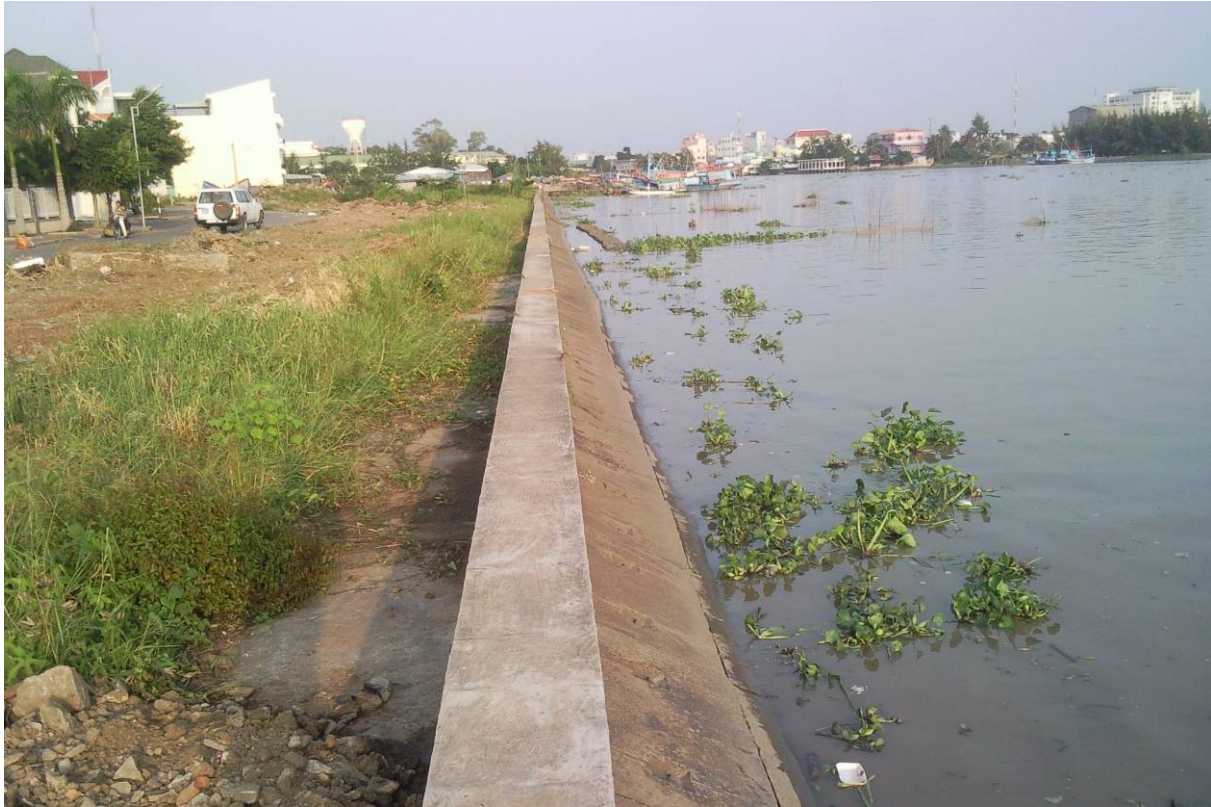
The urban flood protection at Rach Gia was visited at the end of the mission. The urban flood protection consists of concrete seawalls with a wave return wall at the top. Figs. 16 and 17 show two examples in the new land reclamation area of Rach Gia. It has to be mentioned that other parts of the city of Rach Gia are not protected by seawalls.

Fig.16: Seawall in Rach Gia City

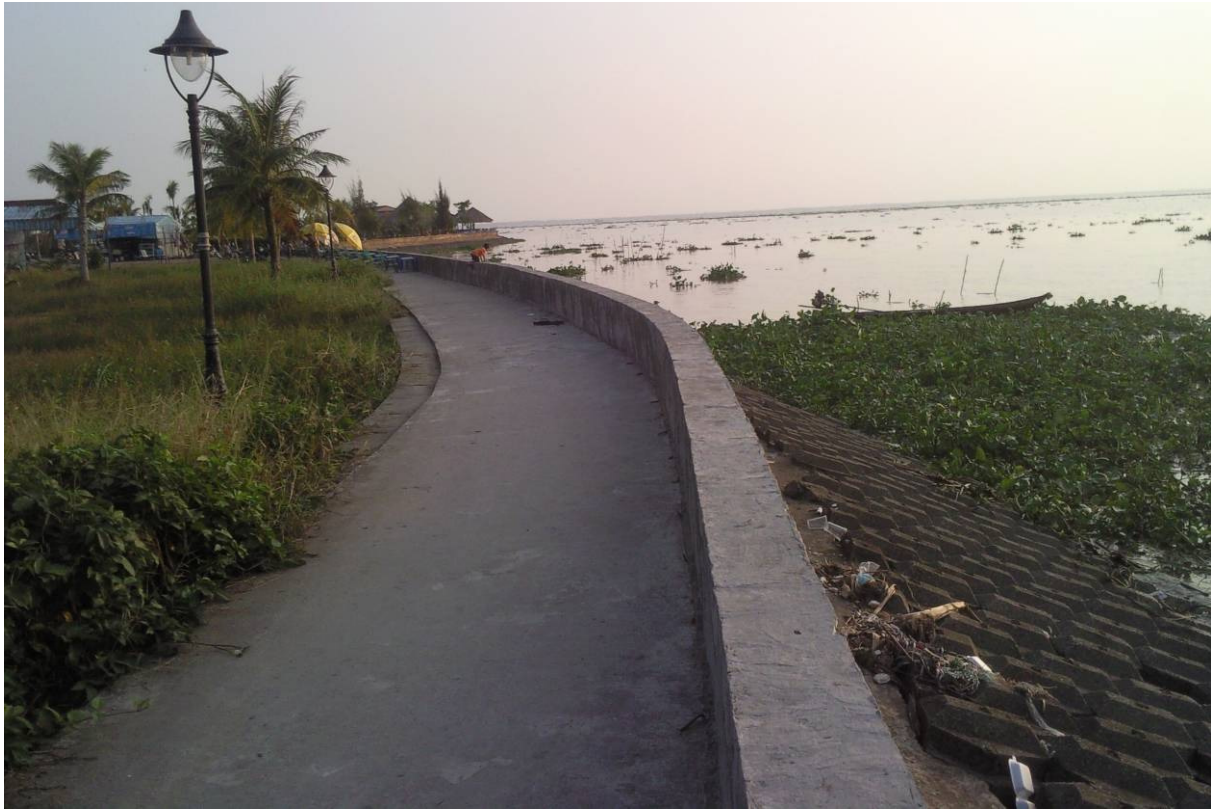
Fig.17: Seawall in Rach Gia City
