DIKE SURVEY REPORT

Results of an initial dike inspection in the Ca Mau Province

GIZ in Vietnam

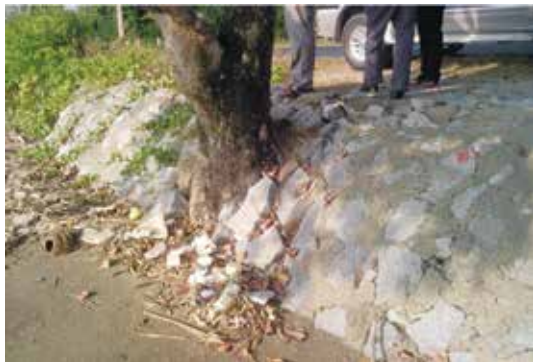
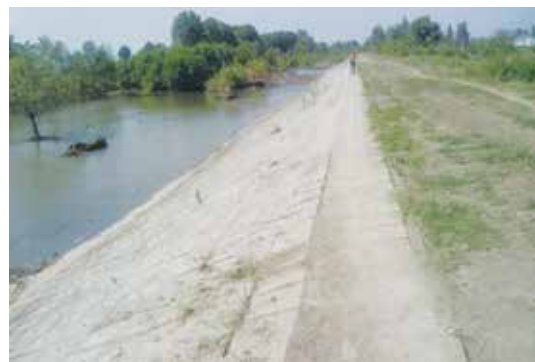
Figure 3: Highly damaged dike revetment (left) and dike revetment with concrete slabs (right)
[Heiland & Schüttrumpf, 2009]

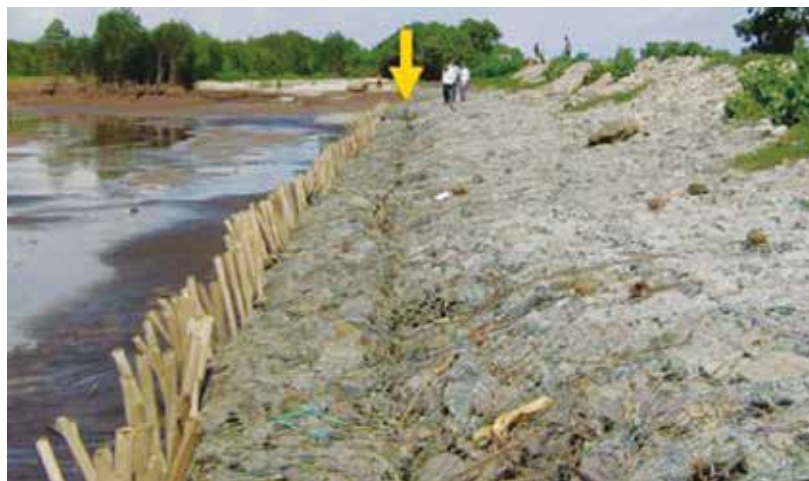
Figure 4: Toe protection with wood piling. Yellow arrow: Gap in revetment due to further erosion
[Albers & Von Lieberman, 2011]

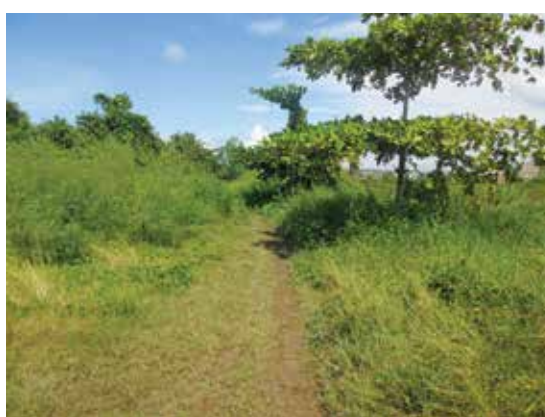
Following the dike line a few hundred meters, the dike's appearance changes and becomes less ordered (see Figure 7). There, vegetation can also be found on the dike crest and the transition from the dike crest to the slopes is harder to define.

Figure 7: View along the dike

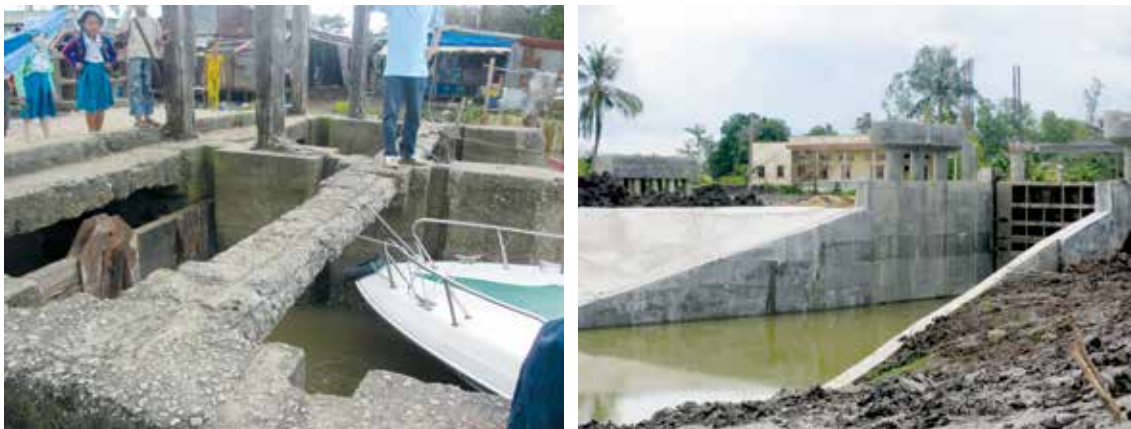
Besides the described dike section, a sluice gate closing the channel R. Huong Mai was visited (see Figure 9 left). This sluice gate is connected to the dike line and therefore helps to protect the hinterland from floods. However, the dike section next to the sluice has settled so that water flowed over the dike during recent times (see SIWRP report for the results of the terrestrial survey around the sluice gate). A new sluice gate is under construction more inland (see Figure 9 right). This sluice gate is not connected to the dike line yet.

Figure 9: Sluice gate connected to the dike line (left) and sluice gate further inland (right)

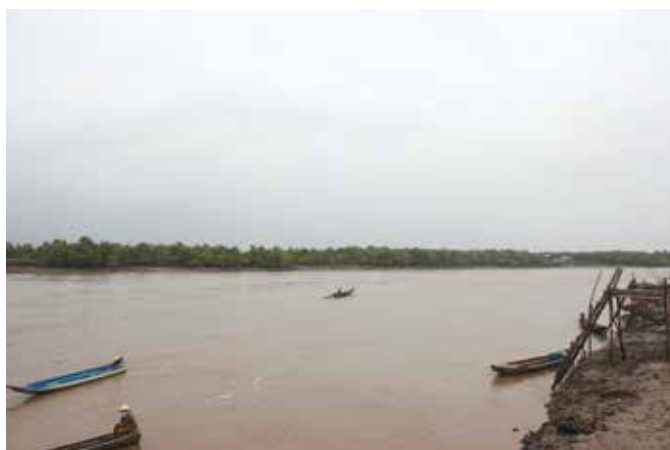
Nearby the visited site, an open channel (Song Ho Gui) with a width of more than 20 m can be found (see Figure 11). As there is no sluice gate closing this channel, a flood could move inland unhindered even if a dike existed.

Figure 11: Estuary of Song Ho Gui (open channel) leading to the sea

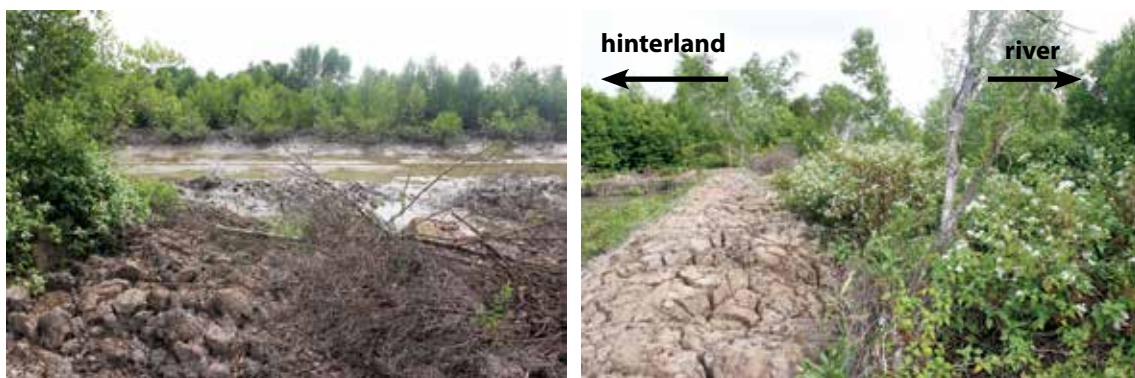
In a distance of 200 to 300 m from the channel Song Cua Lon, the river dike in the Lam Hai commune can be found nearby the bridge that is momentarily constructed to connect Ngoc Hien with the rest of the Cà Mau province. In some parts much vegetation can be found on the dike crest (see Figure 12); in other parts aquaculture embankments cover the dike crest (see Figure 13 right). A trench (not used) exists in front of the dike, followed by mangroves (see Figure 13 left).

Figure 13: View from the dike crest towards the channel Song Cua Lon (left) and view along the dike line (right) (03.01.2014 #4)

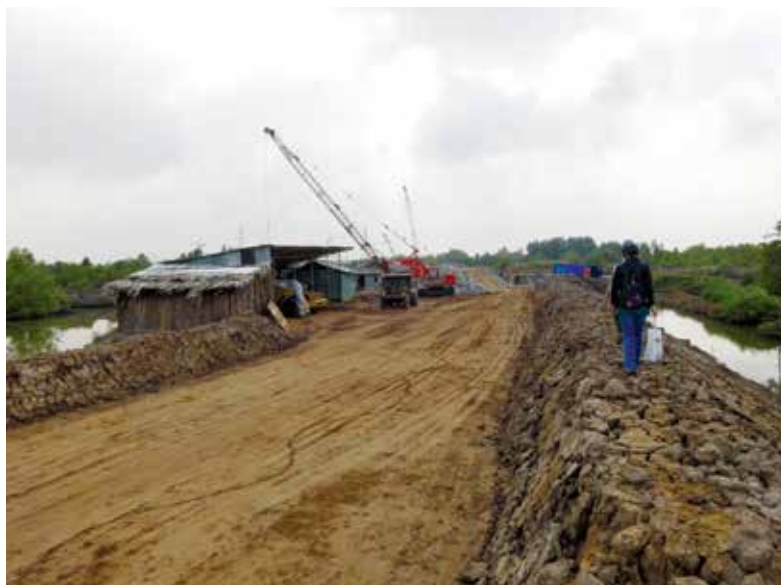
The dike shows very steep slopes as a result of erosion. Embankments that were constructed on top of the dike are not compacted and show very deep cracks (at least up to 30 cm). The material consists of blackish silty clay with many roots in it. No people are living in front of the dike. Aquaculture ponds exist directly behind the dike. There are no sluice gates of the aquaculture farms interrupting the dike line as these are built towards another smaller channel in the hinterland. Towards the bridge, the dike is under construction and enhanced to build a street on top of the dike (see Figure 14).

Figure 14: Dike construction works nearby the bridge to build a road on the dike

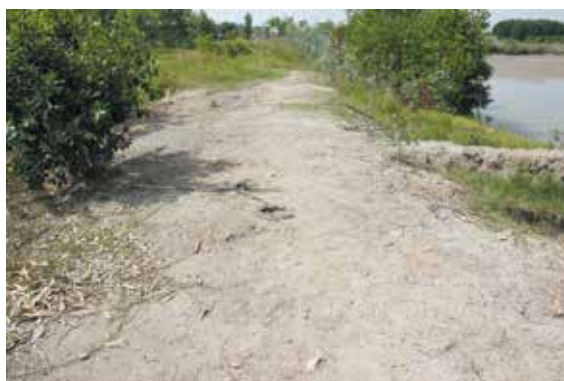
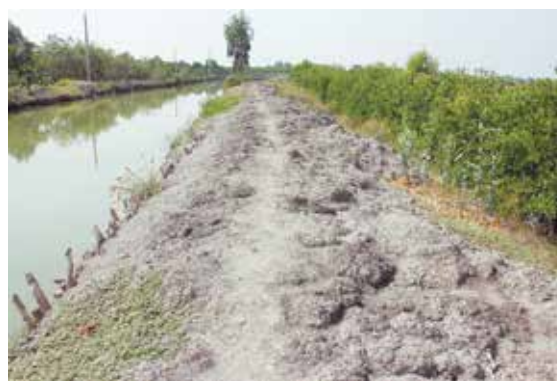
An about 7 – 8 km long river dike exists in the Tam Giang province. This dike's geometry differs a lot from one survey position to the next due to the influence and impact of human activities (see Figure 15). Single plants cover the dike slopes, especially at the transition to the aquaculture ponds. A trench can be found in front of the dike due to excavated soil material, partly filled with water, partly without. For the purpose of aqua farming, the dike toe was stabilized with wood pilings on a small section of the visited site (cf. Figure 15 right).

Figure 15: View along the dike line (03.01.2014 #10 left and #12 right)

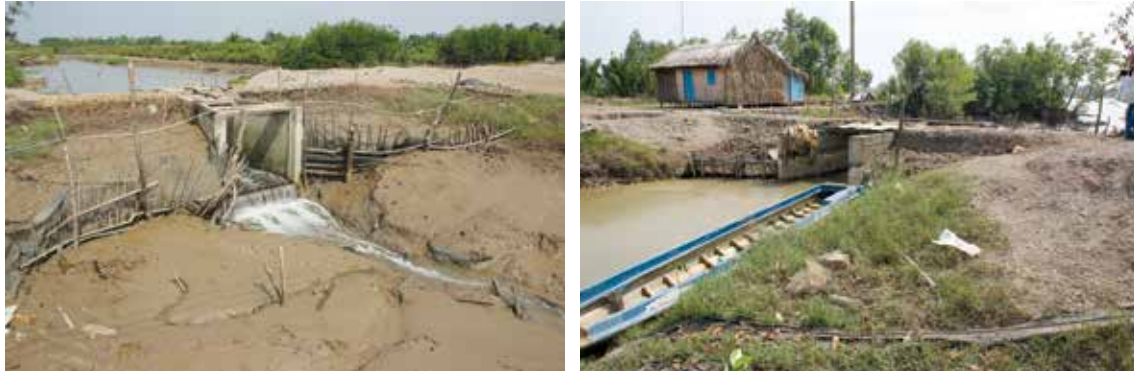
The dike line is often interrupted by sluice gates from adjoining aquaculture farms. Due to the more seaward construction of these sluice gates, the dike line meanders. Existing sluice gates do not show major damages, but the channel exits are affected by erosion and scour holes can be found.

Figure 16: Sluice gate photographed from front (left) and back (right) (03.01.2014 #9)

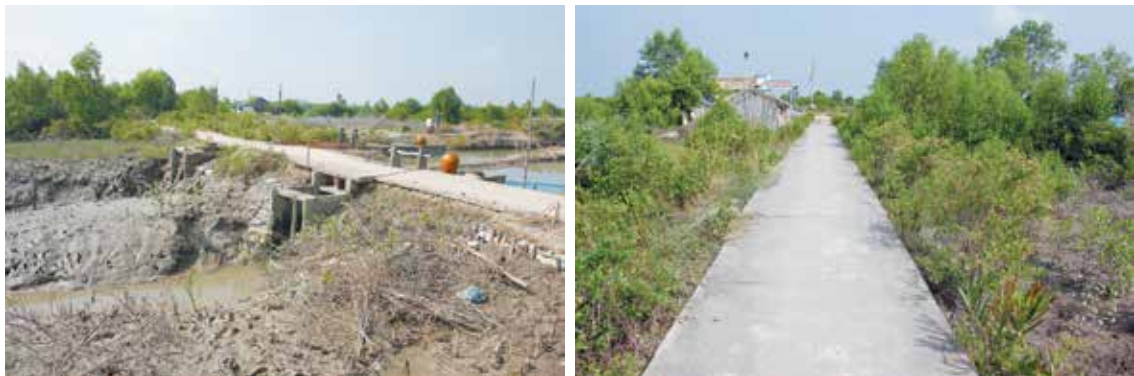
Several houses, a school and an embankment with a small road on top can be found in front of the milestone line. The embankment with the road on top (see Figure 18) was built closer to the channel and is not planned to be increased due to too high costs and the destruction of the road system. Furthermore, the dike is planned to be constructed more inland to consider the occurrence of erosion.

Figure 18: Embankment with road in front of the milestone line next to the channel

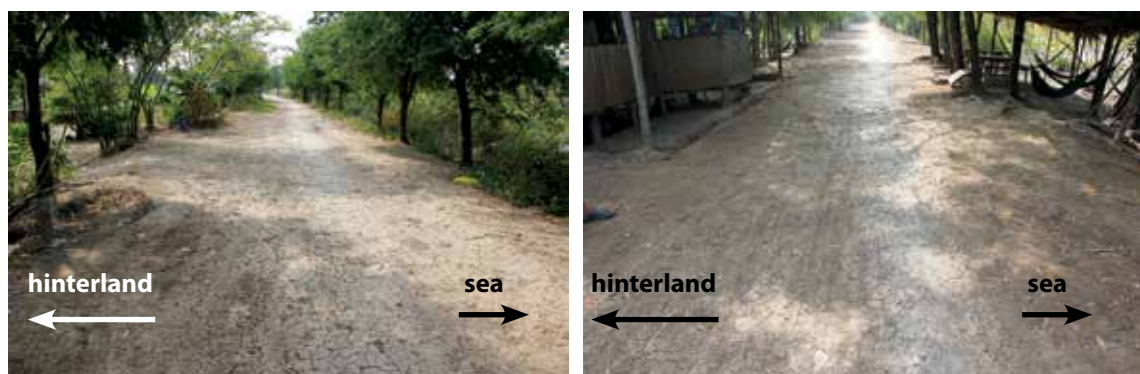
The visited dike section in the Tran Van Thoi commune was built in 1997 (information given by local people) and is part of the 90 km long West-Sea Dike. Due to a quite clear structure of the dike elements, the dike crest and dike slopes can be identified in general (see Figure 19). In average, the dike crest is between 5.50 to 6.50 m wide and used as a road for motorbikes and pedestrians. Single small buildings can be found on the dike crest and/or seaward slope. Inland households of local people adjoin directly to the dike or are built on the former landward dike slope. Partly it seems as if dike material was excavated to use it for private purposes. Many trees can be found on the dike slopes and the transition to the dike crest, which were planted during a previous project in order to prevent erosion.

Figure 19: View along the dike line (06.01.2014 #1 left and #5 right)

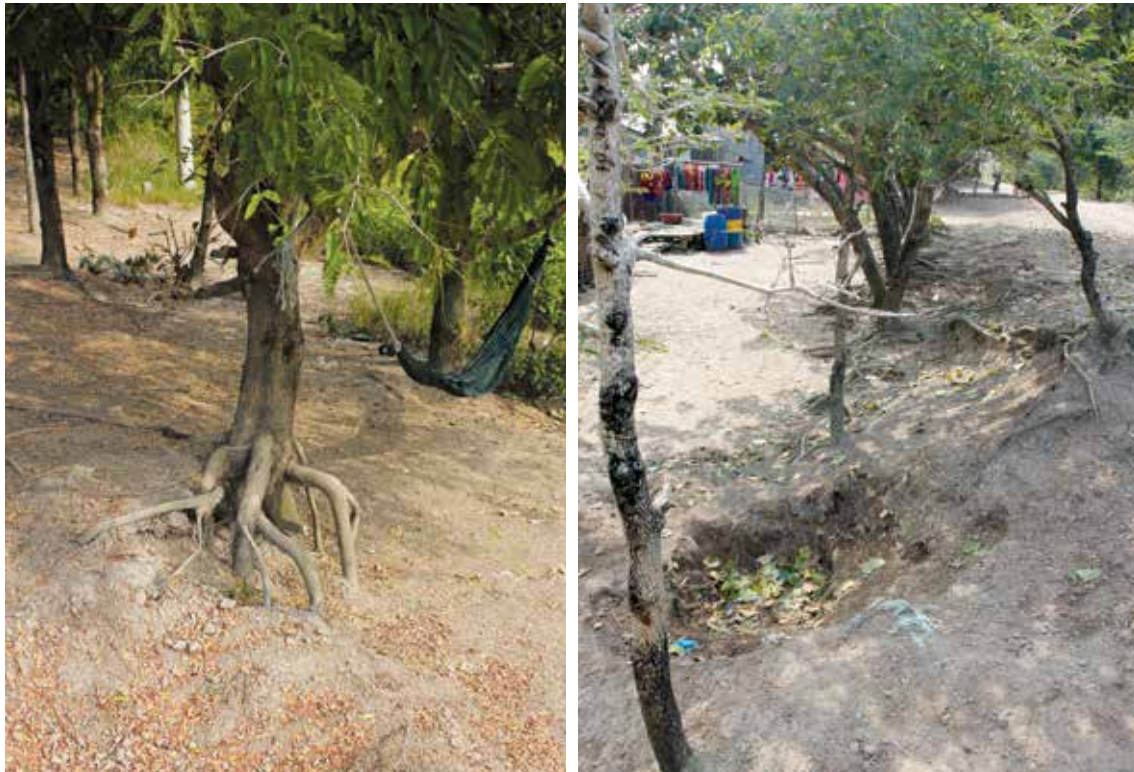
Although this site is not influenced by floods yet, the dike is eroding a lot due to rainfalls that wash away the dike material. Consequently, huge erosion can be found especially between the trees on the dike slopes. Furthermore, the roots of the trees have become visible and the stability of the trees decreased. Big break outs on the dike slopes can already be found, most probably as a result of fallen trees (see Figure 20).

Figure 20: Tree on dike slope with exposed roots (left) and break out on dike slope (right)

- Work on cost-effective and applicable measures to stop/prevent dike erosion (e.g. a grass cover). Start a pilot project to test and monitor this measure at an appropriate site (Tran Van Thoi district – Song Doc commune?)
- Awareness rising of local people, especially households living behind the dike, with the objective to decrease the number of human impacts on the dike and to increase the motivation of maintaining the dikes
- Give support in establishing a regular dike survey/dike control program at the provincial DARD to guarantee that changes of the dike condition are notified, documented and reported instantly and threats are prevented. Therein the local people should also be hindered from using the dike for private purposes and informed about possible consequences of their impacts

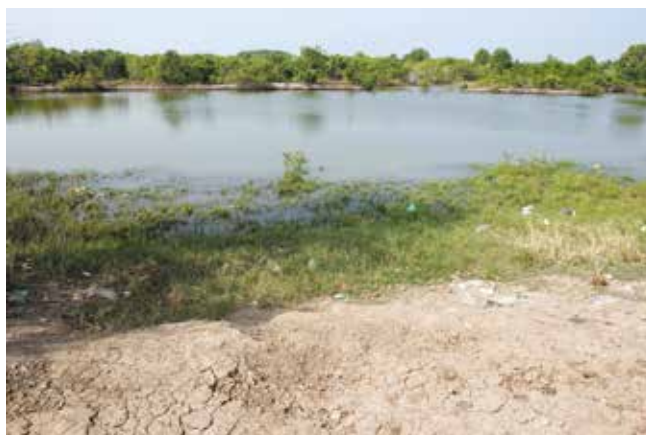
About 1 km of critical mangrove forest can be found in front of the dike at the visited site. Further north the mangrove belt is narrowed down; only a few meters of mangrove forest exist 5 km northern (information given by local people). Dike material was excavated from the seaside which resulted in a big trench in front of the dike. This trench is now used for aquaculture (see Figure 21).

Figure 21: Aquaculture pond and mangrove belt in front of the dike

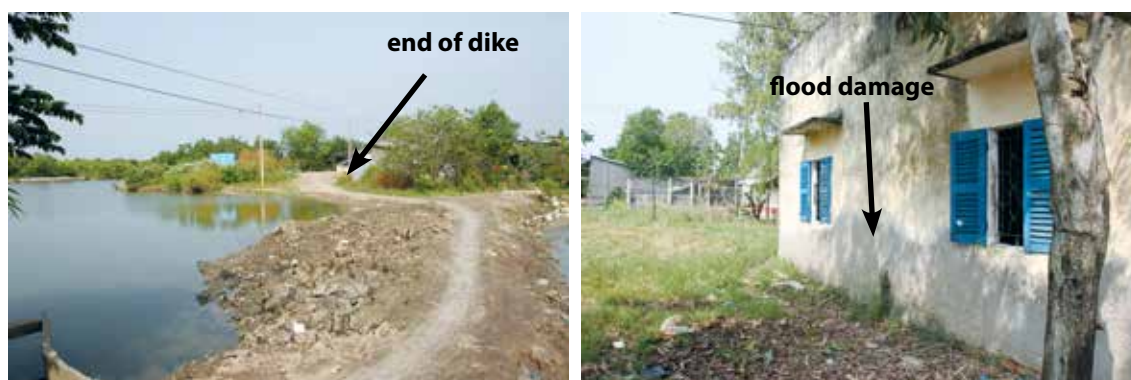
Figure 22: End of the dike (left) and house without flood protection (right)

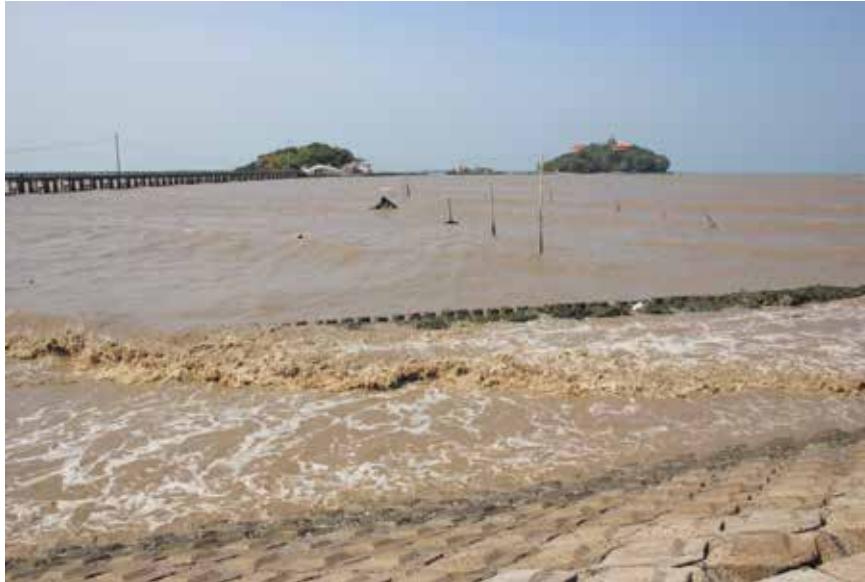
A seaward toe protection has been constructed and furthermore a breakwater in form of concrete piles and gabions was installed in front of the dike to decrease the forces of incoming waves (see Figure 24).

Figure 24: View towards the sea (20.01.2014 #3)

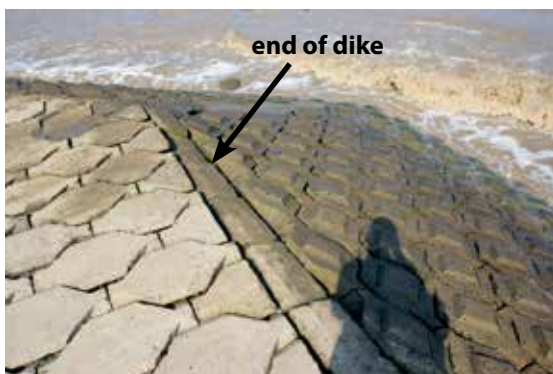
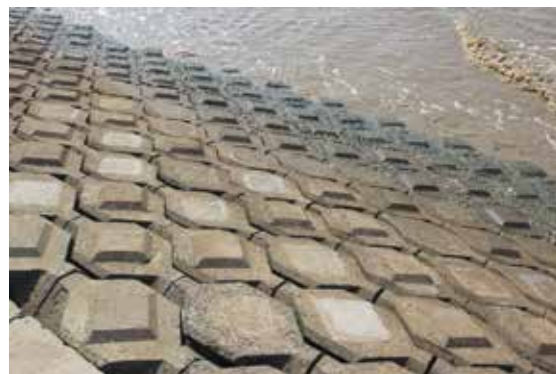
In order to increase the friction and consequently increase the wave energy loss during wave run-up on the seaward dike slope, different kinds of concrete slabs were used for the dike construction: Compared to the concrete slabs that are used for the dike crest and landward slope, the concrete slabs for the seaward slope show additional roughness elements (see Figure 25 left). Some slabs of the seaward slope are already missing these additional roughness elements (see Figure 25 right). It is assumed that the concrete slabs with missing additional roughness elements were not produced in one piece. Rather these roughness elements were added manually and the bond failed due to too high stress.

Figure 25: Concrete slab revetment on dike crest and seaward slope (left) and missing roughness elements on the seaward slope (right)

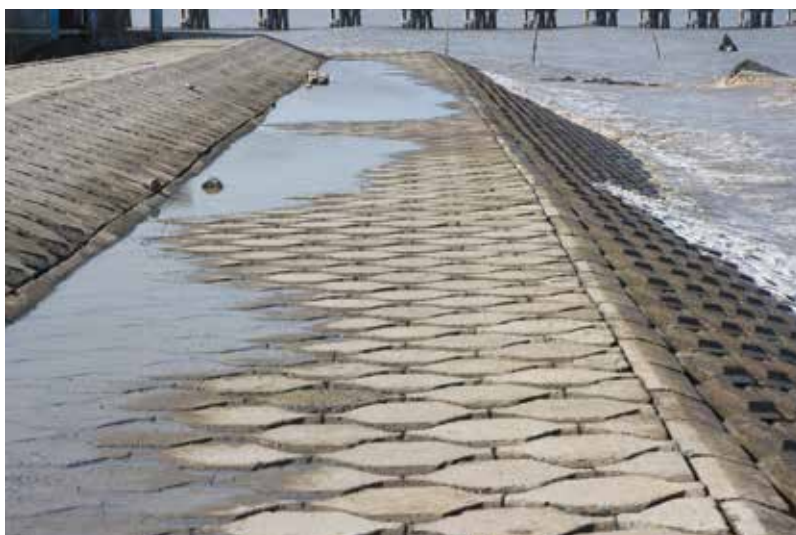
Due to settled or washed out dike material, settlements of single stones and also settlements of larger areas can be observed (see Figure 25 left and Figure 26).

Figure 26: Settlements of the seaward berm filled with standing water

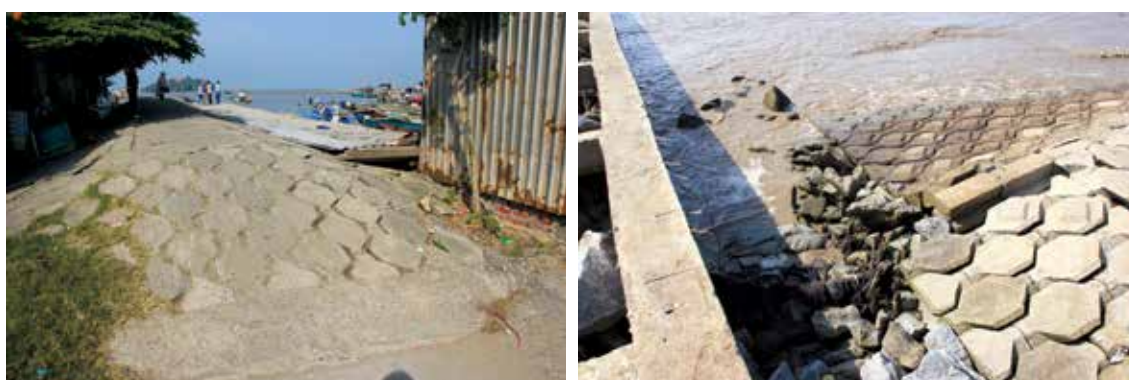
Both ends of the dike show an abrupt border and no connection to further flood protection measures. The sluice that closes the channel has been constructed a few hundred meters more inland and is not connected to the existing dike (see Figure 27 left). Along the coastline (see Figure 27 right), a wave breaker (2 rows of piles with stones in between, see Annex G) follows the described dike. In case of a flood, the water could flow along the borders of the dike into the hinterland.

Figure 27: Ends of the dike construction near Hon Da Bac island

Two years after the construction of the visited dike section, no tremendous damages were visible during the site inspection. Furthermore, this construction represents a milestone in the design and construction of dikes in the Cà Mau province. Still, future maintenance is required to prevent the progression of smaller damages mentioned above and a concept has to be developed to connect the dike to further flood protection measures.

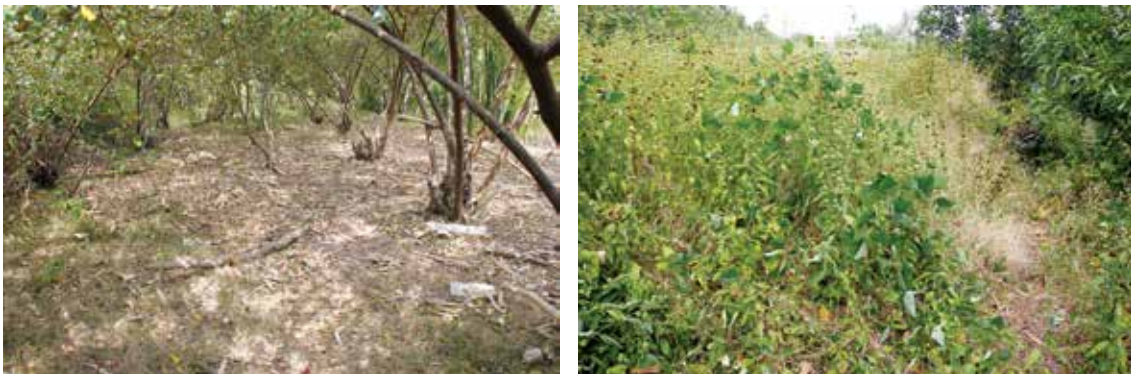
As part of the 90 km long West-Sea dike, the visited dike section in Cai Doi Vam shows a great variability of plants on top of the dike crest and dike slopes. Due to human impacts and missing maintenance, this dike section has lost the typical and aspired appearance of a dike. No paths are available and the dike crest is sometimes hard to pass (see Figure 28). Transitions between the dike crest, dike slope and surroundings land cannot be defined precisely. On top of the dike a fruit plantation, which is managed by the household living nearby, and further plants can be found.

Figure 28: View along the dike line (06.01.2014 #9 left and #7 right)
