SEA DYKE REHABILITATION in Kien Giang Province

TECHNICAL REPORT
November 2008

Sea dyke rehabilitation in Kien Giang Province

Technical Report on the Reconnaissance Mission - November 24th to 28th 2008

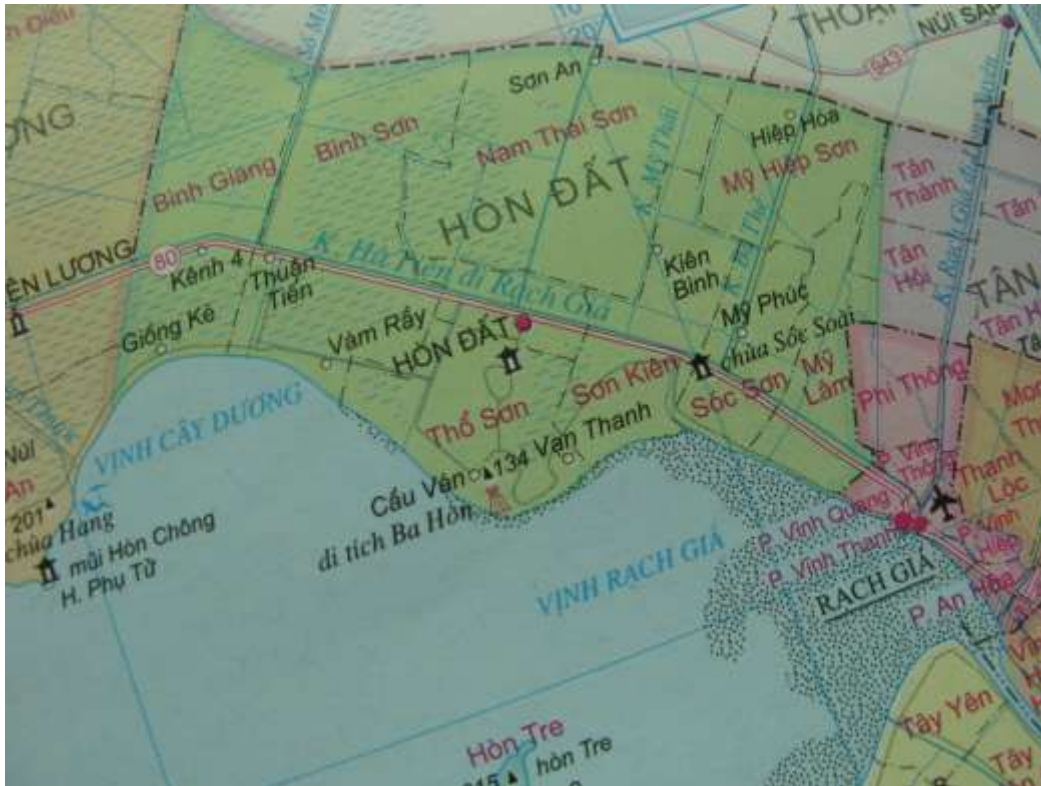
In Hon Dat District strong sea currents are eroding a sea dyke that is meant to protect the local people and their agricultural land from inundation during storms. The Province and District authorities have continually tried to grow mangroves in these areas but so far have failed. They have also repaired eroded sections of the dyke in the past. The Vietnamese Government has a dyke reinforcement program in place and the Province plans to repair this section of the dyke using funds from this program once the strong sea winds cease in November 2008.

Photo 1: Hon Dat District

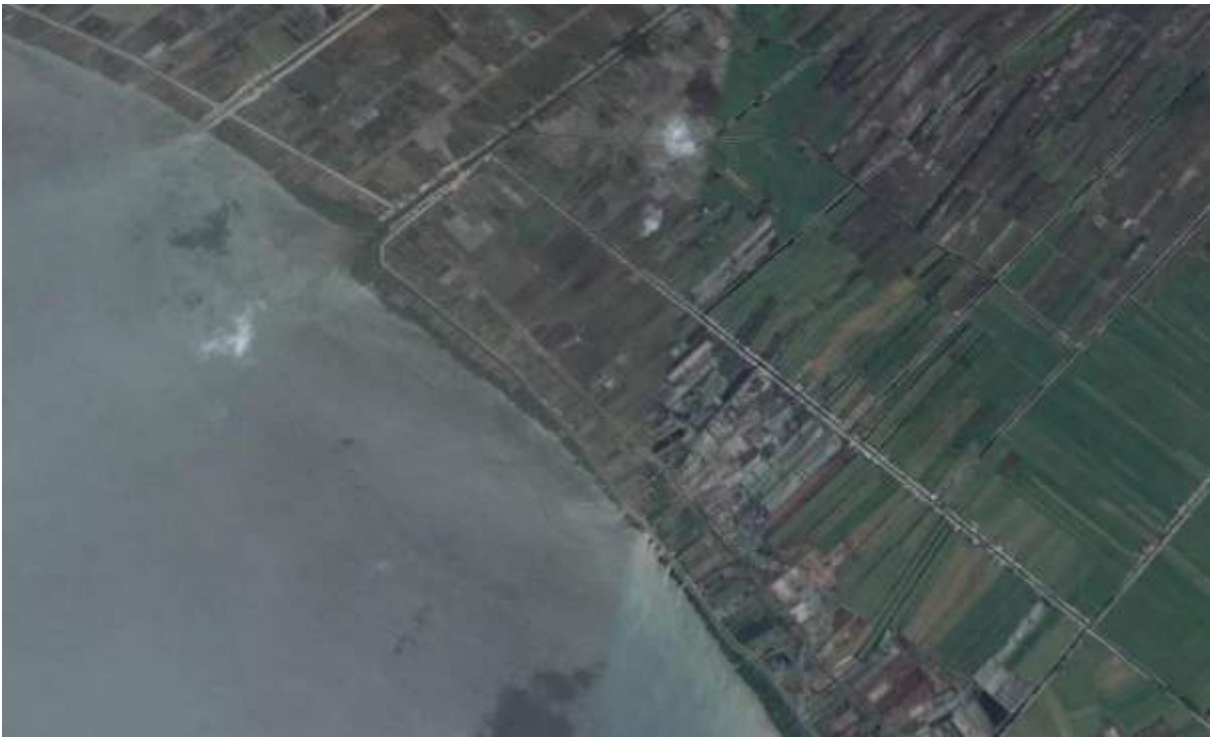
Photo 2: Affected area at Hon Dat District approx. 2 km south of the channel mouth

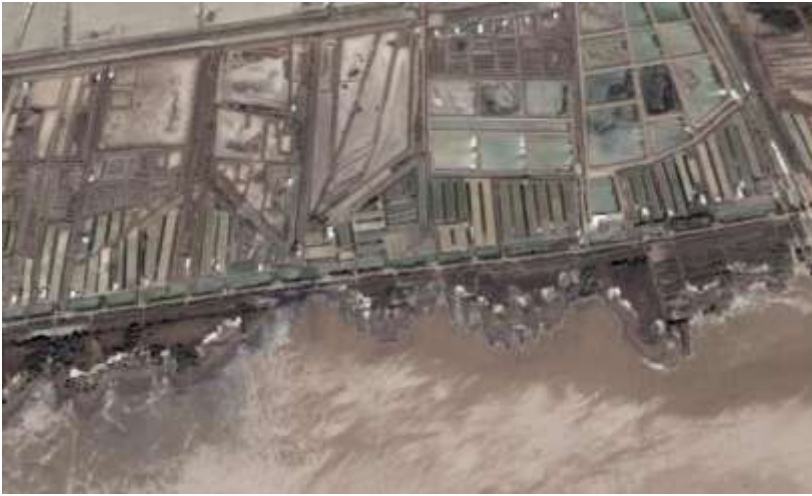
Photo 4: Eroded Foreshores

At the first site of the visited area about 200 m along the sea dyke the foreshore was eroded and in this area the former mangrove belt had completely disappeared. In some parts the erosion had also affected the toe of the dyke and in one spot overtopping of the dyke had occurred. In the area affected by erosion the dyke slopes are protected by gabion mattresses and loose rocks, whereas sand bags have been placed on the dyke crest where overtopping had occurred.

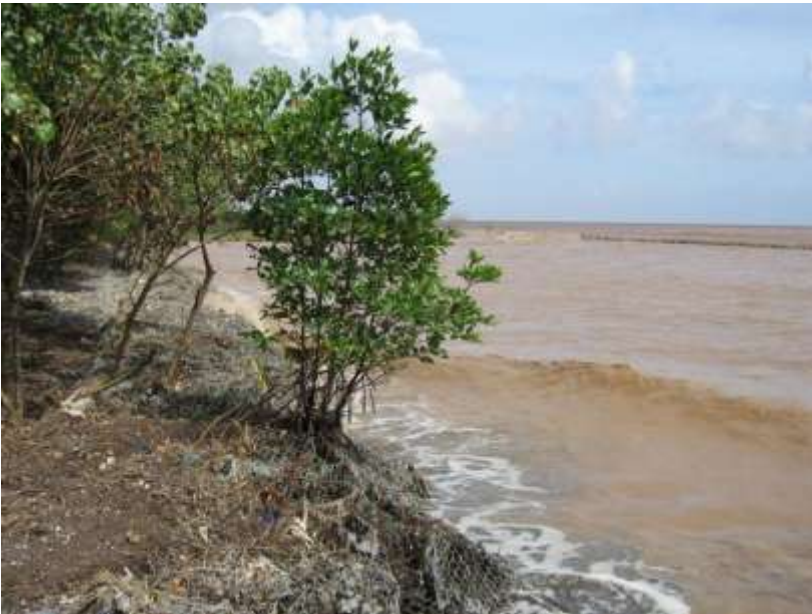
Photo 5: Eroded Foreshore, Protection with gabion mattresses

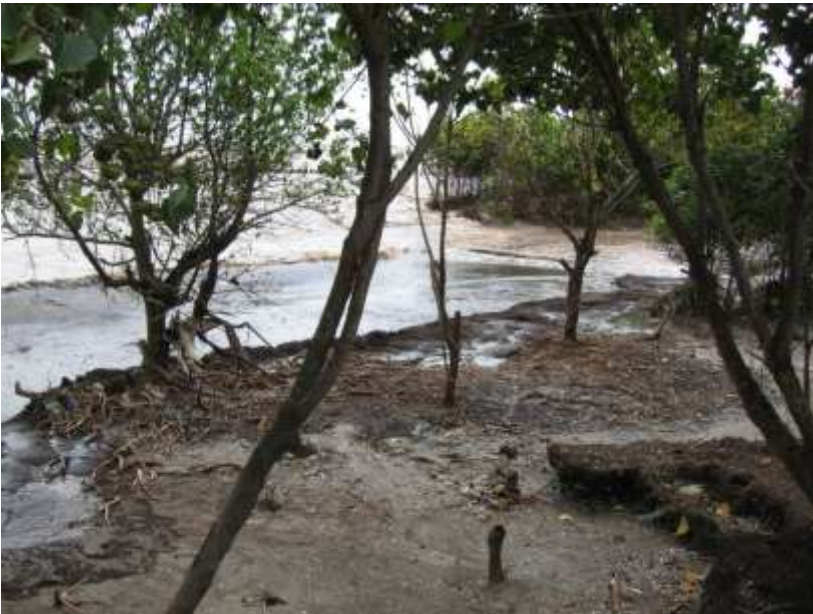
Photo 6: Eroded Foreshore

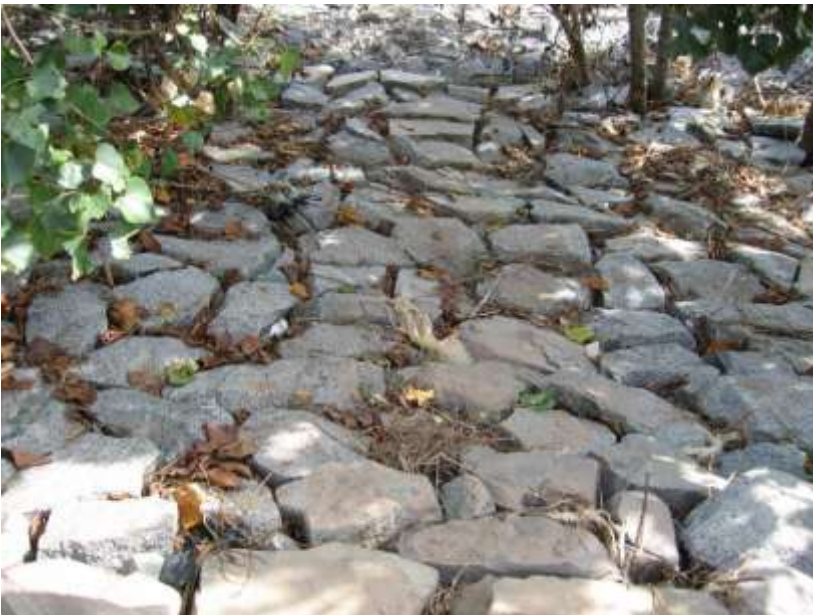
The slopes on both sides of the dyke can be estimated around 1:3, the crest width was about 5 to 6 m. The landside slope is covered with bushes, at the seaside slope small trees are growing. No signs of seepage through the dam body could be found on the landside dam slope or toe. However, it is difficult to inspect due to the vegetation.

Photo 7: Slope protection with rip-rap

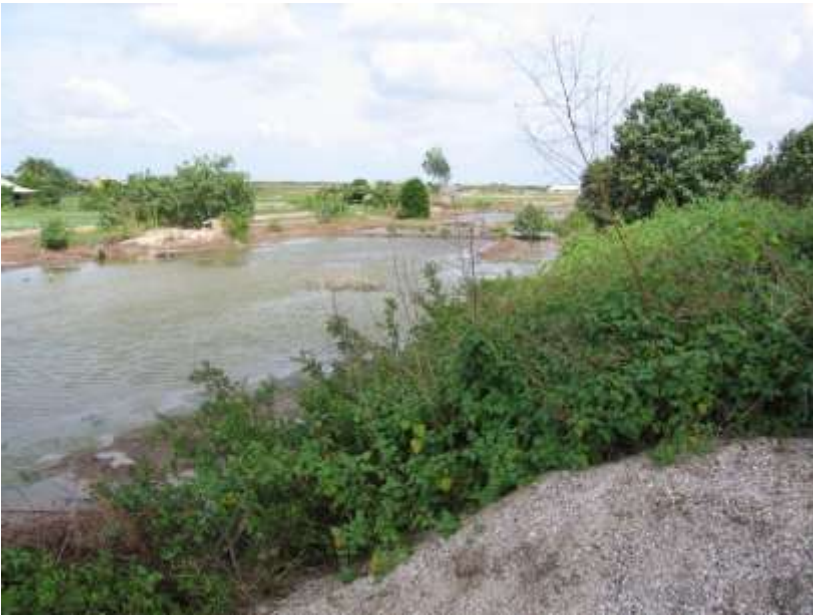
Photo 8: Landside slope of dyke

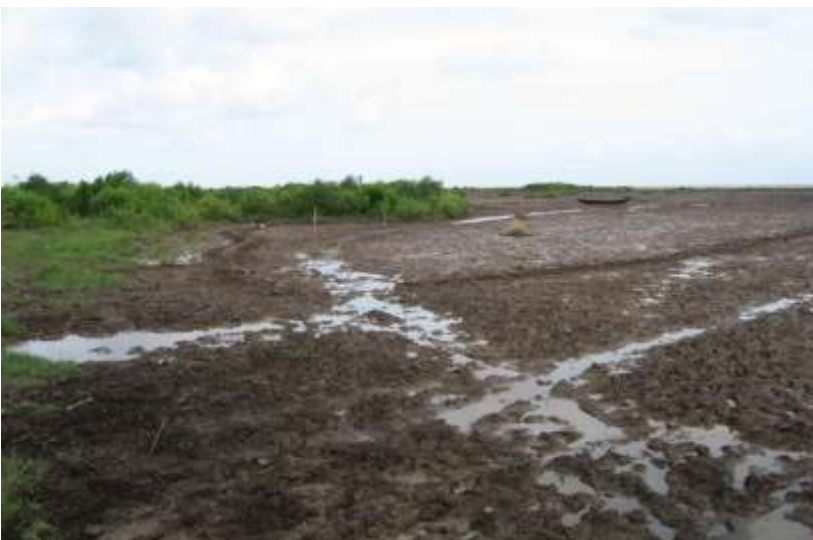
The second site visited is located some km east of the first site. In this area the coast provides an open shore of about 300 to 400 m where the mangrove belt has completely disappeared. No sign of erosion could be found and it seems obvious that this has been caused by the extensive use of this area as access to the sea by fishermen. During the visit several boats had been placed in front of the shore and the area was covered with footprints and traces of slipping boats.

Photo 9: Area used by fishermen

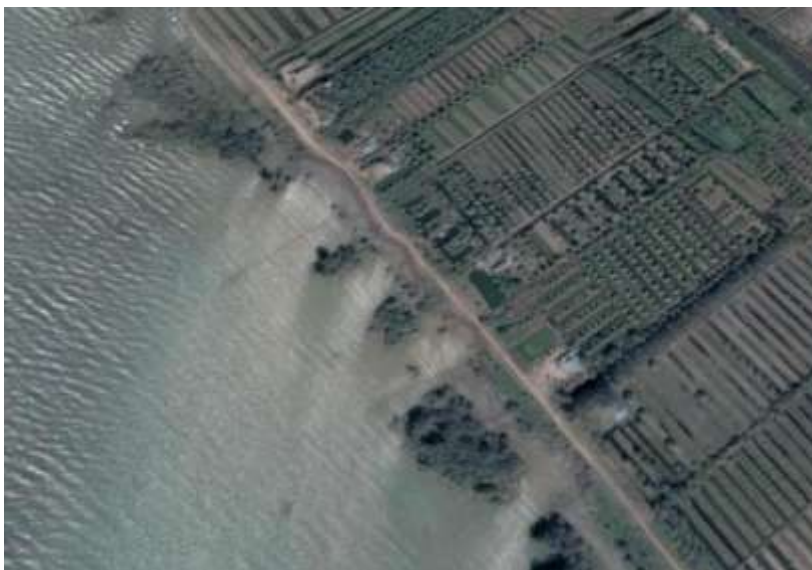
Photo 11: Affected area of erosion

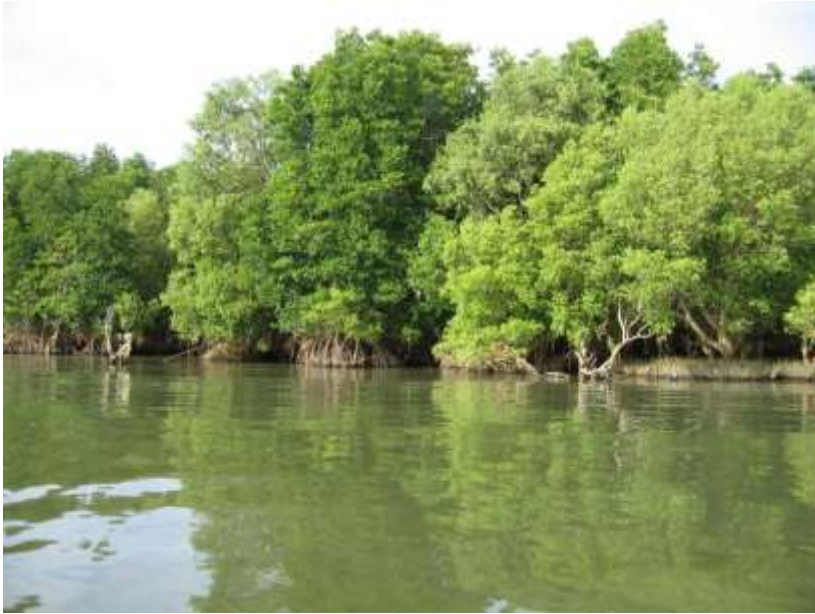
Photo 12: Mangroves still in good condition

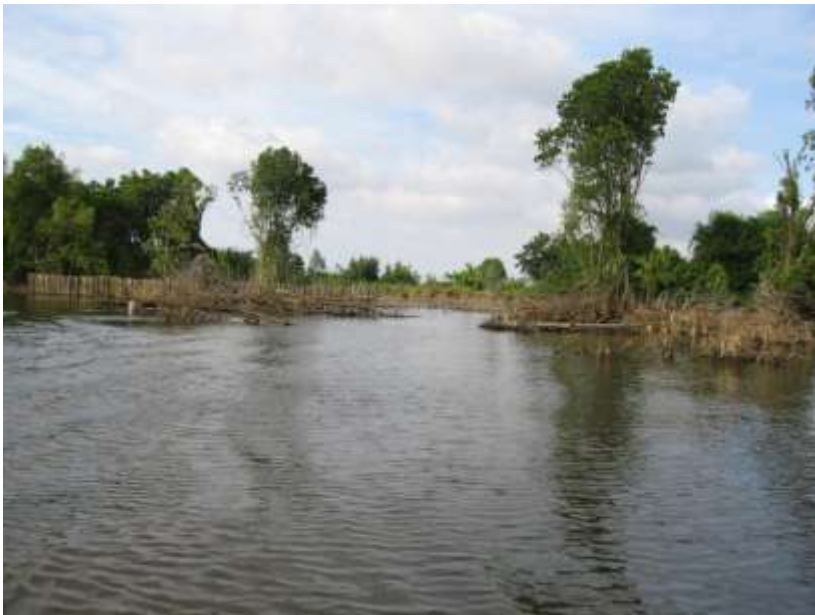
Photo 13: Retreated area of mangroves

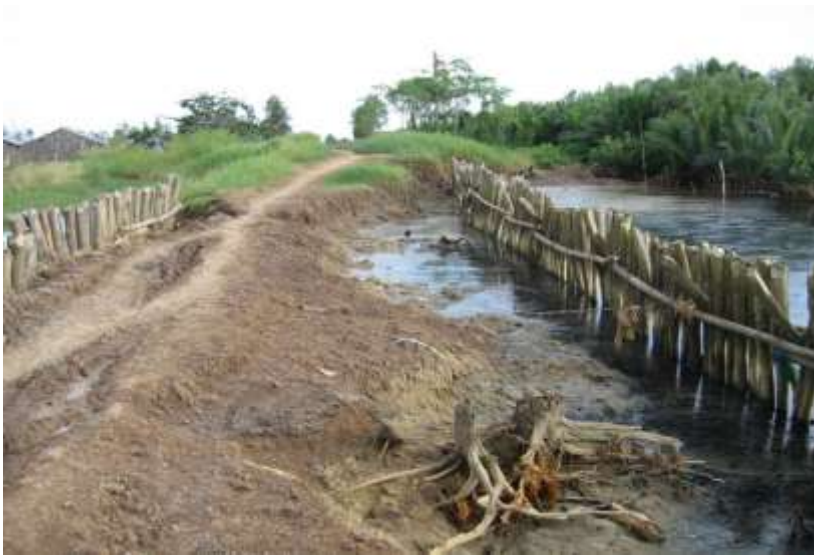
At the inspected site the sea dyke is heavily damaged over a length of about 1 km. In various parts along that stretch the mangrove belt has disappeared and new planting of

mangrove was not successful. In the areas where Mangroves do no longer exist, the seaside slopes of the dyke are deeply eroded and have in some spots completely collapsed. At one spot sea water has already penetrated the dyke.

Photo 14: Collapsed dyke

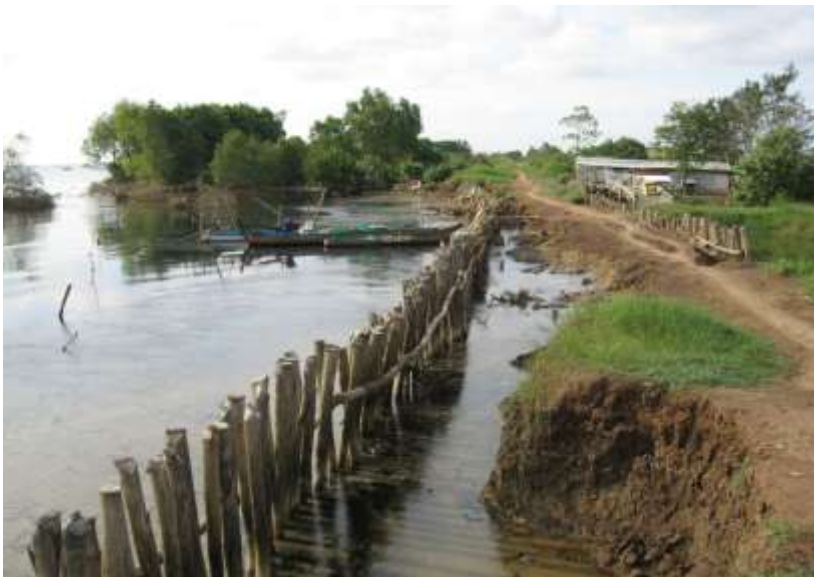
Talking to the local people the team was informed that the dyke had been constructed about eight years ago. At that time the mangrove belt was still in good condition. However, the mangroves disappeared within three years time after dyke construction. Material for the dyke construction has been removed from the sea side of the dyke, thus creating a long trench along the seaside toe. With the disappearance of the mangrove belt in this area the sea side slope of the dam suffered continuous erosion by heavy currents and some over-topping incidents.

Photo 15: Eroded dyke

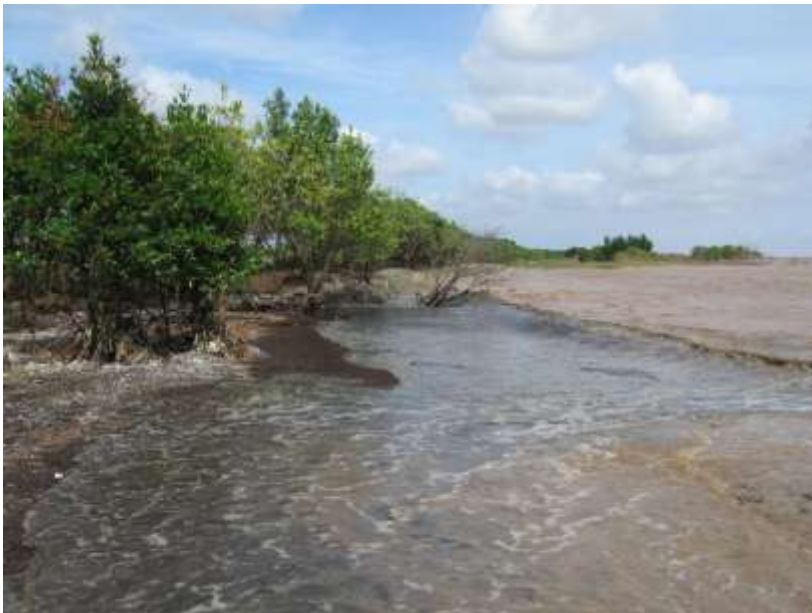
Regardless of what might have caused the erosion of the foreshore and the disappearance of the mangrove belt at the visited site, the only way to stabilize the area and to prevent further destruction of the dyke is to construct breakwater barriers along the affected area. Those barriers could reduce the strength of the current towards the shore.

Photo 16: Eroded foreshore area

However, for an appropriate design of the breakwater barriers and in order to avoid negative effects, flow model studies are strongly recommended.

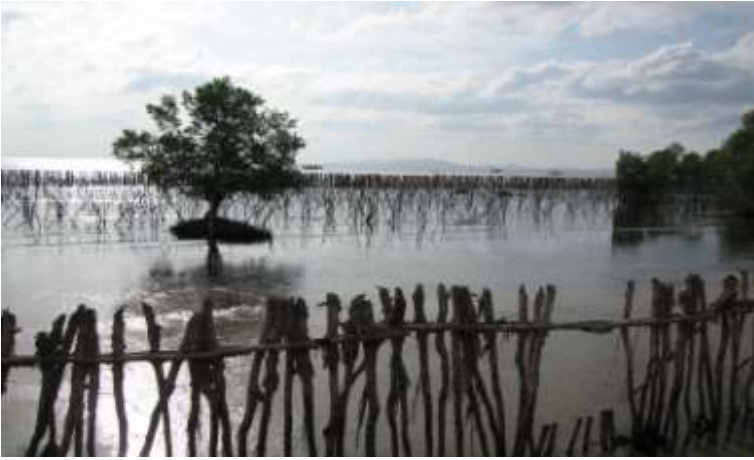
Strong sea currents and rise of the water level due to climate change is a general problem which may affect the mangrove belt along the coast. The mangrove belt is vulnerable where it is narrow or already partly damaged as can be seen also in other areas of the Kien Giang coastline.

Photo 17: Eroded areas of mangroves

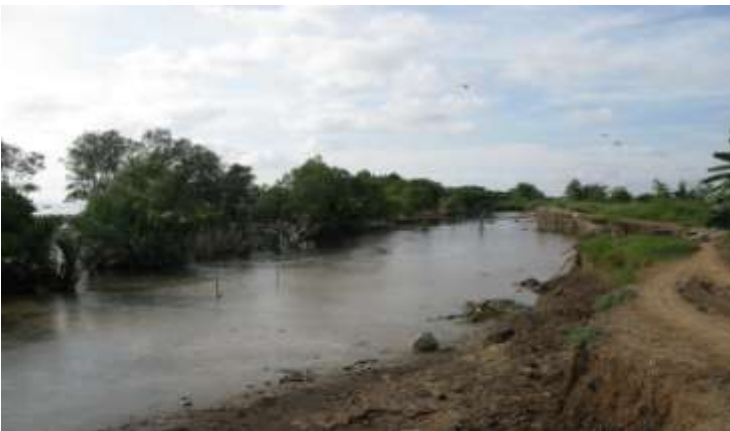
In the case of the dyke at Hon Dat District, soil material for the dyke construction was excavated off the foreshore, thus creating a trench along the entire length of the seaward dykes toe. This trench represents a vulnerable area for erosion which can develop turbulences within the trench, due to outgoing waves. The turbulences gradually destroy the slopes and create more erosion channels in the sediment of the foreshore thus destroying the mangrove trees. Once this has happened, the erosion channels will expand and mangrove destruction will proceed rapidly. It will also affect the mangrove belt which is still in good condition as seawater turbulences enter adjacent areas through already existing trenches. This means that in the adjacent forested areas, part of the backflow will not pass through the mangroves but will be following the routes of lowest resistance and pass through the eroded areas.

Photo 18: Excavation trench along the dyke

The material for the dyke construction was extracted from the seaside area. This has resulted in the formation of a wide and deep trench along the seaward side of the dyke toe. This extraction of soil, combined with strong currents appears to be the cause of the erosion of the foreshore.

- The trenches along the sea side of the dyke toe shall be refilled with the remaining material of the eroded dyke and other suitable material obtained from elsewhere inland.

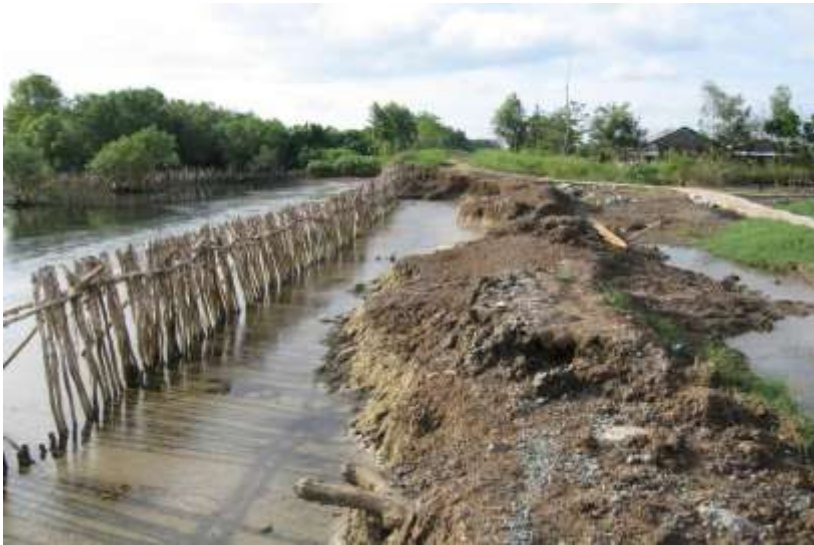
Along the effected area over a total length of 500 to 600 m the dyke is heavily eroded and in some parts completely destroyed. The height of the dyke above natural ground can be estimated at 2 m, the crest width was 6 m. The slopes of the dyke are estimated at 1:2.5 to 1:3.

Photo 19: in-homogenous dam material

In one spot the dyke has been overtopped by seawater and has ruptured. Examination of the eroded surfaces showed that the soil material is not of homogenous quality. Traces of organic material, gravel and clay were found mixed with the soil.

- Where the natural clay cover within the trench is affected it shall be replaced by adequate clay material before filling it with ordinary soils.
- The dyke must be constructed of homogeneous soil material of the characteristics specified in Annex 1.
