Shoreline and Mangrove Resource Condition of the Mainland Coastline of Kien Giang Province, Vietnam: Key Pressures and Restoration Requirements

June 2012

Conservation and Development
of the Kien Giang Biosphere
Reserve Project

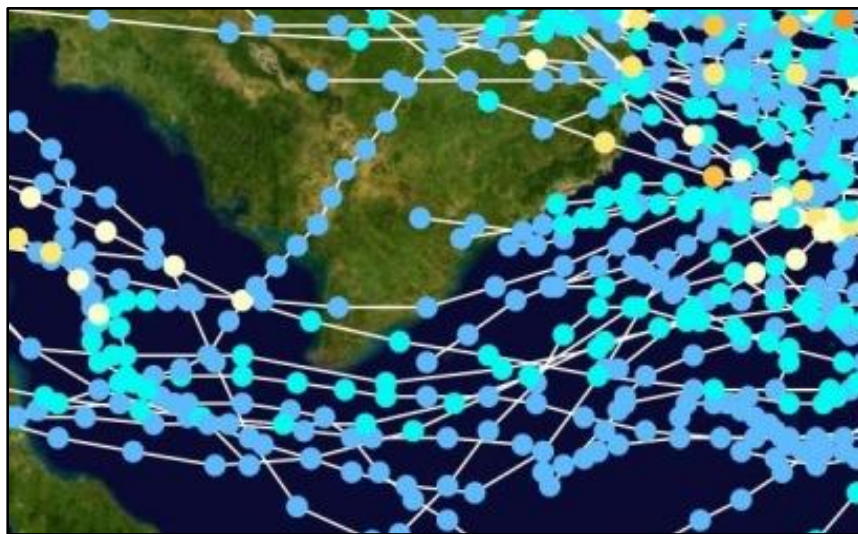
Figure 3. Regional tropical cyclone tracks from 1980 – 2005, coded by Saffir-Simpson category. The points show the locations of the storms at six-hourly intervals. Source: Wikipedia.
