Video Assessment and Shoreline Mapping of the Ca Mau Province, Mekong Delta, Viet Nam

This report presents a summary of the condition of the mainland coastline of Ca Mau Province as determined from Shoreline Video Assessment (SVAM) carried out in May 2013. The assessment focused on both the extent and severity of erosion and the extent and condition of the mangrove resource. Published reports outlining the spatial extent of the key pressures on the mangrove ecosystem both now and as they are projected to occur in the future as a result of climate change modelling are reviewed.

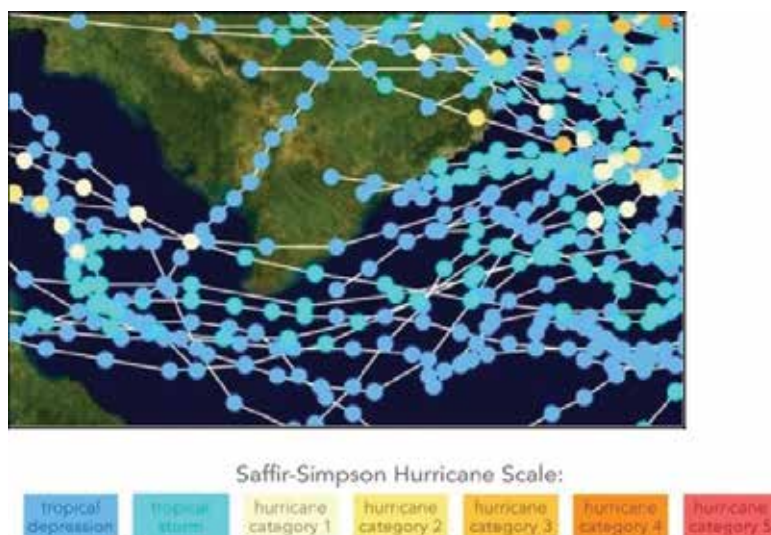
Figure 3. Regional tropical cyclone tracks from 1980 – 2005, coded by Saffir-Simpson category. The points show the locations of the storms at six-hourly intervals. Source: Wikipedia.

3 shows the tracks of cyclones from 1980 to 2005. In 1997, Typhoon Linda moved across the southern tip of the Ca Mau peninsula and caused widespread damage across the two provinces. It resulted in flooding, damage to mangrove and plantation forests, damage to housing and power infrastructure and inundation and associated damage to agricultural production. As more mangroves are removed the exposure of the occupied hinterland to significant damage is increased.
