RAPID VIDEO SHORELINE ASSESSMENT

A case study in Kien Giang Province

Conservation and Development of the Biosphere Reserve
of Kien Giang Province Project,
Department of Science and Technology,
320 Ngo Quyen Street, Rach Gia City,
Kien Giang Province, Vietnam.

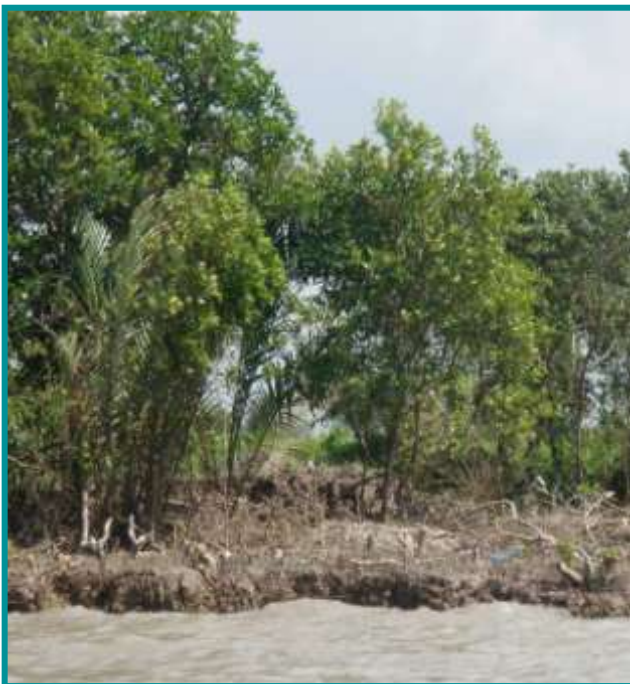
Increased fragmentation of these forests has reduced their capacity to withstand physical processes such as wave action, coastal currents and wind that are related to their location on a semi-exposed coastline. Consequently large areas of coastline are currently eroding or are at risk of erosion in the near future.

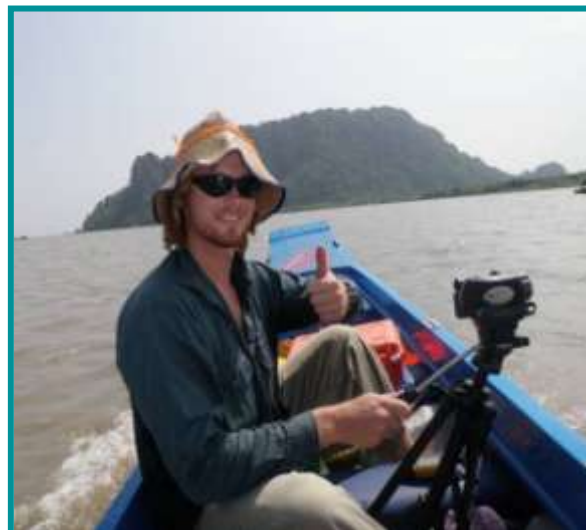
In February 2009 a video of the shoreline was taken using a Sony Handycam from a boat running parallel to the coastline approximately 25m from the shore. A GPS was used to record latitude and longitude every 3 seconds.

Video of the coastline was reduced to 1 second frame .jpg files.. The shoreline features in each frame were then scored. Only the initial 20m intertidal zone visible in the frame and/or the directly adjacent terrestrial habitats (if visible) were used for assessment.

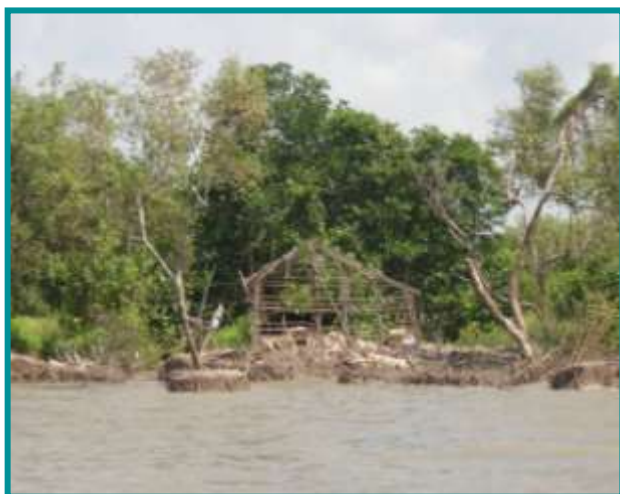
Nearly a quarter of the mangrove coastline (30km) is experiencing active mangrove loss due to erosion.

Overall, one-third of the coastline is eroded or eroding.

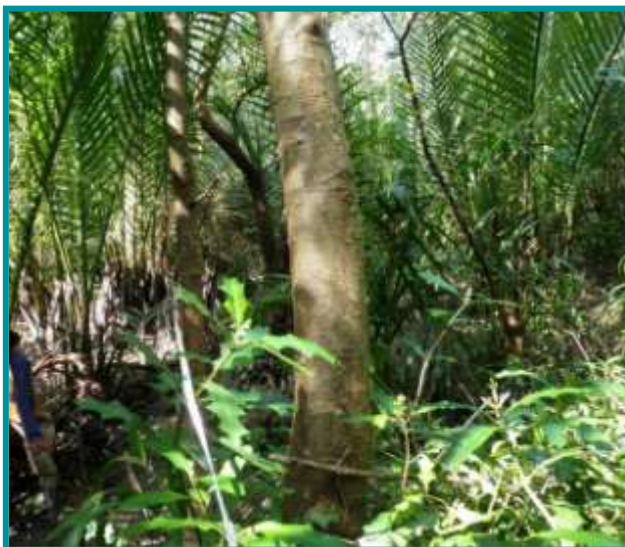
78% of mangroves along the shoreline have high biomass (although they may be limited in width)

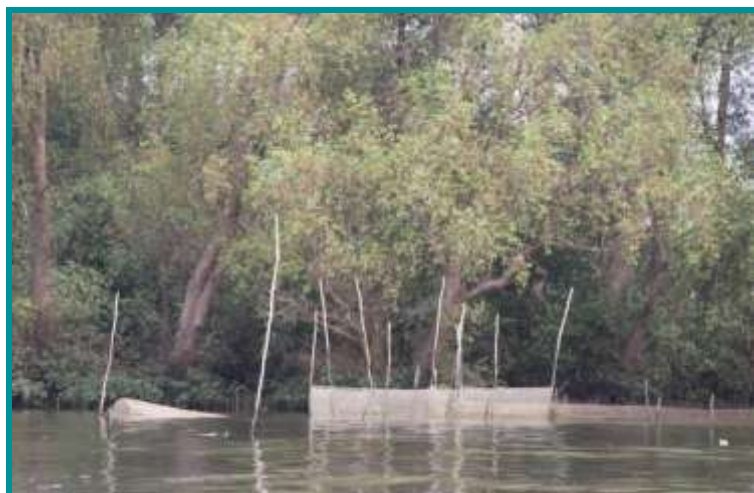
Mangroves were identified as being valuable fish habitat for edible and tradeable aquatic resources.

Assessment of fish traps showed that 81% of all fish traps were associated with mangrove presence and 69% were associated with intact continuous forest.

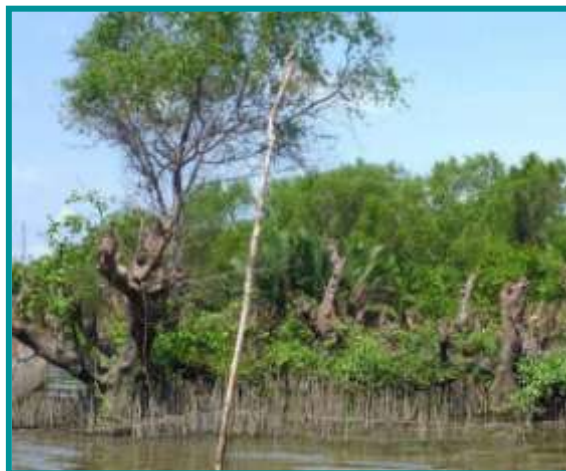
Most cutting occurred in *Avicennia* (49%) and *Sonneratia* (19%) forests, with cutting observed in 65% of continuous *Sonneratia* forest. This suggests that *Sonneratia* is a target species for wood harvesting. It was also observed being felled and coppiced to create habitat in association with fish traps.

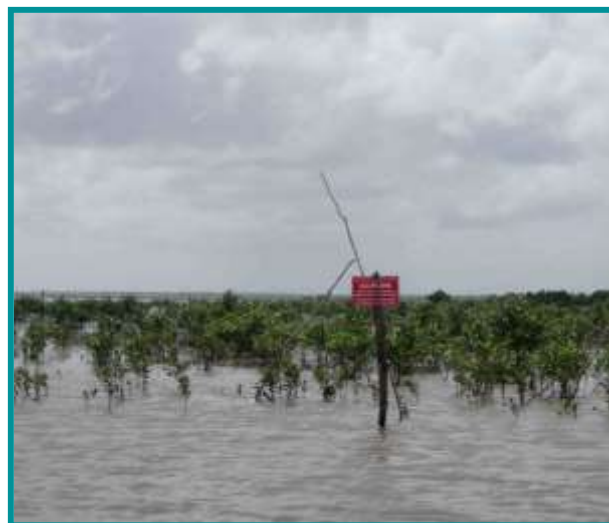
50% of recent past mangrove plantings have been successful. Current strategies to replant mangroves could be improved to increase seedling establishment success and protect vulnerable coastline.

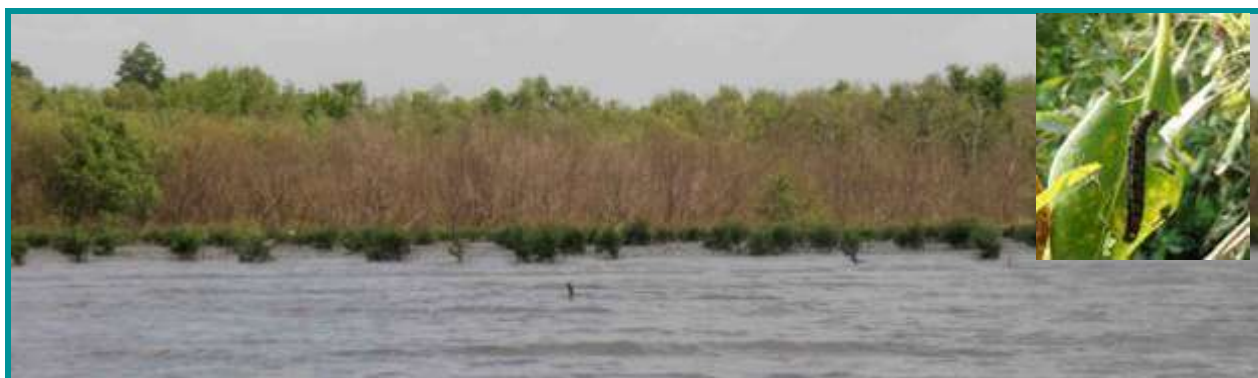
Root burial associated with litter accumulation in Kien Luong district was observed to have killed an 800m section of mangroves near Hong Quao. Extensive litter accumulation was noted to be present on a further 7km (4%) of the coastline.

Severe herbivory on *Avicennia* from an unidentified caterpillar, caused extensive foliar leaf loss. This was observed mostly in An Bien and An Minh districts and in planted, prograding forest

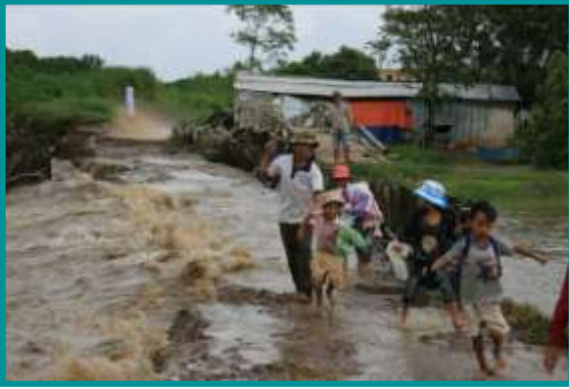
The rapid degradation of exposed earthen dykes emphasises both the importance of the mangrove fringe in wave attenuation and shoreline protection and the ineffectiveness of earthen dykes as a strategy for coastal defence.

From the survey, 5km of aquaculture ponds were recorded as being breached and damaged by erosion. Additionally, 19 homes and villages were observed to have been abandoned or are directly threatened by coastal erosion. In the event of a storm surge resulting from a typhoon, it is likely that many more homes will be damaged and the loss of
