Rheinisch-Westfälische Technische Hochschule Aachen
Institut für Wasserbau und Wasserwirtschaft

MASTERTHESIS

Development of sustainable coastal protection concept for Ca Mau/ Vietnam

Aachen, October 2015

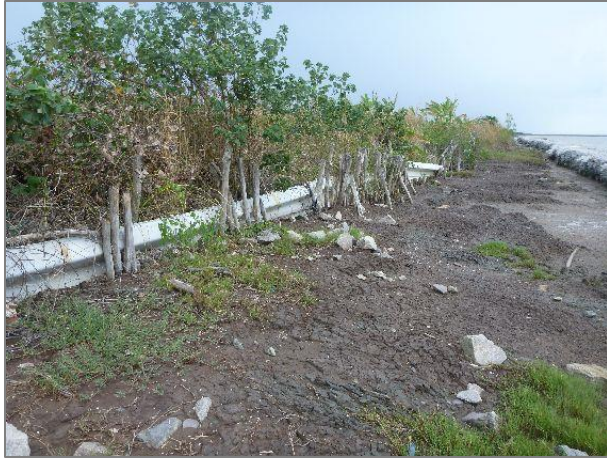
Figure 3-6 First aid measures of dike toe protection and gabions km (-16) (Sikora)

Around km (-16) the erosion is effected by the sea. As visible in Figure 3-6 no foreland protects the dike and the erosion reached the dike crest already. The width of the dike crest in this area is less than 4 m. At the same stationing point serious landward erosion also took place. Ponds are responsible for this erosion. The following sketch represents the cross profile at these areas. The next serious landward erosion spots are located at km (+9) to (+16). Because of the way of construction the resulting edge through canal dredging is close to the dike crest. The last serious spot is at km(+29). At this point the erosion has already damaged the dike crest. Canal dredging in combination with a regular use as landing stage for the local settlement effected this strong erosion. The local residents have already recognised the serious damage and tried to protect the dike body with wooden piles over a length of 17 m. At this part, the dike crest is only 2.7 m wide, while next to it the crest has a width of 3.5 m. Light erosion damages, with the potential to become more serious in the future are around km (-19) in Ca Mau, at km (+4) to km (+6) and km (+18) at Kien Giang. There, the close connection to the sea with ongoing erosion caused by an adjacent inland canal in connection with a dense settlement (as described below) provides a risk. The cross profile of km (+24) pictures a similar issue between km (+23) and km (+26).

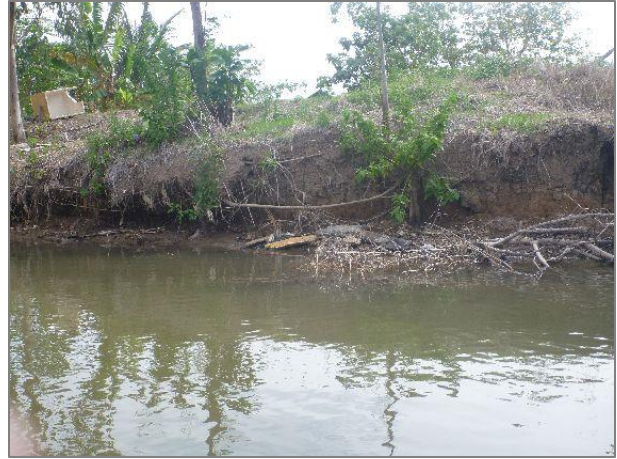
Figure 3-7 Effect of dredged channels connected to the dike toe km (8) (Sikora)

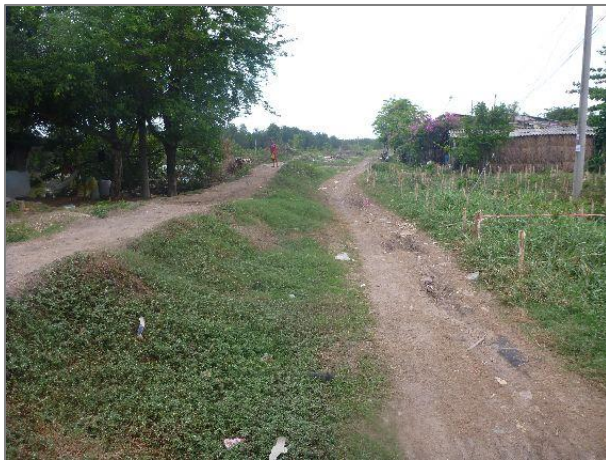
Figure 3-8 Difference in height at the dike surface at km (-41) (Sikora)

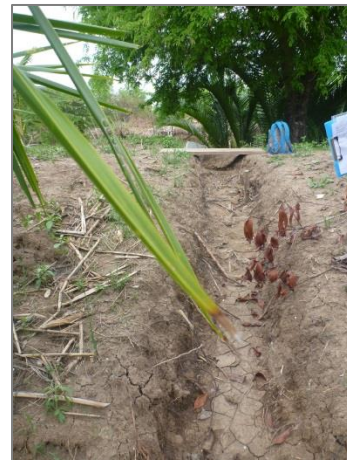
Figure 3-9 Loss of dike body km (4) (Sikora)

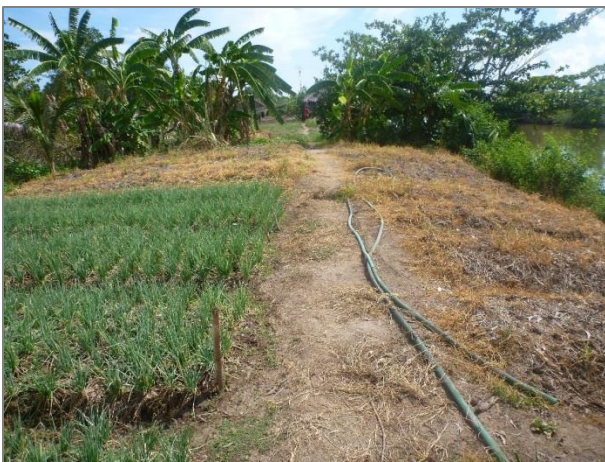
Figure 3-11 Onions at dike surface km (1) (Sikora)

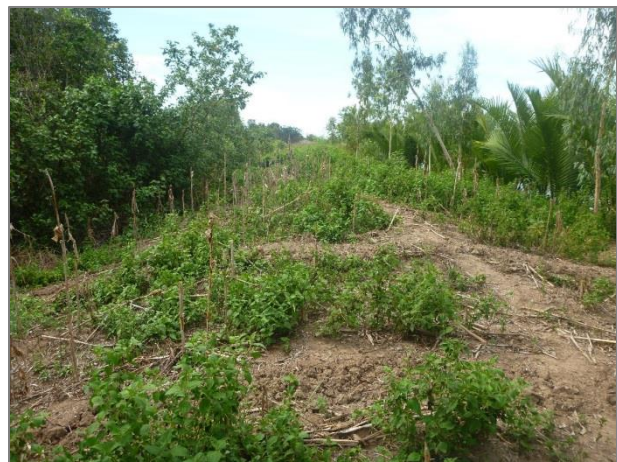
Figure 3-12 Corn at dike surface km (7) (Sikora)

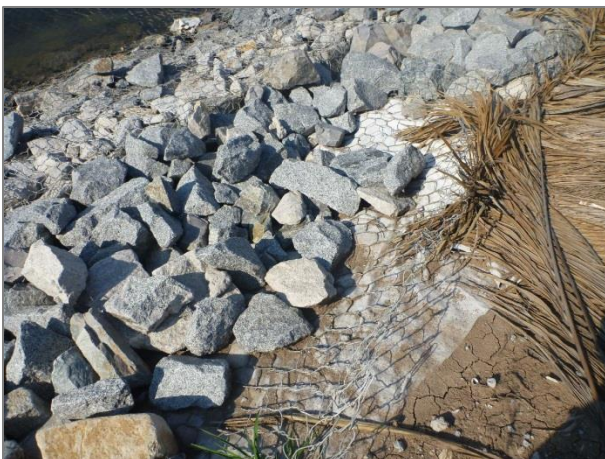
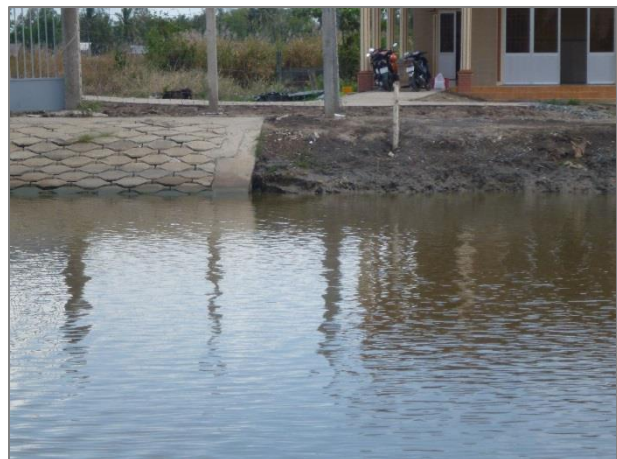
Figure 3-13 Rip-rap prevent and geotextile, sluice new 1 (Sikora) Figure 3-14 Paving stones and scour hole, sluice 8 (Sikora)

Damages exist at each sluice. The main ones are settling of the revetment, scouring at the end of revetment and cracks at and between the concrete plates, but none of these damages hinders the function of the sluice. The expectation of visible corrosion damages caused by the contact with sea water has not been confirmed.

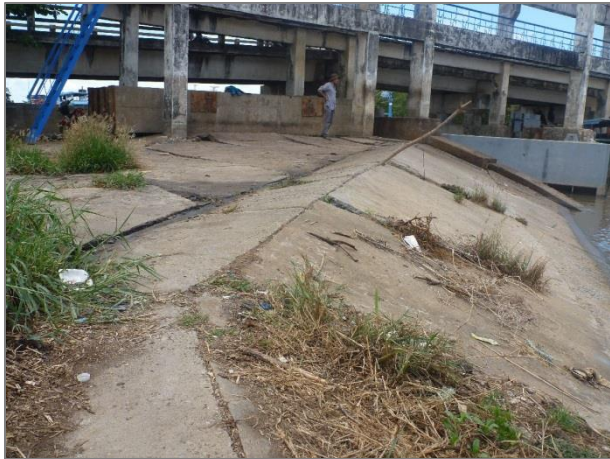
Figure 3-15 Settling of concrete plates, sluice 10 (Sikora)

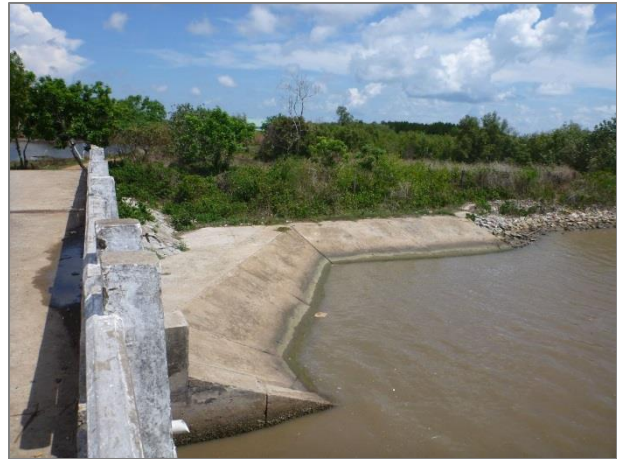
Figure 3-16 Overview of typical revetment arrangement, sluice 7 (Sikora)

As already written, 9 sluices exist and two more are under construction at the investigation area. Their position is pictured in Annex C at the general maps. In Annex B each sluice is described in detail with regard to their construction and condition. The oldest sluice is no. 10, constructed in 1998 between Ca Mau and Kien Giang. All sluice gates are miter gate and have movable concrete plates as safety gate. Except of sluice no. 4 which has 3 sluice gates, all other just have one gate. The sluices just vary in their gate dimensions, which is between 5.50 m and 11 m in width and between 4 m to 6 m in depth, whereby the smallest width of the canal is 30 m and in maximum 80 m. In general the sluice structure gets protected against erosion with concrete plates, whereas for the canal bank protection mostly paving stones and rip-rap prevent is chosen. Further at the sluice gates under construction a geotextile under the rip-rap prevent is visible. All paving stone are octagons with the span of 45 cm and a thickness of 35 cm. The granite stones used for the rip-rap prevent are classified as LMB_{60/300}, according to DIN EN 13383 (Eisenhauer 2002).

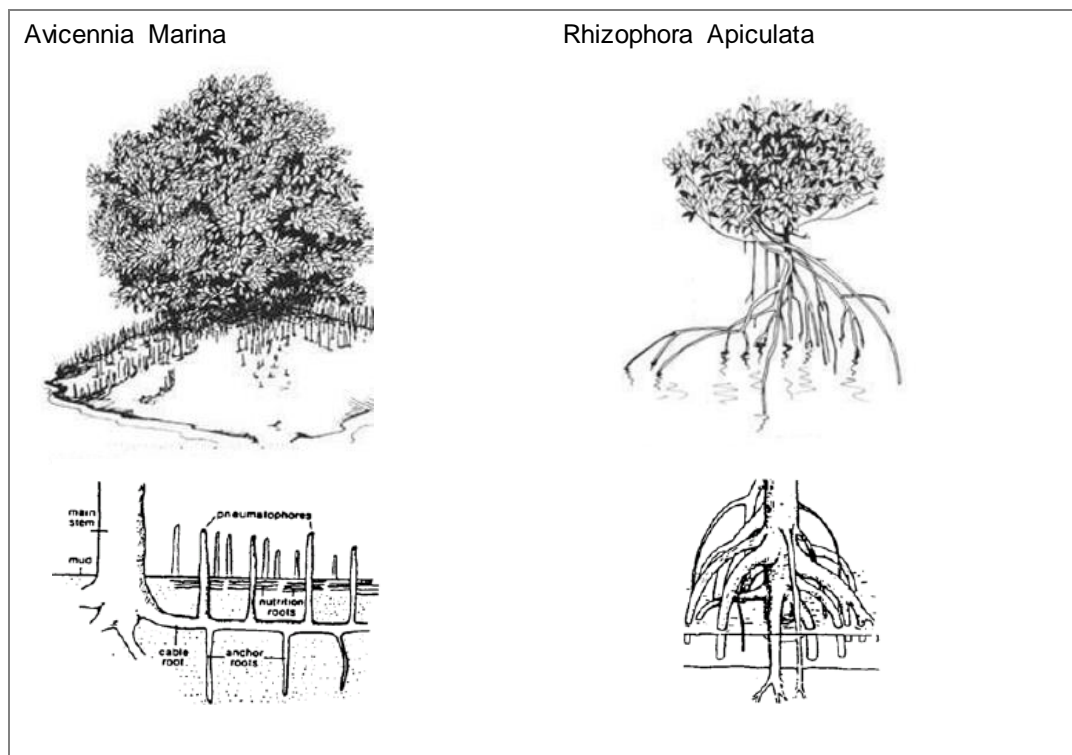
Figure 4-3 Relevant Mangrove species at the investigation area (Burger 2005)

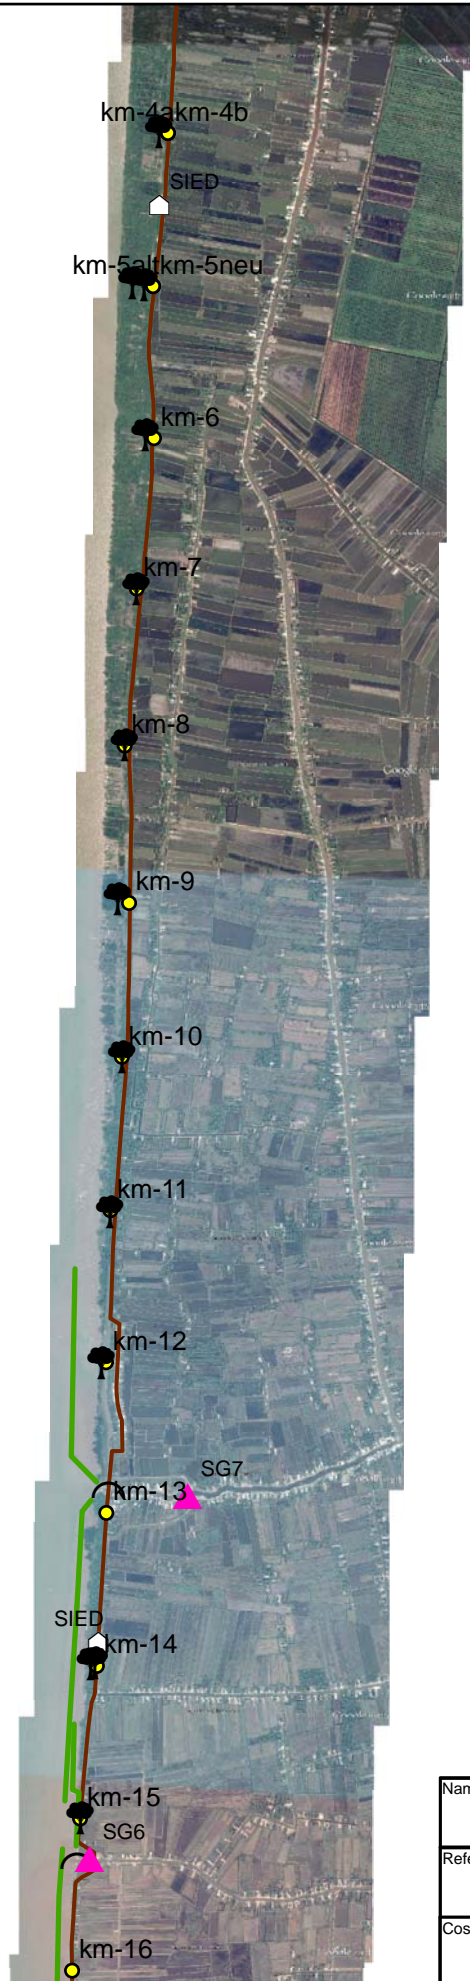
Name: Map 2/7	Content: Section (-28) to (-16)
Reference Scale: 1:50.000	Date: October 2015
Customer: GIZ Vietnam	Author: M. Sikora

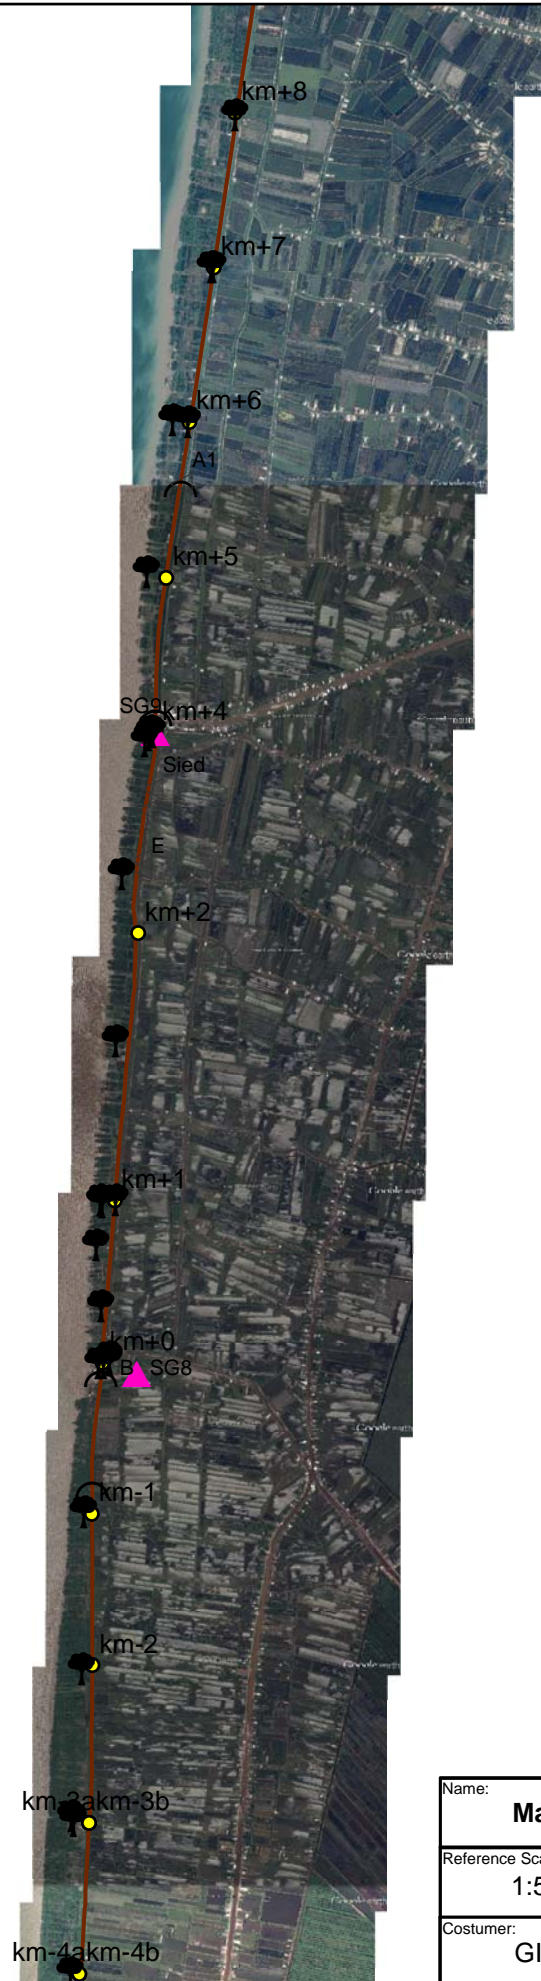
Name: Map 3/7	Content: Section (-16) to (-4)
Reference Scale: 1:50.000	Date: October 2015
Customer: GIZ Vietnam	Author: M. Sikora

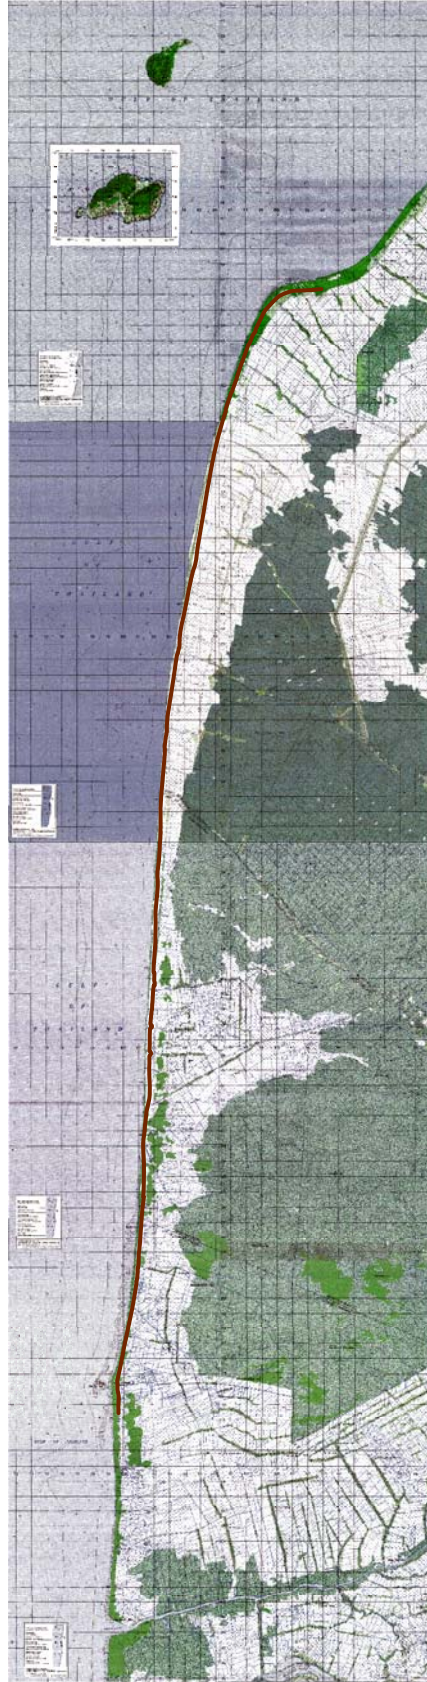
Name: Map 6/7	Content: Section (13) to (29)
Reference Scale: 1:50.000	Date: October 2015
Customer: GIZ Vietnam	Author: M. Sikora
