# Mangrove restoration on degraded, barren land

Approach, results and lessons learnt from Bac Lieu Province

The project "Adaptation to Climate Change through the Promotion of Biodiversity in Bac Lieu Province" is funded by the Federal Ministry for the Environment, Nature Conservation, Building and Nuclear Safety (BMUB) and implemented by GIZ in close collaboration with the Department for Agriculture and Rural Development Bac Lieu. It's objective is to enhance the protective effect of coastal forests through the sustainable use of resources and the promotion of biodiversity.

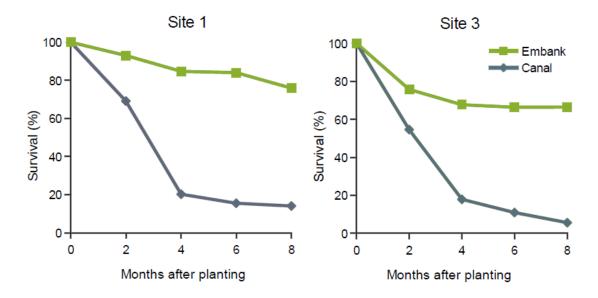
Figure 3: Overall survival rates in canals and on embankments over the first eight months after planting at site 1 and site 3.

After eight months, the overall survival rate on embankments at both sites, planted in 2011, was more than 70 %. Considerable seedling mortality on the embankments had been expected during the first dry season due to a lack of water, but as shown in Figure 3, most seedlings died during the first two months after planting, before the onset of the dry season. Very few seedlings died during the dry season, implying that their roots were well enough developed to tap sufficient subsurface water to survive over the dry season, even though the top 20 cm of soil was quite dry (around 30 % by weight). However, it should be noted that the dry season of 2011-2012 was atypical in that it was much 'wetter' than average, and this, too, could account for the good survival over the dry season. In addition, although unconfirmed, it is likely that water moved laterally and perhaps vertically from the canals into the subsurface soil of the embankments, thereby supplying water to seedlings with roots deep enough to tap it.

On the other hand, survival was very low in the canals at both sites in 2011 (Figure 3). This was most likely a result of the very high rates of sediment deposition in the canals, which buried many of the seedlings. While some sediment accumulation in the canals was expected, the very rapid infilling around the mouths was not expected. Not only did this bury many of the seedlings, it also prevented the canals from draining fully, thus leading to more or less permanent ponding of the canals, a condition that most mangroves do not handle well. After considerable infilling of the canals with sediment in 2011, *Bruguiera cylindrica* was planted in the canals in 2012. With the experience from sites 1 and 3, no seedlings were planted in the canals in the year of establishment (2012) at sites 2 and 4.

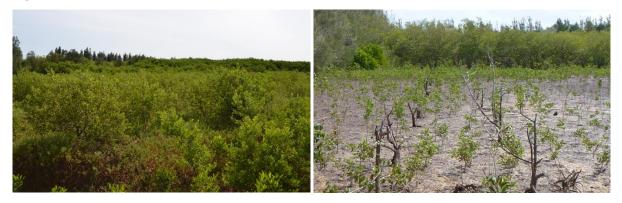
Figure 9: Left: Canopy development of Lumnitzera at site 3 (with land preparation) after one year; and right: Canopy development at a site without land preparation after one year

In November 2013 salinity was measured at a planting site without land preparation on which seedlings had been growing for 16 months. The salinity was at an average of 51ppt, which is double of what was recorded at a prepared planting site. Comparing these values to the plant development (Figure 9), it can be concluded that salinity highly affects the growth rate of seedlings.

Given that *Lumnitzera*, and to some extent *Xylocarpus*, appear to grow successfully on embankments adjacent to canals, it is fair to question whether they would also grow equally well on high land of a similar elevation without the need to dig canals, thereby reducing the cost of afforestation appreciably? As indicated above, in the 2011 plantings at Sites 1 and 3, it is highly probable that water moved laterally from the canals into the subsurface layers of the embankment, which could have been a critical factor contributing to survival over the first dry season. This question is currently being tried to be answer with plantations in 2012 and 2013. In 2012 *Lumnitzera* was planted on a small patch of elevated, barren land without land preparation. The survival rate is slightly lower than at the reference sites with land preparation, but the canopy and overall plant development is much worse as seen in Figure 9.
