Project-No.: 13800-01

Construction supervision of bamboo fences in Bac Lieu Province, Vietnam

Coastal Forest and Ecosystems Management

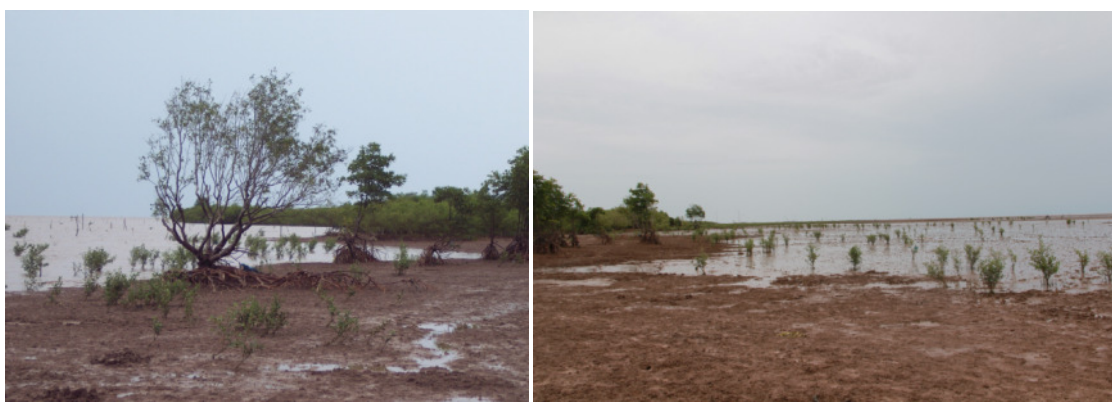
In the frame of a baseline study in December 2011 different locations along the coast of Bac Lieu Province were evaluated concerning erosion (ALBERS, 2012B). In the area around location 4, approximately 5 km southwest of the border to Soc Trang Province, local erosion occurs (Figure 1). This location has been chosen as the first construction site for the bamboo fences (Figure 2).

Figure 1: Local erosion at location 4

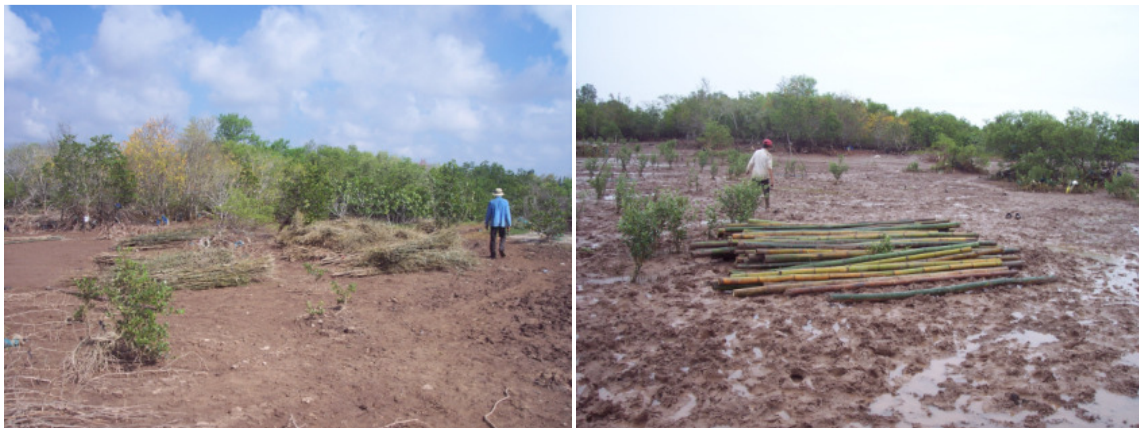
A temporary place for the storage of the bamboo, the bundles, the connection material and the tools needed for the installation was set up at a higher position on the remaining floodplains at location 4 (Figure 4).

Figure 4: Temporary storage place

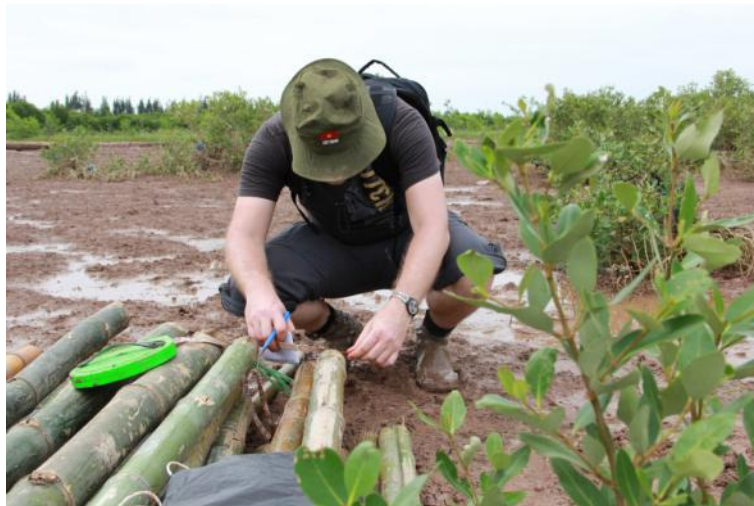
During the construction the length and the diameter of numerous bamboo poles was measured (Figure 5). The mean diameter of the poles was 69.5 mm. The mean length was 3.00 m. Thus, the length and the diameter of the bamboo poles fulfilled the requirements of the tender. The characteristics of the used bamboo exceeded the values assumed in the design of the structure (ALBERS, 2011).

Figure 5: Measurement of the diameter of the installed bamboo

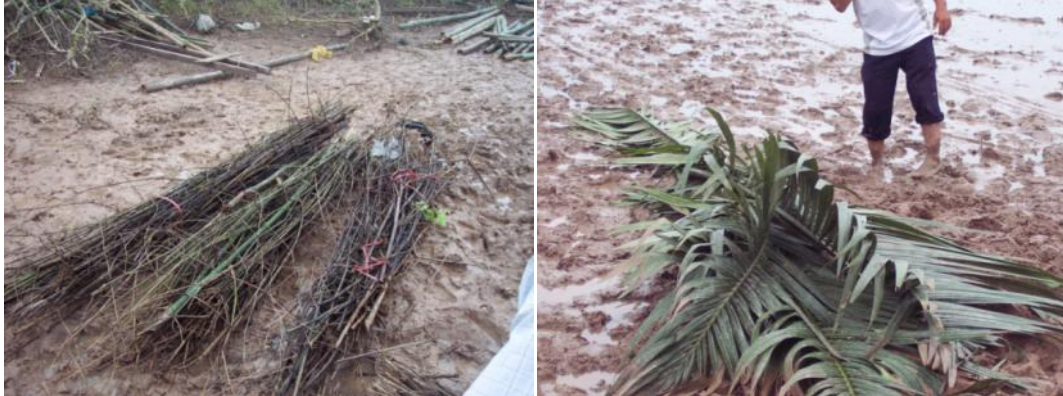
For the bundles smaller bamboo branches were tied up (Figure 6, left). The length of the bundles was between 2.00 m and 2.50 m.

The dimensions, density, permeability and the flexibility fulfilled the requirements of the tender documents.

Additionally Nypa leaves were delivered for the installation in the bamboo fences (Figure 6, right).

Figure 6: Bundles (left), Nypa leaves (right)

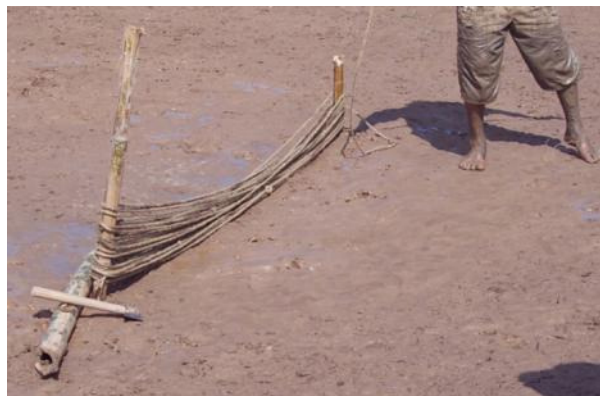
In the tender documents the connection material was defined to be rattan. This material was also used during the construction of the sample section in December 2011 (ALBERS, 2012A). Before the construction started, the contractor mentioned a problem with the tendered material: Rattan with the required quality is hard to find in sufficient quantity, available rattan is of poor quality. In a site consultation meeting on May, 16th alternatives were discussed. Nylon lines were refused due to the low inner friction, the poor handling and especially the short durability (in UV light). Jute rope was agreed upon (Figure 7). It is a natural product and its advantages are:

- High tensile strength
- High durability
- Good handling
- Availability

Figure 7: Jute rope

The connections of the vertical and the horizontal poles were made using joint lashes (Figure 14). As preparation of the works the jute rope has been cut into pieces of approximately 2.0 m lengths (cf. Figure 7). The connection of the horizontal bars to the vertical poles could be used to adjust the vertical poles to a certain extend.

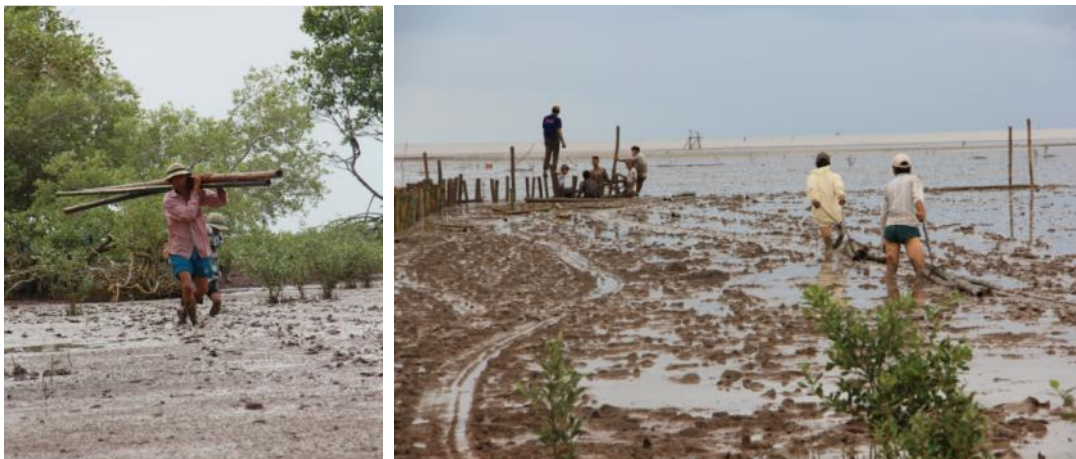
For the construction of the fences the bamboo and the bundles were brought from the temporary storage place on the floodplain to the site of installation just in time. They were carried or pulled by the workers through the mud or water. Especially during low water when the mud-flats fell dry this was a hard and time consuming work in the mud (Figure 8). While the water level was high enough materials were floated out to the site of installation.

Figure 8: Transport of the bamboo and the bundles through the mud

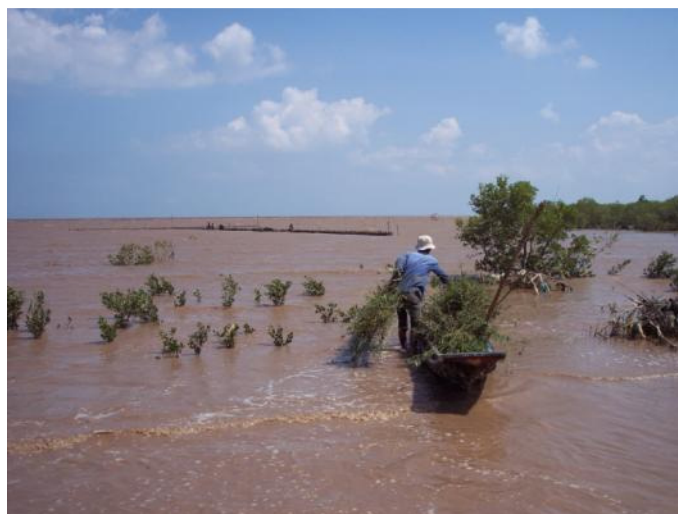
Occasionally a long-boat was used to bring larger amounts of bamboo and bundles to the site of installation (Figure 9). This was a fast and more convenient way of transportation.

Figure 9: Transport of materials using a long-boat

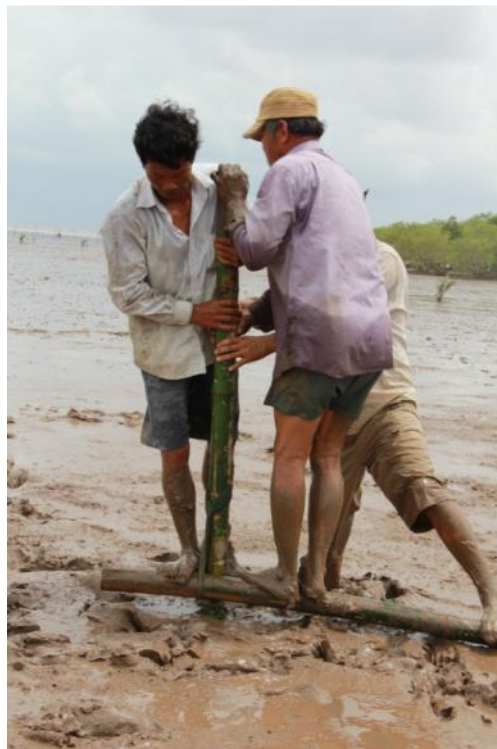
The vertical poles were installed manually. After being transported to the site of installation, they were put into the right position and adjusted along the cord. First they were stuck into the mud as deep as possible. Afterwards teams of three to four workers pulled the poles down to the required depth using their own weight. Therefore a rope or belt was attached to the bamboo pole and another bamboo poles was stuck through the loop that formed the other end of the belt or rope. Then, the workers stood on the horizontal poles and pulled the vertical poles into the mud (Figure 10). This procedure was similar to one of the installation methods executed at the sample section in December 2011 (ALBERS, 2012A).

Figure 10: Installation of the vertical poles

Due to rests of roots or other items in the soil, some of the poles could not be pulled completed to the depth indicated in the drawings. If this is locally limited, it does not have an influence on the stability of the fences. The contractor was ordered to cut the lap poles on the required level.

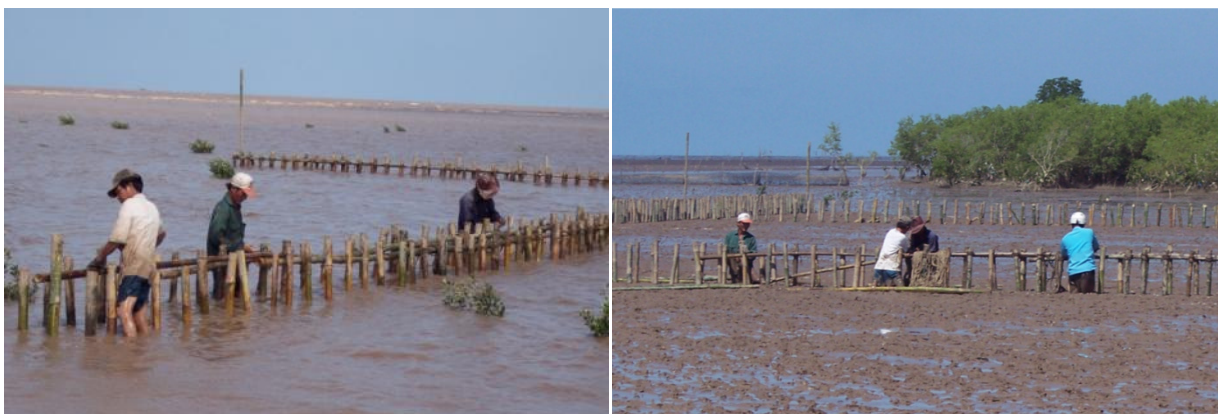
After installation of the vertical poles the horizontal bars were connected according to the construction drawings. Therefore straight bamboo poles were pre-selected. Teams of two workers first attached both ends of the bars and then fixed the other connections. At the construction site this work could be done almost tide-independent (Figure 11).

Figure 11: Connection of the horizontal bars

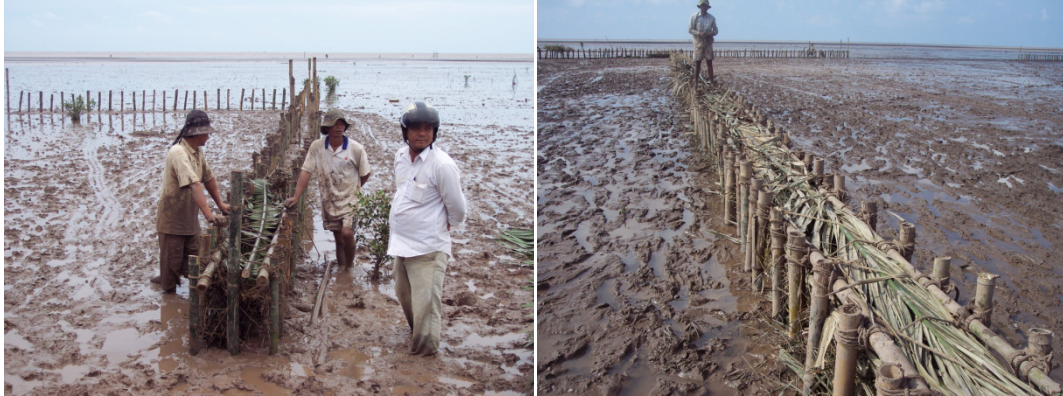
After installation of the horizontal bars the bundles were put between the two rows of bamboo poles (cf. Figure 12). A man's load was used to compact the bundles. Two or three layers of bundles were installed. The top layer was attached to the horizontal bars and the vertical poles. The bundles should always be installed flush with the vertical poles and must have an open structure with smaller branches.

Figure 12: Different grades of completion of the fences

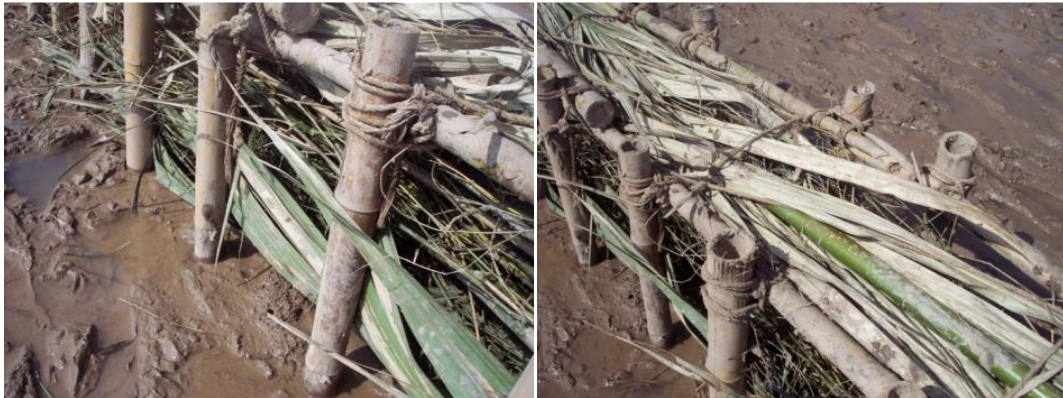
The nypa leaves with its dense structure of the single leaves were used as the bottom layer of the bundles (Figure 13, left). Thus, they have a function of scour protection at the interface of the poles, the soil and the water column.

For the top layer of the bundles also nypa leaves were used (Figure 13, right). The thick trunk of the leaves is helpful to tie down the bundles and the structure of the single leaves forms a dense closing-off.

Figure 13: Nypa leaves as bottom layer (left) and top layer (right) of the bundles

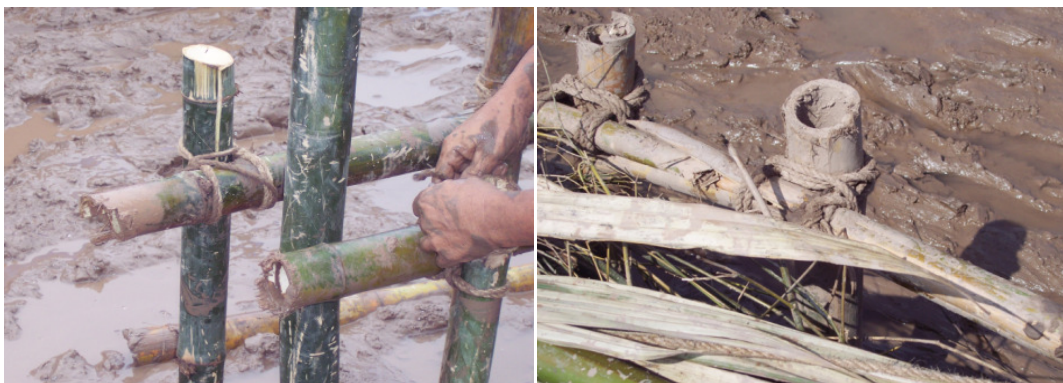
Figure 14: Joint lashes with jute rope

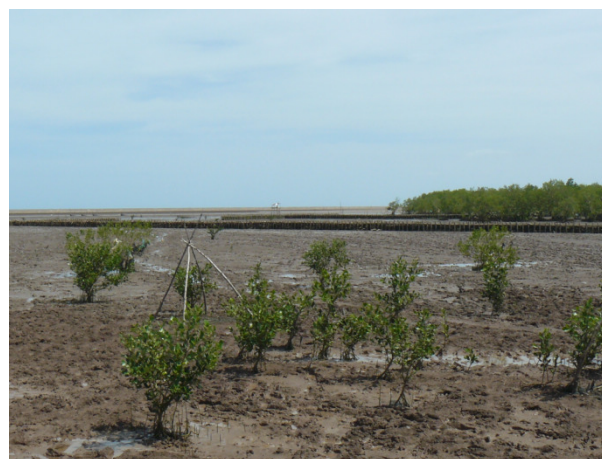
At the time of construction in the surroundings of the breakwater many young mangroves were found (Figure 16). Those mangroves can be used as an indicator for the influence of the fences. For example, transects at the construction site can be defined to carry out a mangrove monitoring. The exact position of the transects and the detailed procedure have to be defined by the GIZ project.

Figure 16: Young mangroves at the site of the fences

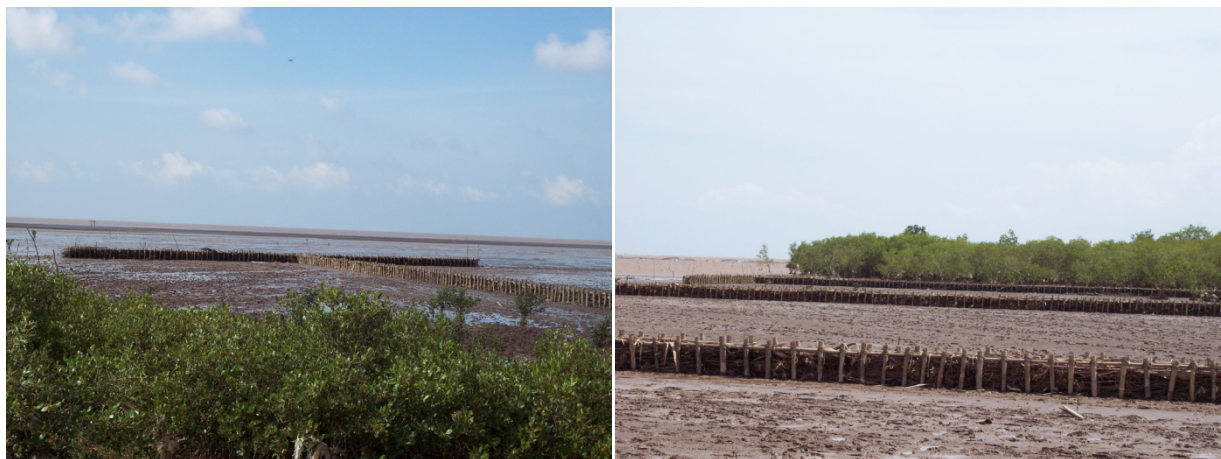
Figure 17: Completed fences
