DIKE SURVEY REPORT

Results of an initial dike inspection in the Ca Mau Province

GIZ in Vietnam

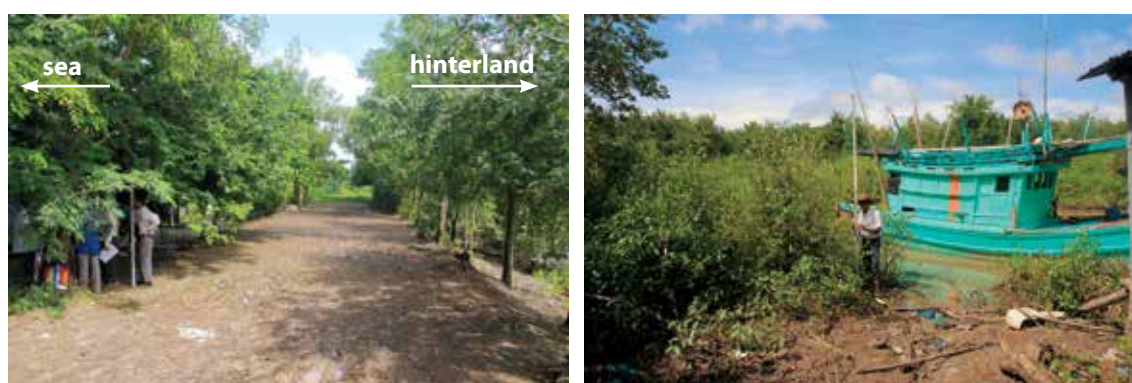
The visited dike section in the Khanh Tien commune lies a bit northern of Hoang Mai and is part of the West-Sea dike. The dike inspection of this site was carried out with a larger team including a land survey team and technicians to take soil samplings. Figure 6 (left) pictures the dike. The dike crest is not paved or covered with grass/plants. Vegetation can be found on the seaward and landward dike slope and trees exist at the transition from the slopes to the dike crest. In front of the dike one can see scattered households and a big trench that was created due to the excavation of dike material and is now used as a channel for boats (see Figure 6 right). A mangrove forest exists between this trench and the sea. The hinterland is used by private aquaculture farms that lie directly at the toe of the dike.

Figure 6: View along the dike (left) and dike foreland (right)

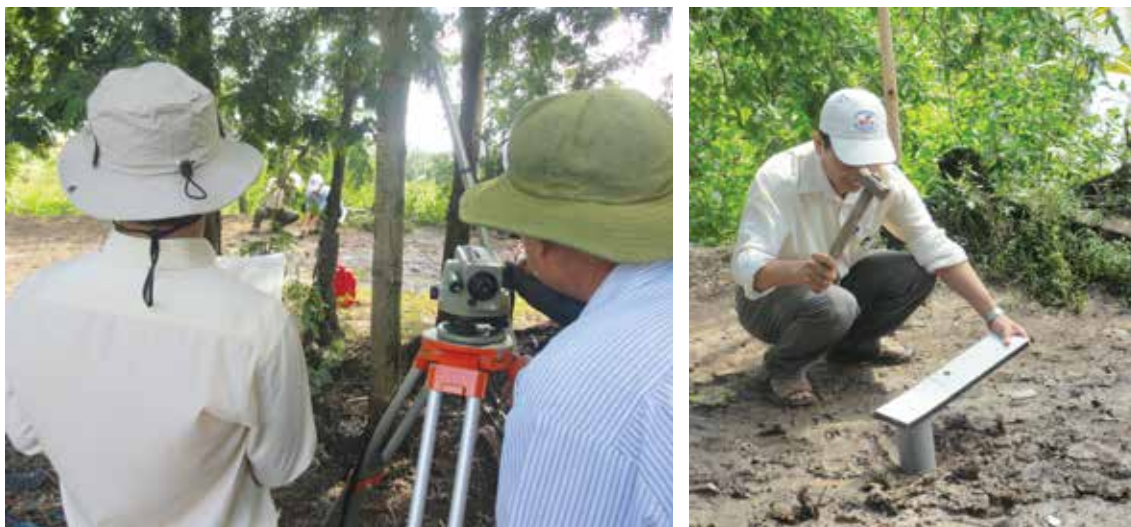
The terrestrial survey was carried out according to Vietnamese national standards by a land surveyor and assistants. The cross-profile of the inspected site was measured. A nearby national benchmark helped to refer the measured elevations to the reference height. Furthermore, dike material samplings were taken to analyze those in the laboratory according to Vietnamese national standards. Figure 8 shows the land survey of the cross-profile (left) and the process of taking a soil sampling (right). First results of the terrestrial survey illustrated that the dike crest settled for about 1 m (design height was 2.5 m, now the dike crest lies at about 1.5 m). The detailed results are presented in the related report of the Southern Institute for Water Resources Planning (SIWRP). A finger test on the dike material has been carried out by an expert and showed that proper material was used for the dike construction (appropriate mixture of clay, silt and sand). The exact grain size distribution and further soil-mechanical parameters, such as the Atterberg limits of dry density, are given in the report of SIWRP.

Figure 8: Land survey (left) and soil sampling (right)

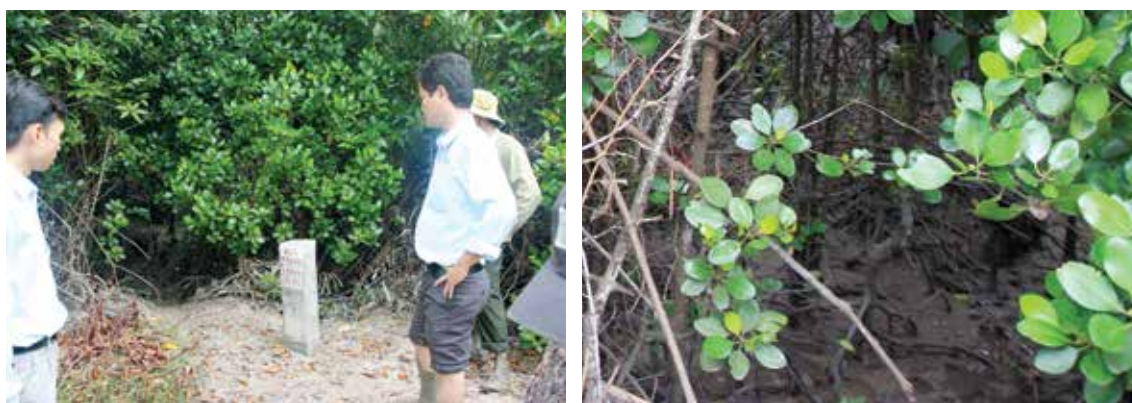
No sea dike exists in the Dam Doi district yet. A wide mangrove belt (about 3 km) that is zoned into protected mangroves (aquaculture and harvesting permitted) and critical mangroves (no people living, harvesting forbidden) can be found. The border between both zones is marked by milestones (ca. every 500 m, picture see Figure 10 left, GPS data and a map available at DARD). About 1 km of mangrove forest is in front of the milestone line. It is suggested to build a dike inland from the milestone line; the cutting of the mangroves that exist there would be accepted. Dike construction material would be taken from nearby areas (e.g. dried soil from dredging channels). The milestone line is covered by mangroves and hard to access; further investigations (especially field tests) will not give much more information at the moment or may not be possible.

Figure 10: Milestone at N 08°49'38.6" E 105°18'37.0" (left) and view along milestone line (right)

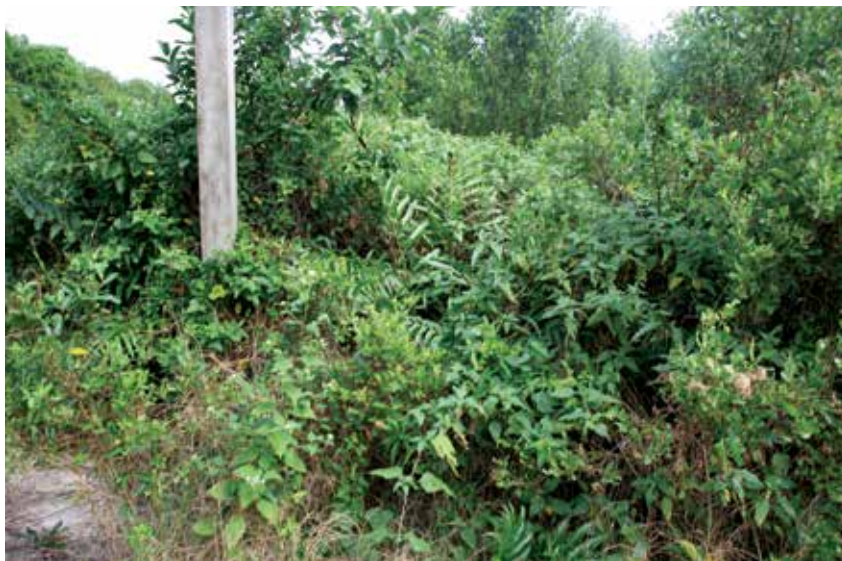
In a distance of 200 to 300 m from the channel Song Cua Lon, the river dike in the Lam Hai commune can be found nearby the bridge that is momentarily constructed to connect Ngoc Hien with the rest of the Cà Mau province. In some parts much vegetation can be found on the dike crest (see Figure 12); in other parts aquaculture embankments cover the dike crest (see Figure 13 right). A trench (not used) exists in front of the dike, followed by mangroves (see Figure 13 left).

Figure 12: View along the dike line (03.01.2014 #2)

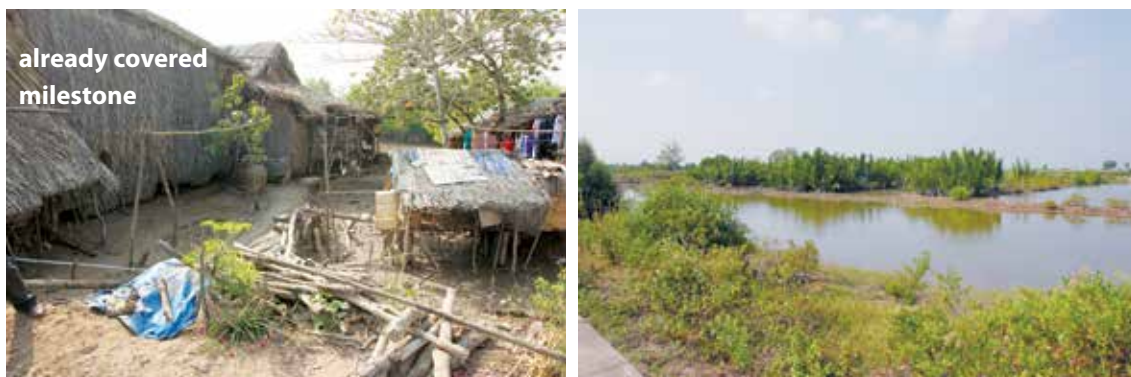
Yet no river dike has been built in the Dat Moi commune. However, construction preparations were undertaken by placing milestones ca. every 300 m. Some of these milestones are now already partly covered by constructions of the local people (see Figure 17 left). The distance between the channel and milestones is about 50 to 100 m. It is planned to build a dike along the milestones. The line of milestones leads through aquaculture ponds, houses and further obstacles (see Figure 17).

Figure 17: Milestone at N 08°45'18.1" E 104°57'09.2" and surroundings houses (left), nearby aquaculture farms (right)

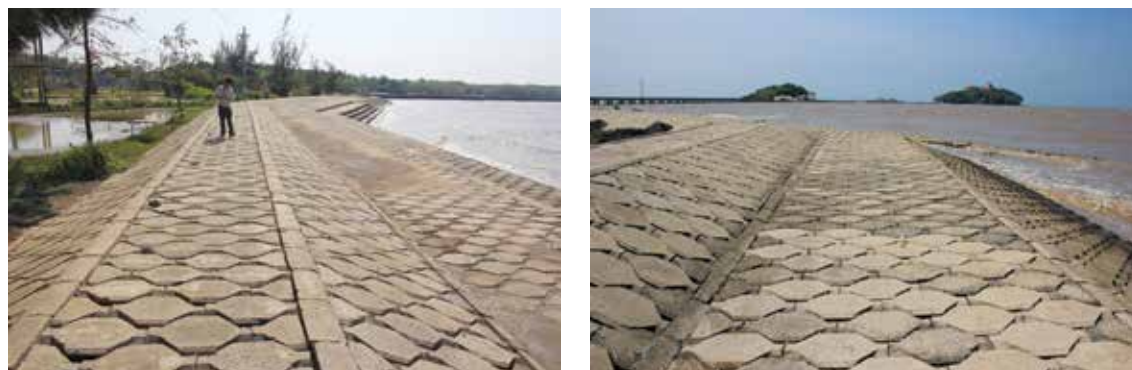
In the Khanh Binh Tay commune near the Hon Da Bac island, a 1.2 km long dike with convex corners in the dike line (bend to the seaside) can be found. Construction works of this dike section began in 2009 according to the design plans and were finished at the end of 2011. The seaward dike slope as well as the dike crest and landward slope are covered with interlocking concrete slabs which were produced by a factory in the Cà Mau province. Additives to make the concrete resistant against saline influences were used. The dike shows regular slopes, respectively a stepped slope in some parts, and a seaward berm in cross-profile. Figure 23 pictures the existing dike.

Figure 23: View along the dike line (20.01.2014 #2 left and #4 right)

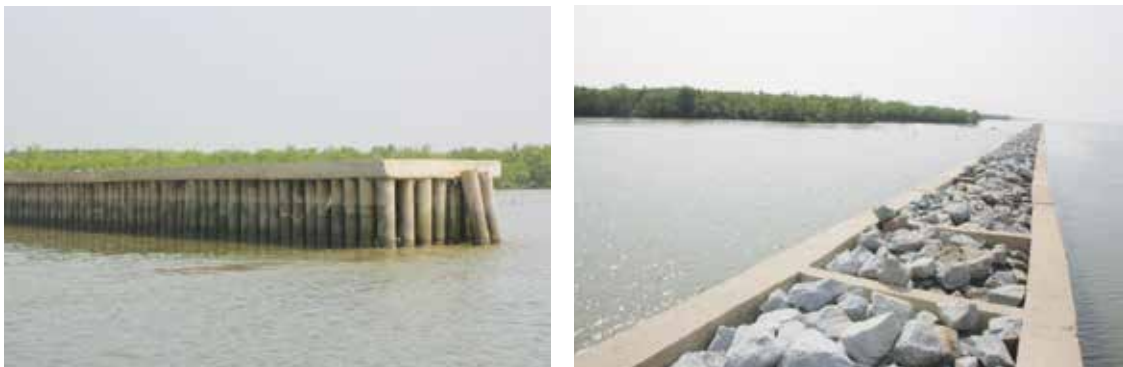
At the channel exit of K. Tan Bien between Phu Tan and Tan Hai commune (N 08°55'44.3" E 104°47'56.9"), a breakwater was constructed to prevent erosion and increase sedimentation. This breakwater was constructed in 2012 with two rows of concrete piles and stones in between. The construction covers both sides of the channel exit, leaving a gap of about 30 m between the two sections to allow boats passing through. The following pictures give an overview of the construction and its surroundings.

Figure 29: Breakwater at the channel exit of K. Tan Bien between Phu Tan and Tan Hai commune

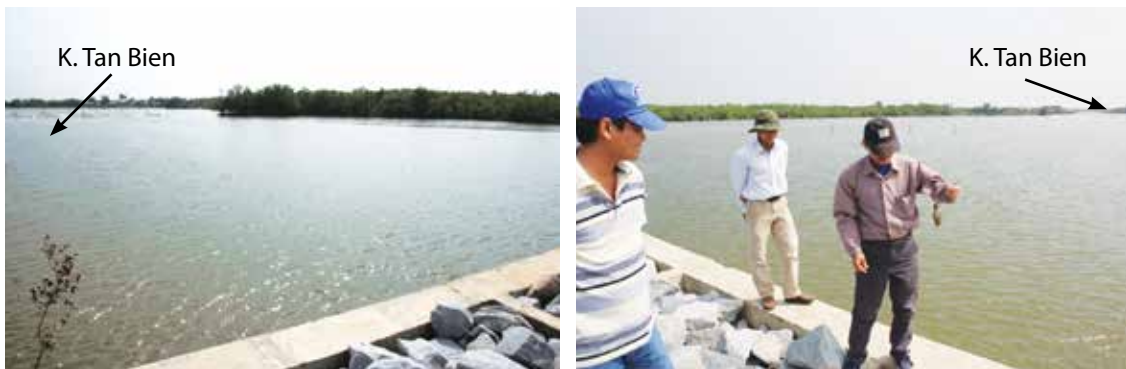
Figure 30: Surroundings of breakwater at the channel exit of K. Tan Bien between Phu Tan and Tan Hai commune

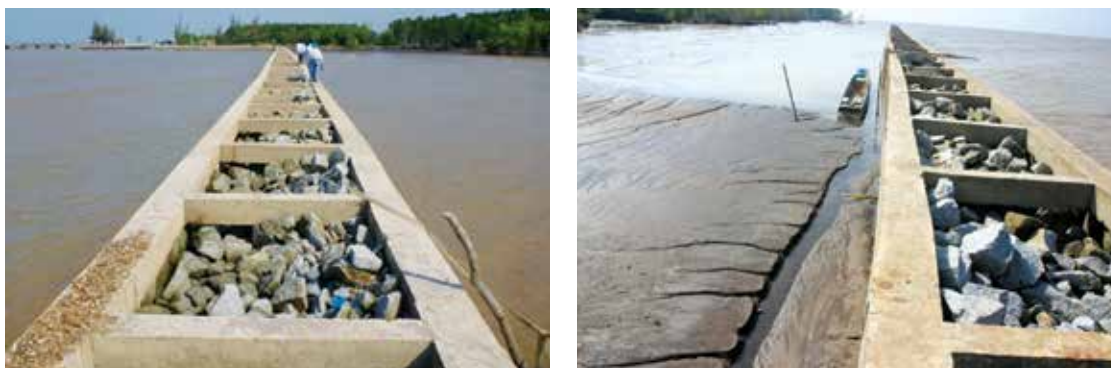
Next to the visited dike section in Khanh Binh Tay commune (see chapter 3.4.2, near 20.01.2014 #1, N 09°10'32.8"E 104°48'31.9"), a breakwater was constructed to prevent erosion and increase sedimentation. This breakwater was constructed with two rows of concrete piles and stones in between. The following pictures give an overview of the construction and its surroundings.

Figure 31: Breakwater in Khanh Binh Tay commune near Hon Da Bac island

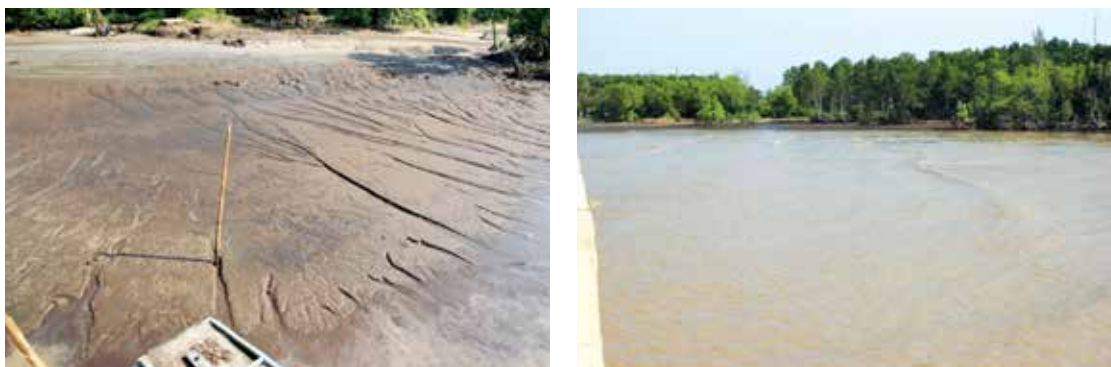
Figure 32: Surroundings of breakwater in Khanh Binh Tay commune near Hon Da Bac island

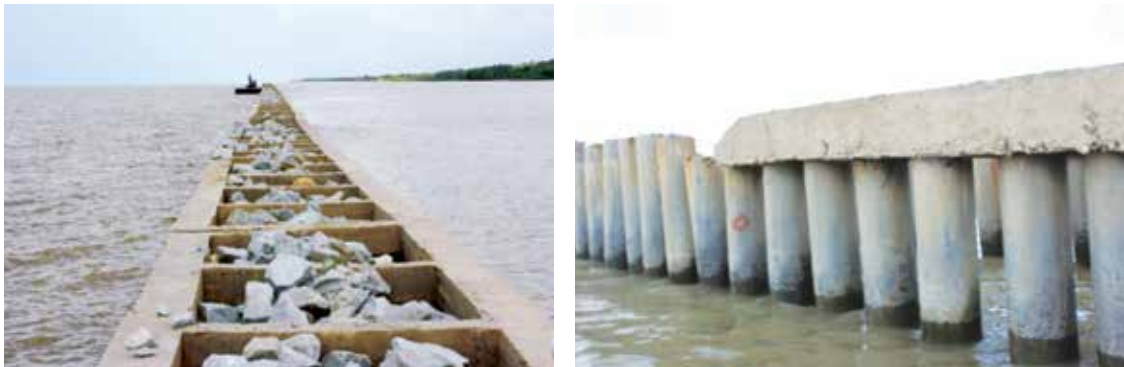
In Khanh Tien commune (see Annex D for map), a breakwater was constructed to prevent erosion and increase sedimentation. This breakwater was constructed with two rows of concrete piles and stones in between. The following pictures give an overview of the construction and its surroundings.

Figure 33: Breakwater in Khanh Tien commune

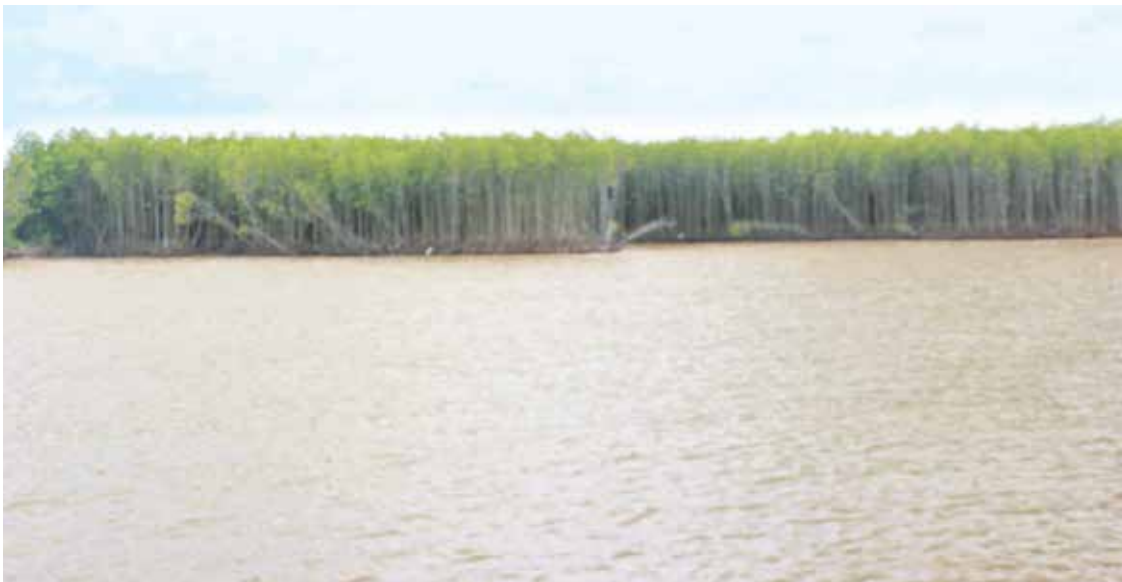
Figure 34: Surroundings of breakwater in Khanh Tien commune

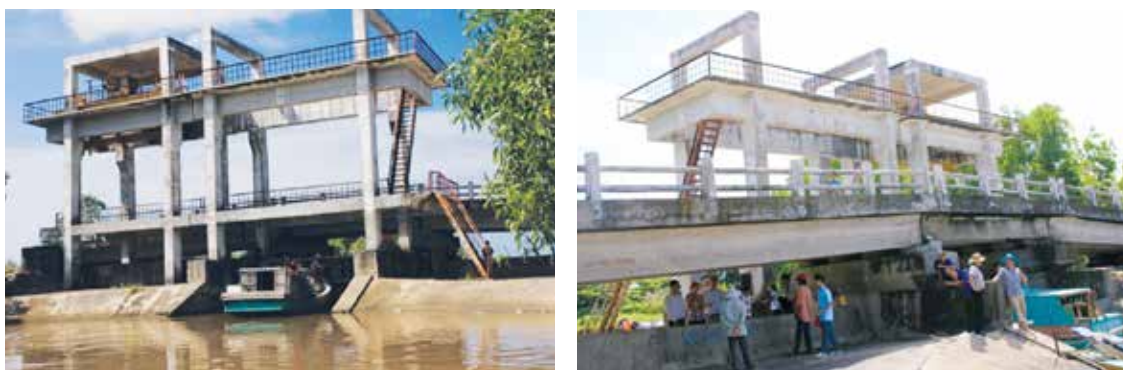
In Khanh Tien/Khanh Hoi commune (see Annex D for map), a sluice gate was constructed. The channel exits outside the sluice gate are on both sites protected by gabions to prevent erosion. At one side a breakwater is connected to the gabions (see Figure 37). The following pictures give an overview of the constructions and their surroundings.

Figure 35: Sluice gate in Khanh Tien/ Khanh Hoi commune: inland view (left) and seaside view (right)

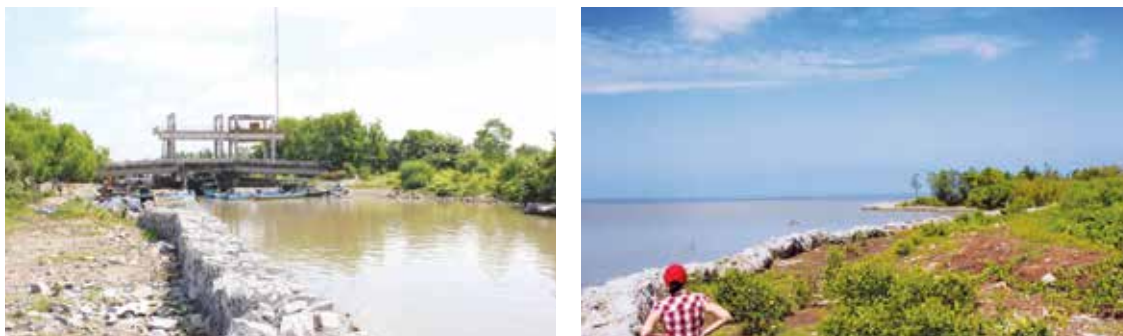
Figure 36: Gabion protection at sluice gate in Khanh Tien/ Khanh Hoi commune

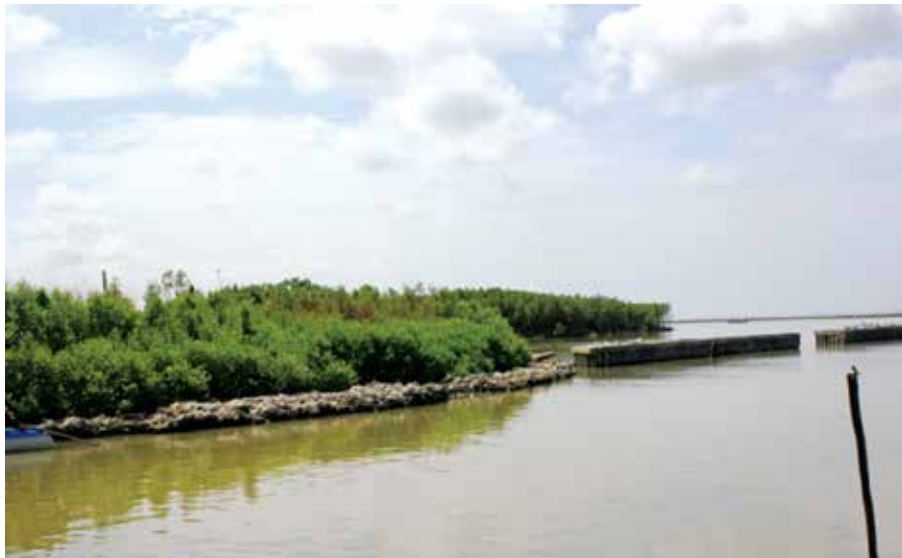
Figure 37: Gabion protection at sluice gate in Khanh Tien/ Khanh Hoi commune and connected breakwater

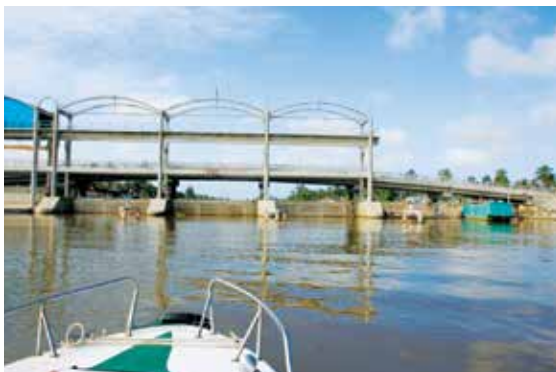
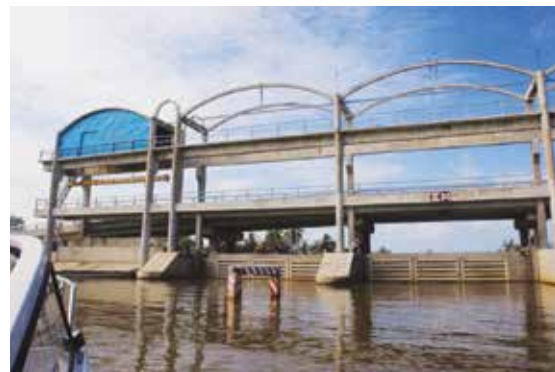
Figure 38: Sluice gate in Khanh Hoi commune: inland view

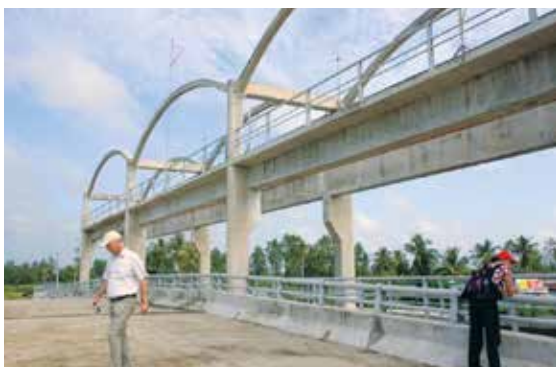
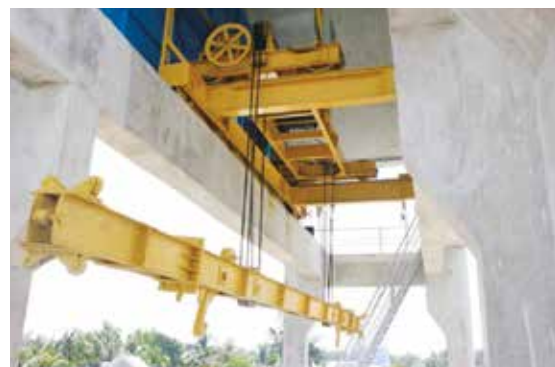
Figure 39: Sluice gate in Khanh Hoi commune
