SEA DYKE REHABILITATION in Kien Giang Province

TECHNICAL REPORT
November 2008

Sea dyke rehabilitation in Kien Giang Province

Technical Report on the Reconnaissance Mission - November 24th to 28th 2008

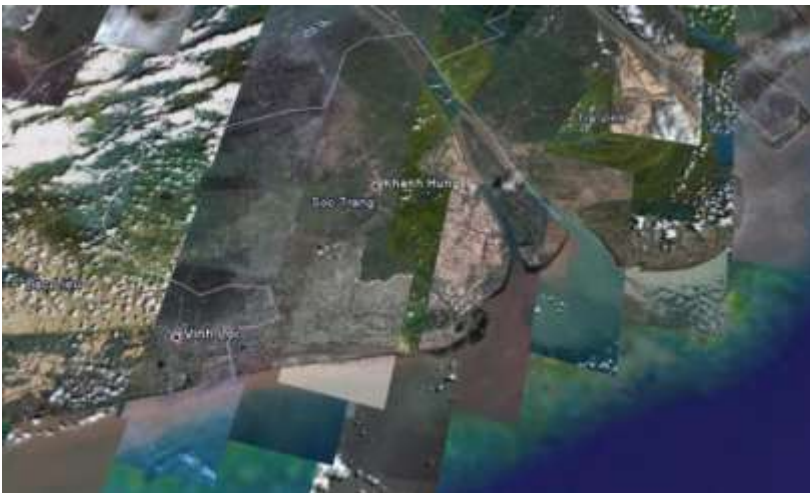
Photo 3: Area south of Soc Trang

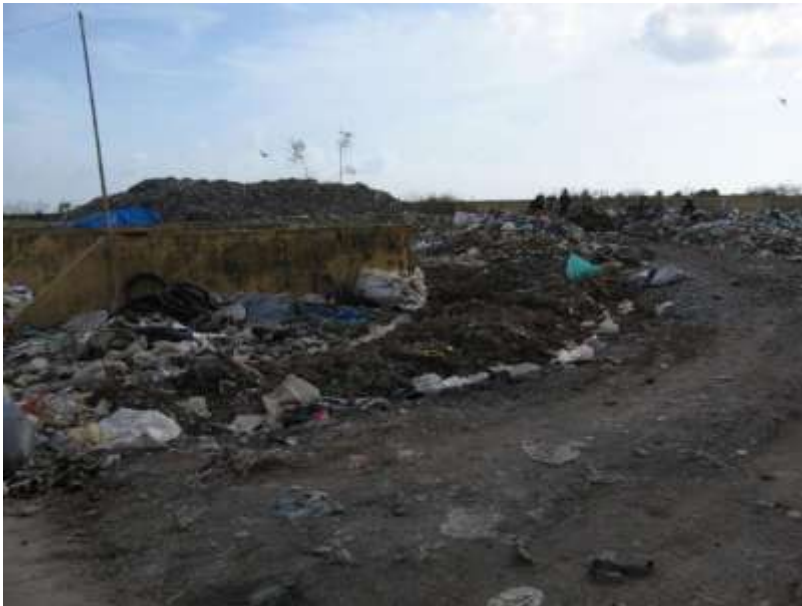
The team also visited a waste disposal area which was built further west close to the shore and outside the dyke protected zone. The access to the disposal area is by means of a dam which connects to the dyke. The disposal area is surrounded by a concrete wall of approx. 1.5 m height, obviously built for protection against flooding.

Photo 10: Waste disposal Area at Soc Trang district
